BP Deepwater Horizon Investigation: Preliminary Insights

Tommy Roth
Vice President, Cementing Product Service Line

John Gisclair
INSITE Support Service Coordinator
September 26, 2010

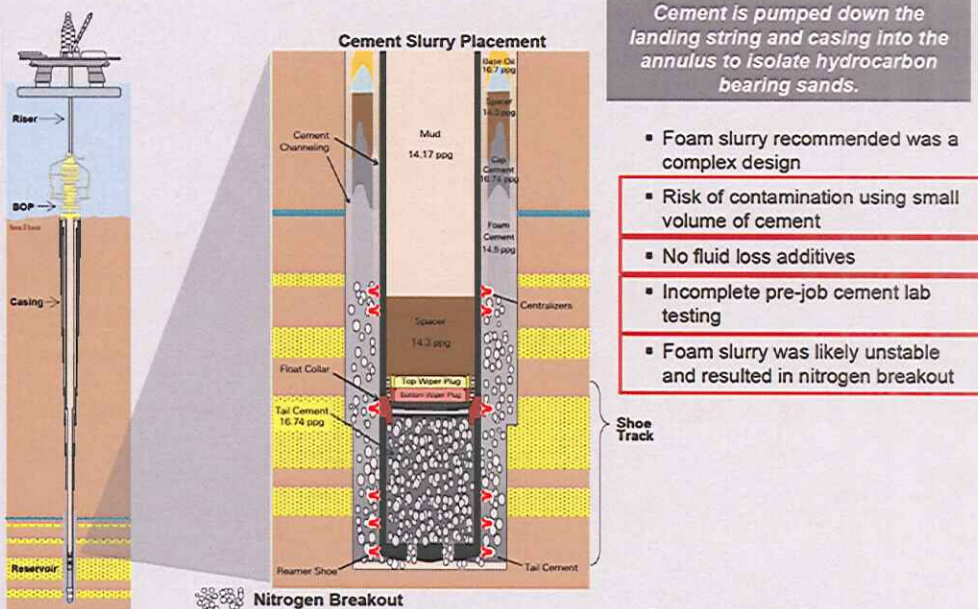
Key Finding #1

The annulus cement barrier did not isolate the reservoir hydrocarbons

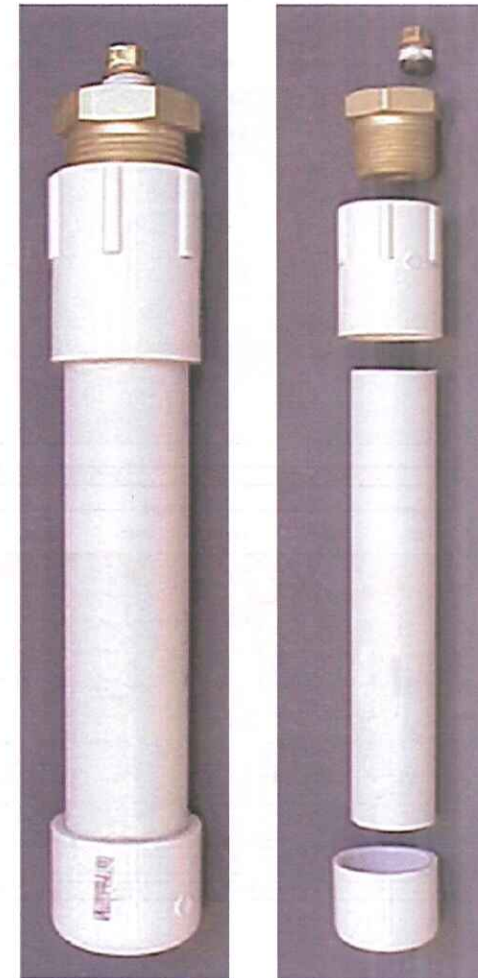
Foam Stability Test

- 16.7 ppg base slurry was mixed per API standards, using rig cement blend and rig water
 - D-Air 3000™ was included in the rig blend that was tested
 - D-Air 3000™ is used to removed entrained air during initial mixing of slurry to ensure accurate surface slurry density
- 16.7 ppg base slurry was conditioned for 3 hours
- 16.7 ppg base slurry was foamed to 14.5 ppg using API's 5-blade foam blender
 - The base slurry foamed in 8 seconds
 - The 5-blade foam blender best represents the energy imparted from the Halliburton field foam generator
- The foam slurry was transferred to a stability test cell and cured for 48 hours
- Foam slurry passed all API 10B-4 9.3.4 requirements
 - The density of the cured foam slurry, using the Archimedes principle, was identical at top and bottom
 - Indicates no free water
 - Indicates no settling

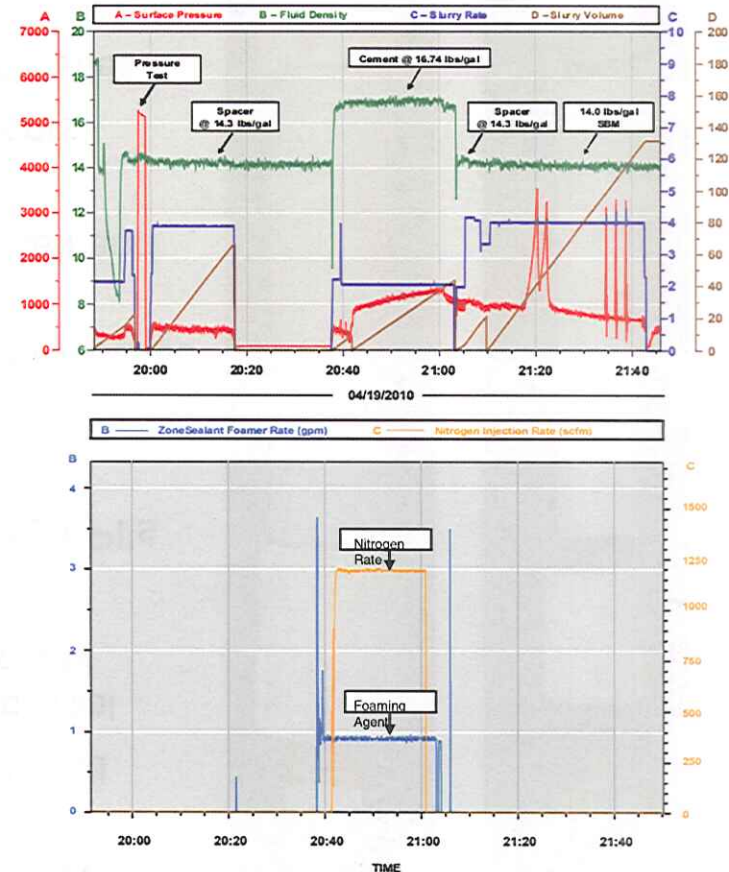
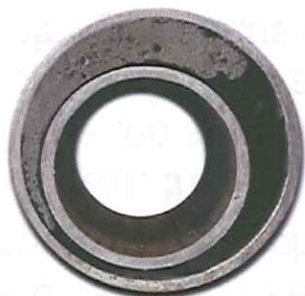
Foam cement mixed and placed in Macondo 9-7/8" X 7" production casing was per design.

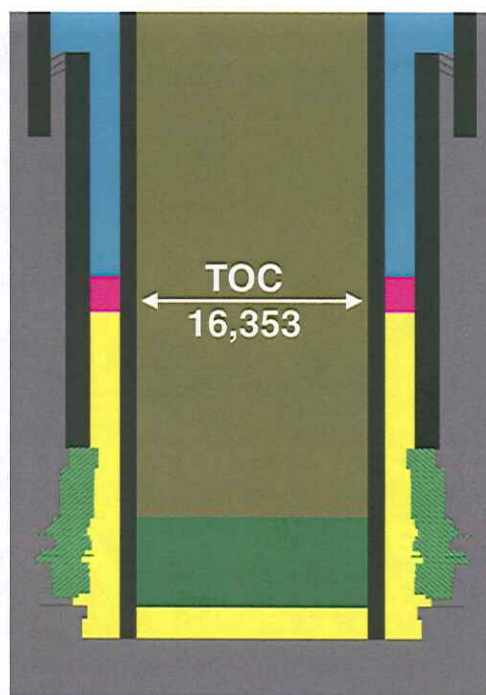
Modeled with 7 Centralizers

**OptiCem™ modeling
indicated significant
channeling would occur
across the reservoir with
only six centralizers
installed**

- OptiCem™ was also run with 10 Centralizers
- Channeling was still predicted
- OptiCem was run with 21 centralizers
- No channeling was indicated
- Casing was loaded on rig with 6 centralizers
- 15 additional Weatherford centralizers were flown to the rig as specified by BP, but BP chose not to use them

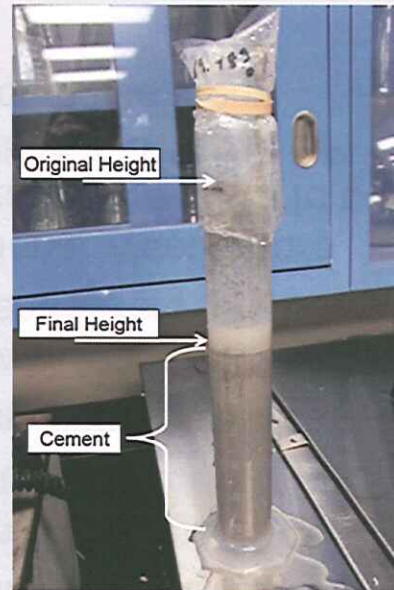
Unstable Foam Sample

An independent lab completed over 500 tests on a representative cement slurry and reported the following:

- 50% quality foam at surface conditions was not stable
- 18.5% quality foam (downhole quality) was not stable
- Yield point of the Halliburton slurry was too low for the foam cement (2 lb / 100 ft² yield point at 135 deg F)
- Fluid loss for the base slurry was excessive compared to industry recommendations (302 cc versus 50 cc per 30 min)

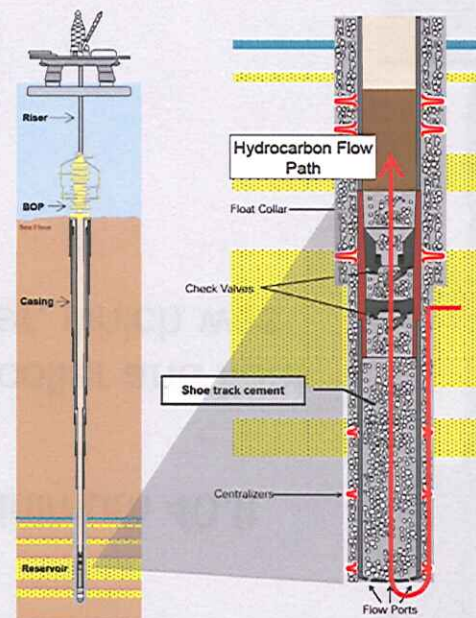
Tail cement is displaced down the casing into the shoe track. The tail cement is designed to prevent flow from the annulus into the casing. The float collar valves, which provide a second barrier, must close and seal to prevent flow up the casing.

- Shoe track had two types of mechanical barriers: cement in the shoe track and the double check valves in the float collar
- Shoe track cement failed to act as a barrier due to contamination of the base slurry by break out of nitrogen from the foam slurry
- Hydrocarbon influx was able to bypass the float collar check valves due to either:
 - Valves failed to convert or
 - Valves failed to seal
- Flow through shoe confirmed by fluid modeling and Macondo static kill data

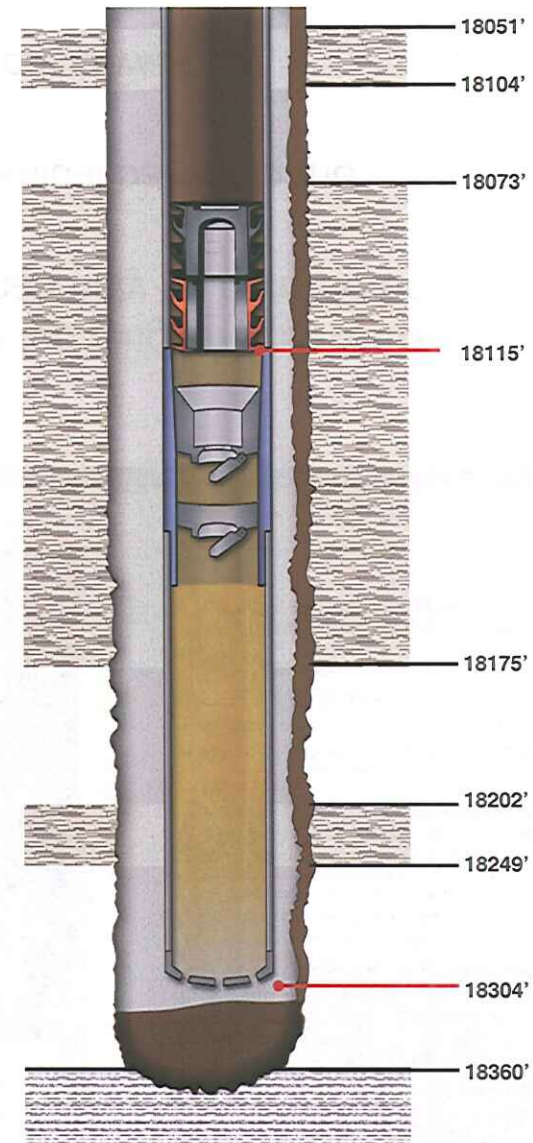
BP's Shoe Track Design

- Drilling was suspended at a total depth of 18,360 ft. with penetration of the loss circulation zone
- Lowest hydrocarbon zone is located at 18,249 ft.
- Annular volume is 1.7 barrels above the bottom of the casing
- Based on BP's well design, the Weatherford float collar was placed at 18,115 ft.
- Bond log tools typically require minimum 40 ft below lowest zone of interest
- Industry practice is to use a float collar and float shoe as a redundant casing barrier, which was not utilized in this design

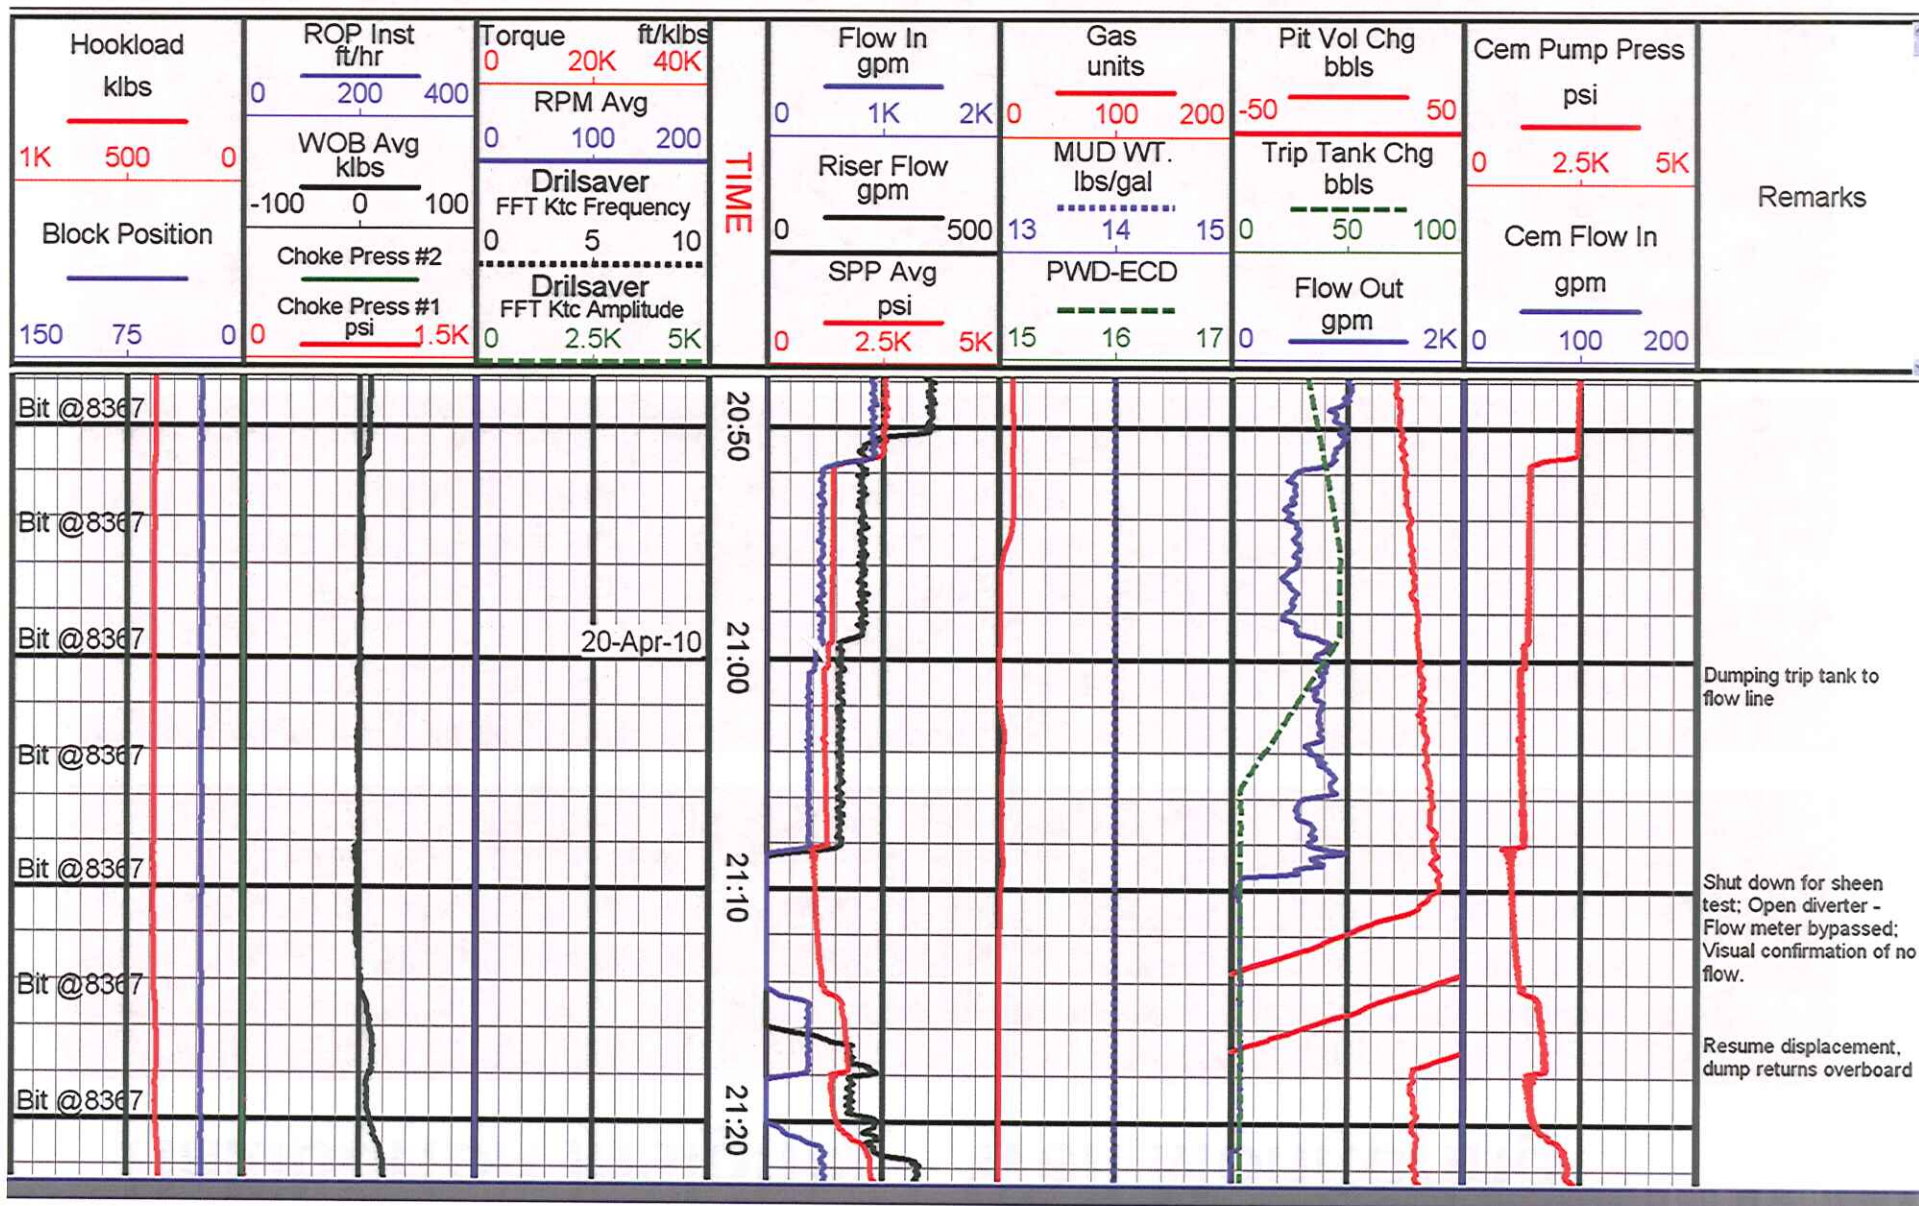
Apr. 20 – 20:50 to 21:20 (8:50 pm to 9:20 pm)

Rig activities that precluded well monitoring

- Flow diverted overboard, which bypassed pit level and gas sensors
- Crane and ballast operations influenced flow out sensor readings
- Mud displacement using unmonitored source pit (sea water chest)
- Tank draining added flow to return line and pits (trip tank, sand trap)
- Fluid was being transferred between pits

Rig activities unknown to mud loggers

- When the rig stopped transferring mud to the supply boat
- Returns switched from active to auxiliary pits
- Transfers of fluid between pits
