12 February 2009

Safety Alert # 4058

Mark III Modular Drilling Control Pod SEM (Subsea Electronics Module) Indication Faults

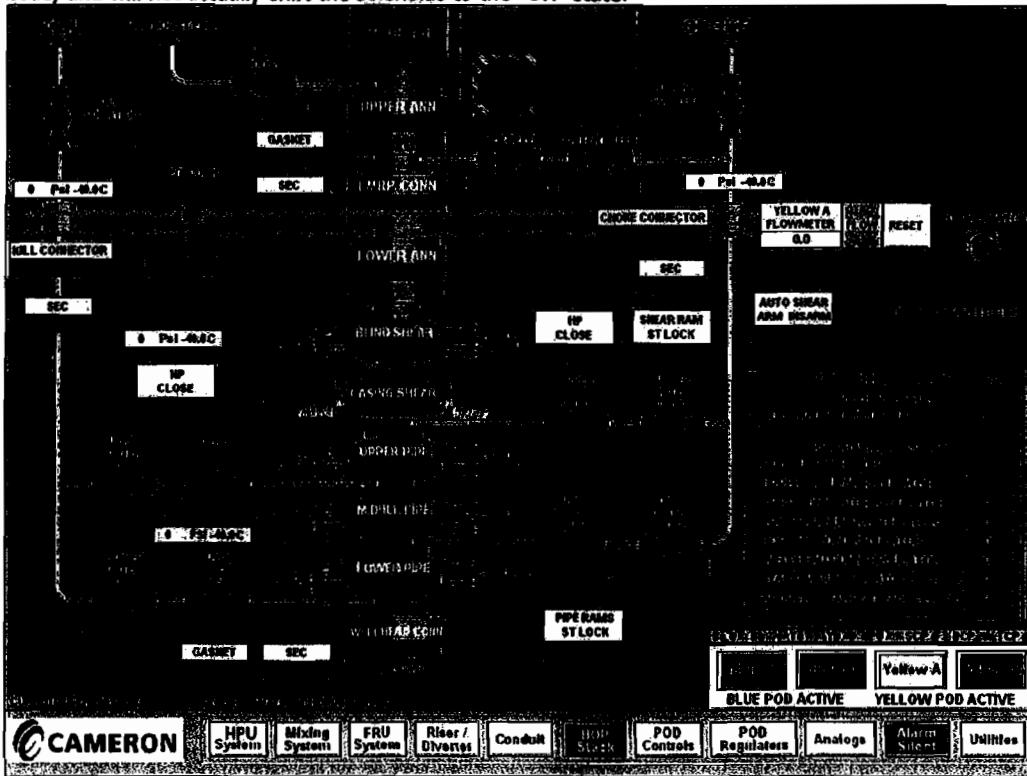
Indication Fault #1

The active SEM indicates going to a "both Diagnostic points on" condition. The HMI BOP screen will show the valve position tag on the screen turning "black" which indicates that the active SEM is reporting back that all solenoids are in the "ON" state (see below screen capture). We have not experienced more than one SEM (Blue A, Blue B, Yellow A, Yellow B) going to this state. This solenoid "ON" position state is an indication issue, and will not actually shift the solenoids to the "ON" state.

The above "Indication Faults" have been traced to the Application Software that is installed on the I/O board within each SEM (there are 2 sets of electronics within each SEM Housing, A and B per Pod). A revised version of the I/O Board Application Software will be required to be downloaded onto each I/O Board and compiled for proper operation. The corrective action can only be accomplished by removing the SEM Cover and gaining access to the individual I/O boards while the system is on the surface. These activities can only be undertaken by authorized Cameron Service Personnel.

1. Select the opposite SEM on the same POD.
2. Reboot the power to the locked SEM at the Communication Cabinet only.

Our testing indicates that, rebooting the locked SEM "ONLY" will reset that SEM. At no time should the operator switch to the opposite POD when they are experiencing either one of these fault conditions.

WARNING: If the opposite POD is selected when the SEM is in a "LOCKED state" there is a possibility that this action could result in an inadvertent shifting of the valves to the "ON" state due to the remaining 3 SEM's attempting to re-align to the LOCKED SEM that is showing all Solenoids in the "ON" position. This could result in the BOP Stack functions moving to an undesirable condition (ie: Accumulator Dump etc.) other than the mode that was set prior to the active SEM "Indication Faults" described above. This could result in failure of the BOP to perform its intended function.

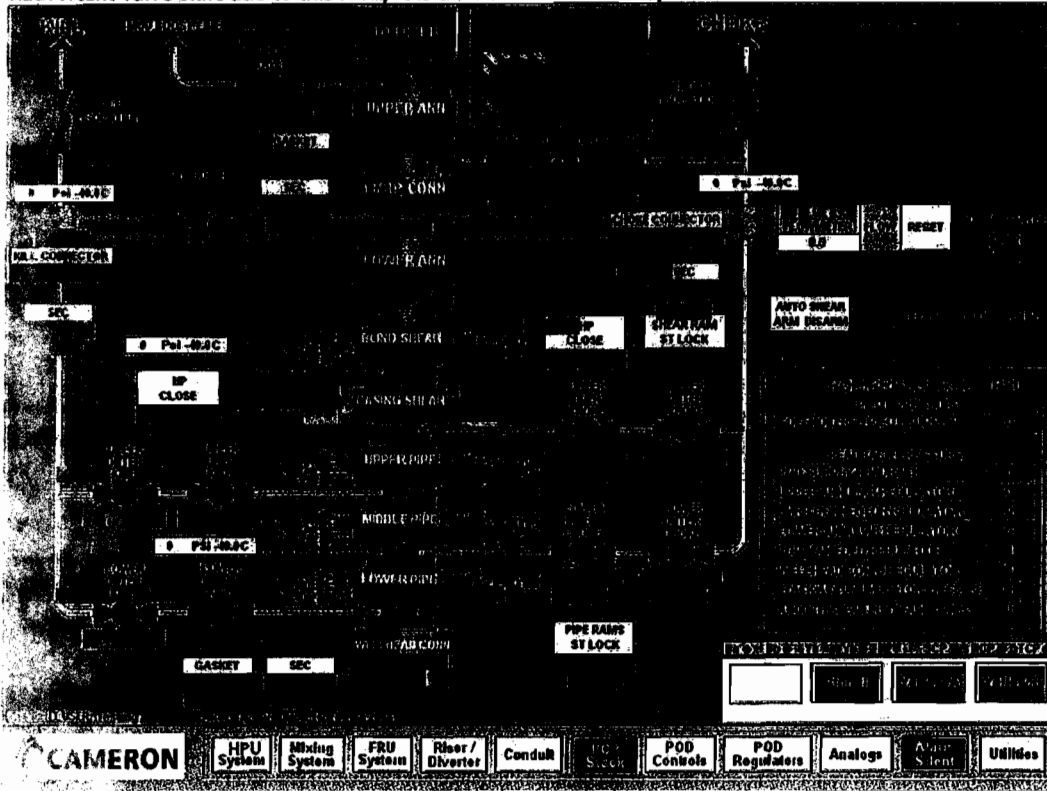
Indication Fault #2

Additionally, we have experienced a single SEM going to a "NO" DSDM (Drilling Solenoid Driver Module) state, which is indicated with the HMI valve position Tag names going to a "Black state" with the word "LOCKED" in the place of the valve position (see below screen capture). This is indicating that the "active" SEM is not recognizing the DSDM (Drilling Solenoid Driver Modules). At no time have we experienced an inadvertent valve shift due to this fault, it is an indication issue only.
