IN THE UNITED STATES DISTRICT COURT FOR THE EASTERN DISTRICT OF LOUISIANA

*In re: Oil Spill by the Oil Rig Deepwater Horizon in the
Gulf of Mexico on April 20, 2010 (MDL No. 2179)*

EXPERT REPORT OF CALVIN BARNHILL *Macondo Engineering, Operations and Well Control Response*

Submitted by Transocean Offshore Deepwater Drilling, Inc.

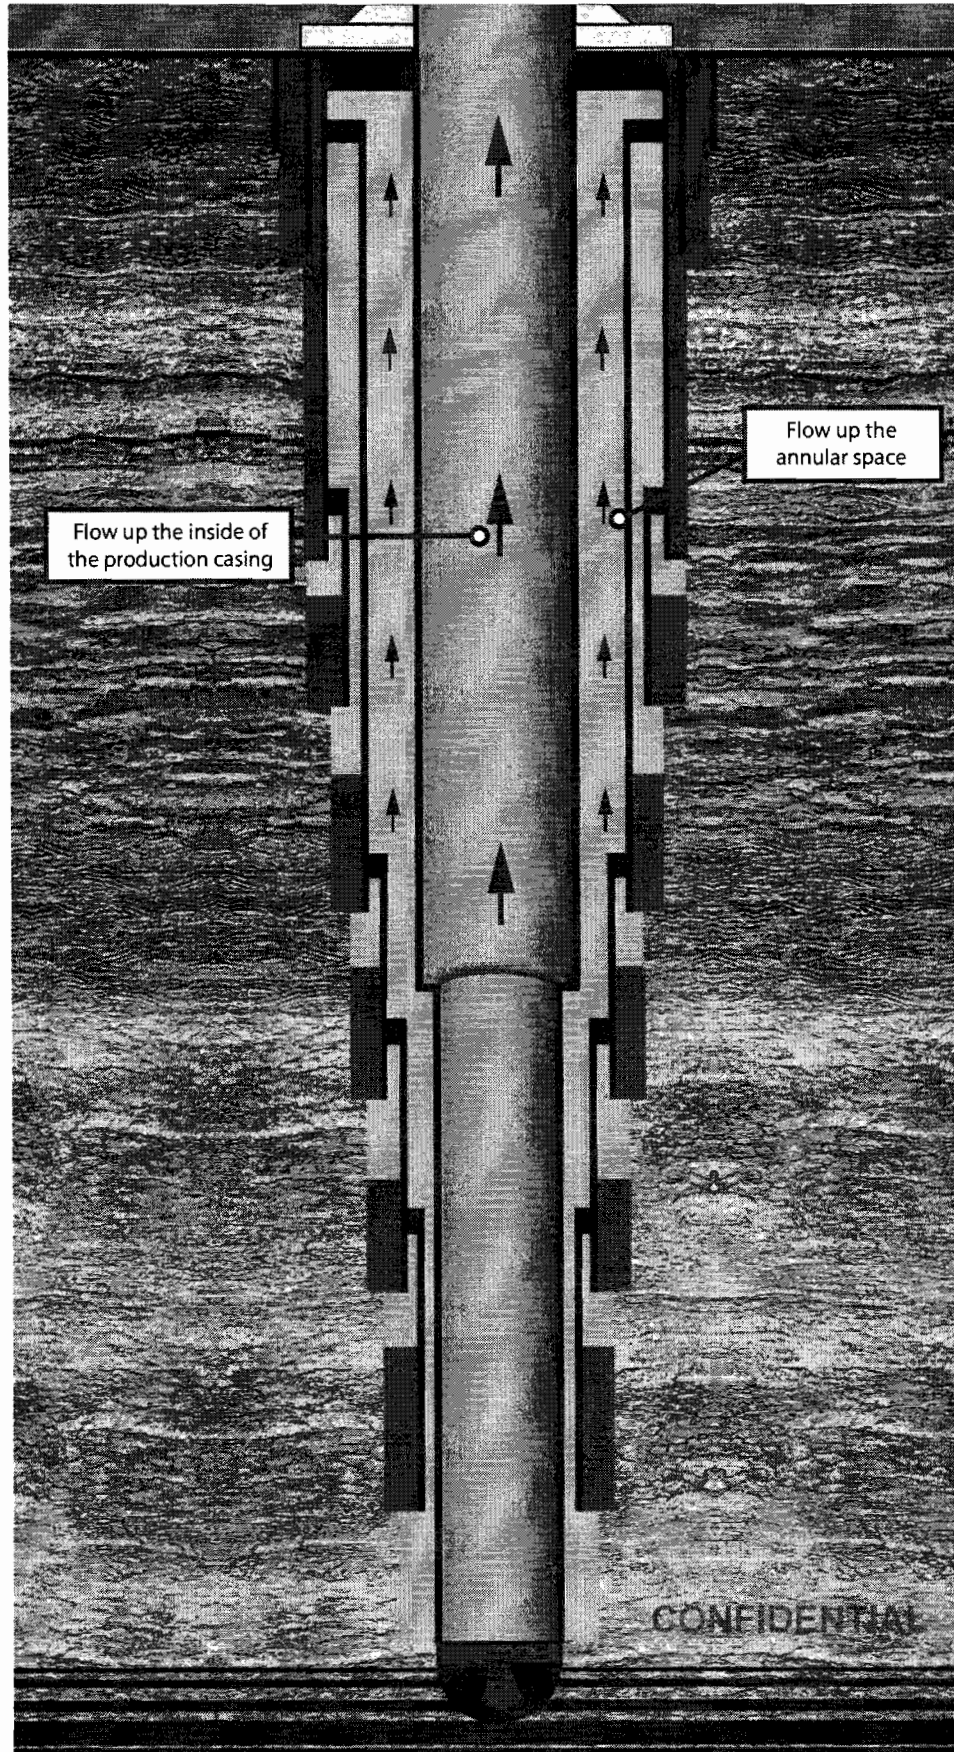
ATTACHMENT D

The Macondo Well had two pathways that required primary flow barriers be in-place, tested and confirmed prior to reducing the hydrostatic pressure inside the production casing and potentially under-balancing the well. Attachment D shows the two pathways. One pathway was the annular space outside of the production casing. The primary flow barrier system for that pathway was comprised of the hydrostatic pressure of the annular fluids, the cement in the annular space and the production casing seal assembly in the wellhead. The other pathway was through the inside of the production casing. The primary flow barrier system for that pathway was the cement in the annular space outside the production casing coupled with the cement in the shoe tract, the double float valves and the production casing itself. Prior to the removal of the riser/BOP from the well, the BOPs were available to provide secondary well control, if activated.
