711 Well control Incident

Location 711
Customer Shell
Date/Time 23rd December 2009 / 17:10 hrs
Loss 11.2 Days £5.2mm to recover
0.9 MT OBM spilled to sea
Transocean Loss of reputation

What Happened?

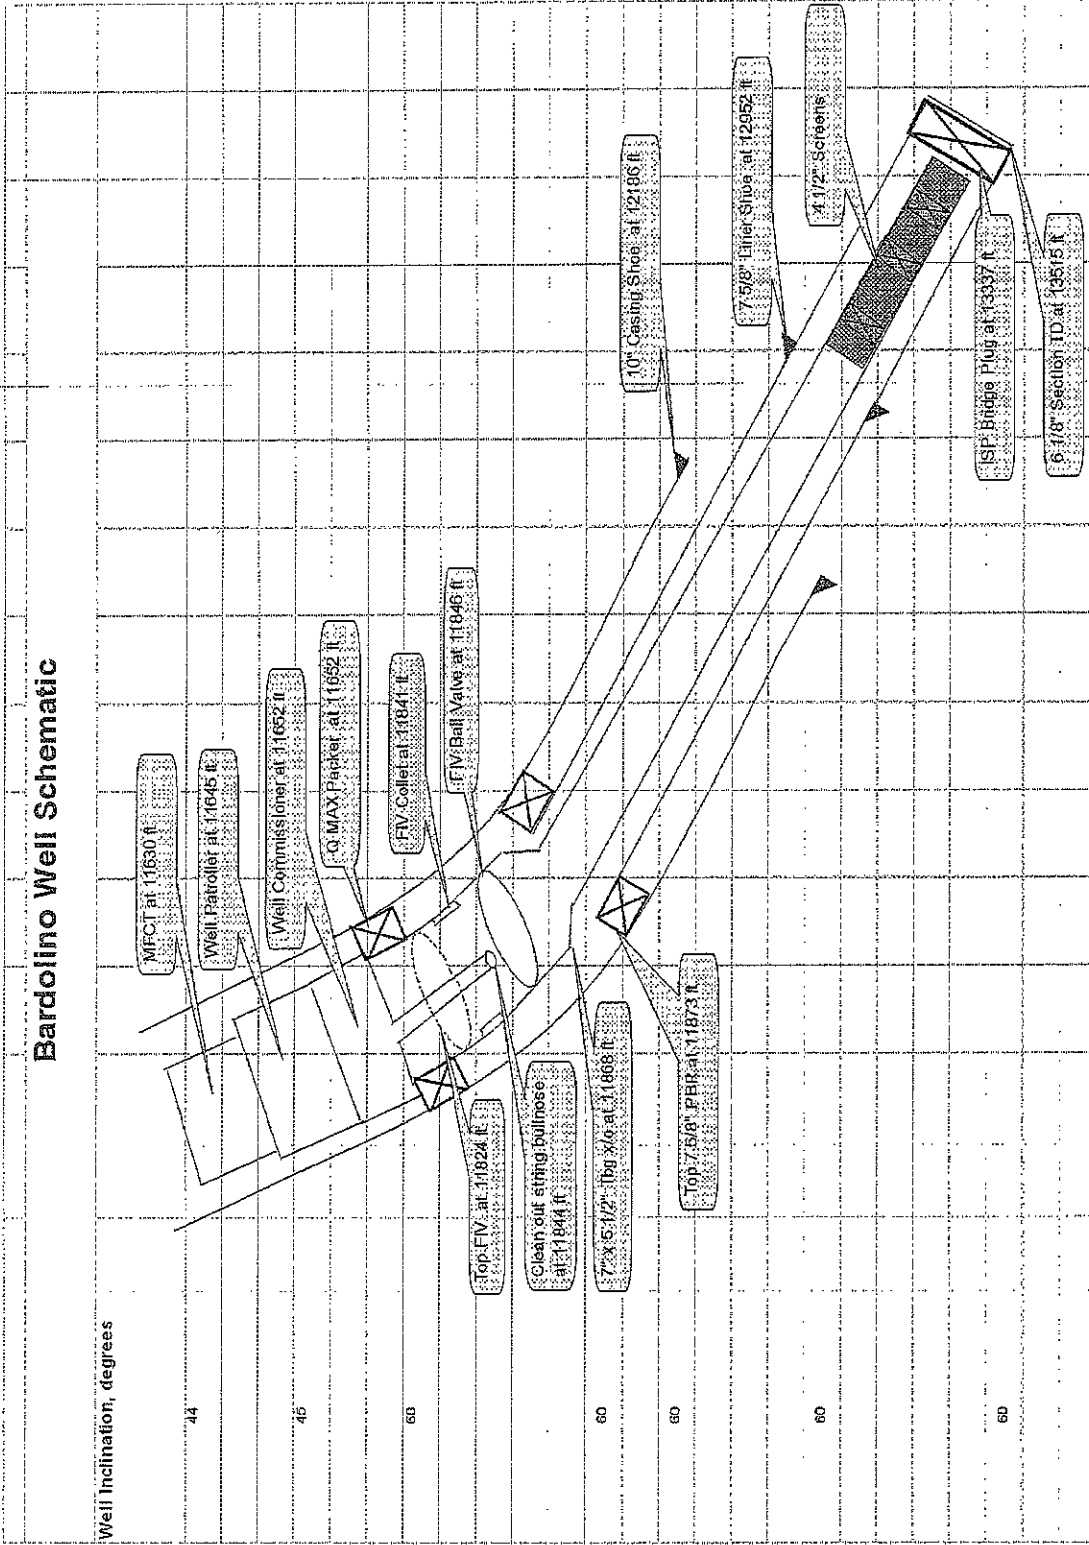
Well Schematic.

- The well had been drilled to TD with 720 pptf OBM. Sandscreens were installed as the lower completion. Barrier isolations to the reservoir were a Formation Isolation valve (FIV), 7" / 5 ½" tubing and a liner packer.

- Tail pipe hung up at FIV – not recognised.
- Investigation team believe that the FIV was mechanically shifted at this point.
