# **Deepwater Horizon Technical Rig Audit January 2005**

## **Introduction**

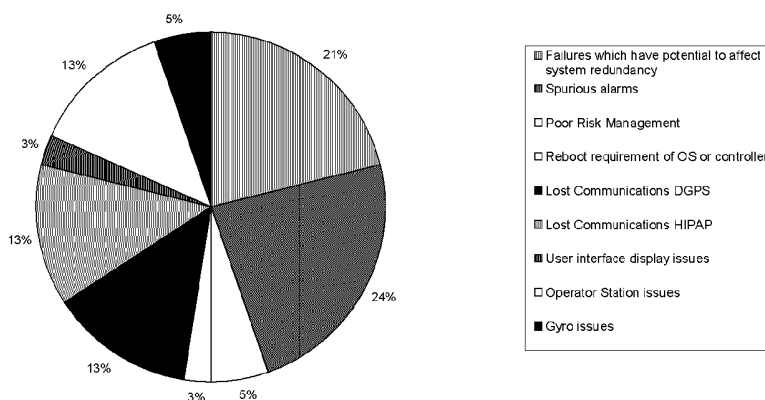
#### Subjective Analysis of Anomaly log

Spurious alarms feature as the largest percentage of anomaly reports. Realistically this would not be unexpected due to the complexity of the system. Lost communications to either HIPAP or DGPS figures highly and again this will always be difficult to manage. A number of the anomalies identified have direct affects on system redundancy and these account for approximately 21 percent of all recorded. The total populated data considered was thirty eight entries based on approximately 1 year's records.

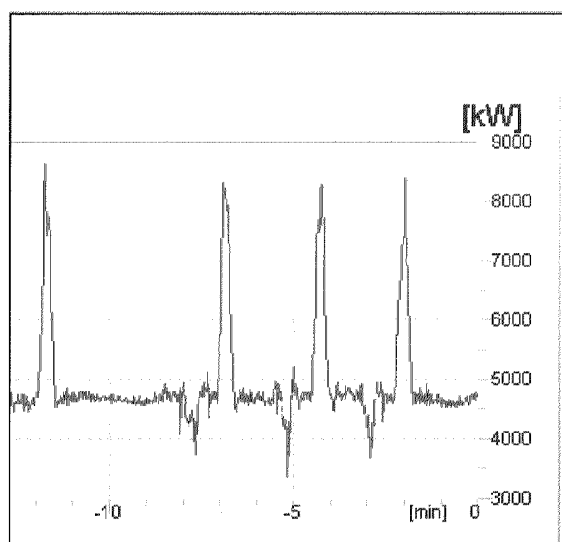
Schematic 1 Screen shot of total power demand whilst running casing, (14 MW available)

The screens that were displayed at the operator stations were suitable given the current rig work scope. The DP operators were monitoring real time variables and were conversant with the application of trends. Typically when running casing and tripping drill pipe their focus of attention was on available power and also frequency fluctuations. In one instance where casing was being run regenerative braking was causing short-term peak demands and fluctuations and a concurrent frequency drop occurred. As this dropped below 58.5 Hz for more than 2 seconds then a load limit signal is generated that caused the thrusters to phase back by 50%. Once frequency increased to acceptable limits the load limiting is disengaged and normal thruster load restored. This occurred whilst onboard but demonstrates that the DP awareness with operational experience is increasing.
