IN RE: OIL SPILL by the OIL RIG
"DEEPWATER HORIZON" in the
GULF OF MEXICO,
on APRIL 20, 2010

MDL No. 2179

REVISED EXPERT REPORT OF
DR. FREDERICK "GENE" BECK
ON WELL DESIGN, CONTROL, DRILLING, AND MONITORING

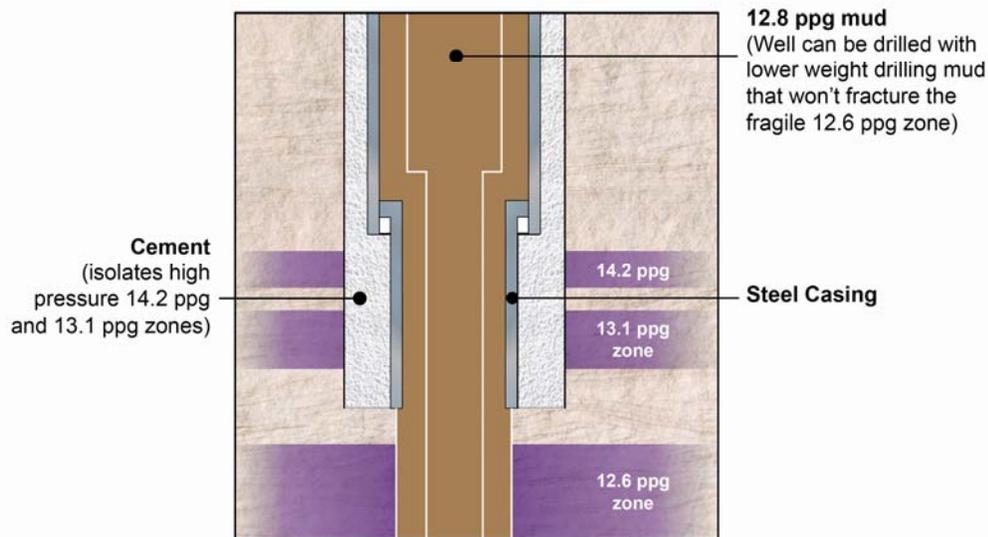
Revised Figure 2: Narrow Drilling Margin Remedy

On the Macondo well, instead of proceeding with caution by installing additional liners BP moved ahead with little or no drilling margin, ultimately damaging the well (*i.e.* cracking the formation) and compromising the cement job. BP could have chosen to isolate the higher pressure formations in the well with steel casing, including the 14.2 ppg (M57B) sand

But BP did not perform this narrow drilling margin remedy. The Macondo well as drilled was therefore damaged and dangerously unstable, and BP consistently lost drilling mud into the formation as it drilled the well. Specifically, the bottom portion of the Macondo well exhibited a pore pressure regression in which the pore pressure atypically decreased with depth, and BP failed to properly design or re-design the well to account for this regression. As discussed below, BP should have isolated the higher pressure formations at 17,467 feet (14.2 ppg) and 17,800 feet (13.1 ppg) such that it could have drilled the target formations near the bottom of the well (at 12.6 ppg) with a lower weight drilling mud. BP's failure to address the pore pressure regression was unreasonable.

zones, as shown in Figure 2 below. That would have enabled BP to continue drilling the well with a lower mud weight that would not have damaged the fragile 12.6 ppg (M56E) zone at the bottom of the well.

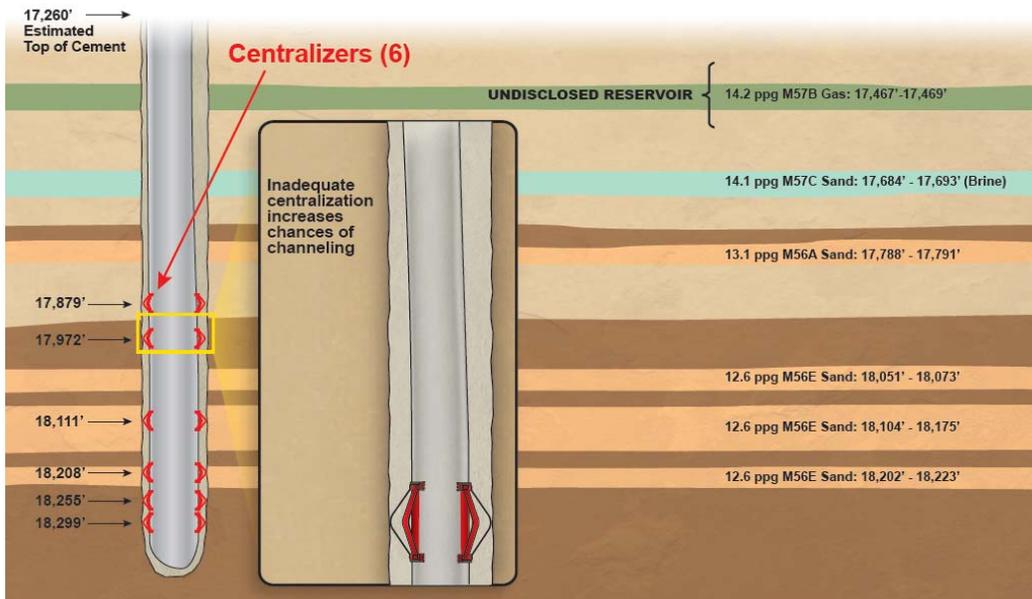
Revised Figure 9: BP's Actual Placement: Lack of Centralizers May Result in Low Stand-off Ratio

Additionally, although BP knew that Halliburton could run an OptiCem™ simulation to determine optimal placement of the centralizers and that OptiCem™ was the only available tool to conduct such an analysis, BP did not ask Halliburton to do so.⁹⁴

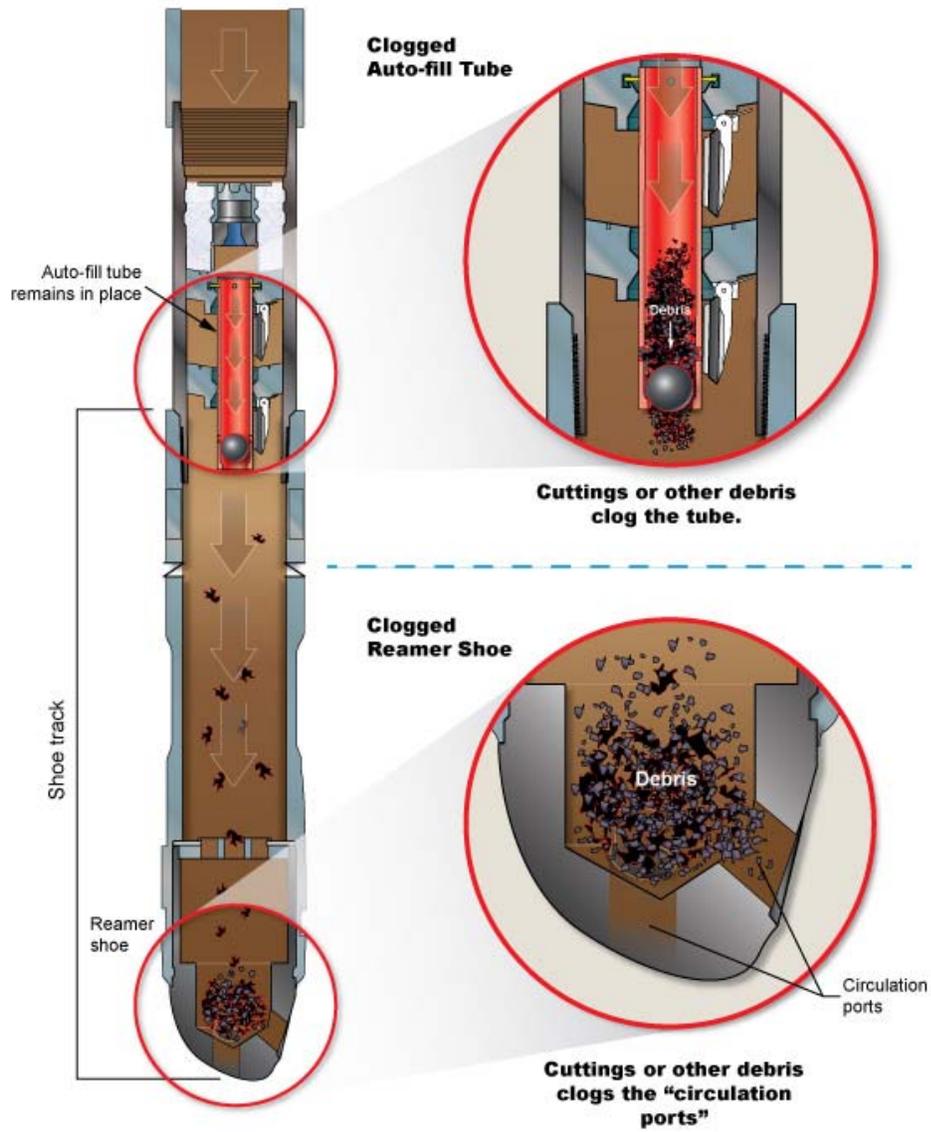
Figure 13: Obstructions Prevent Circulation

Once BP had the casing shoe located at 18,304 feet it was ready to convert the float collar. Robert Kaluza, BP's well site leader, was on site at the time float conversion was attempted. When Kaluza and the crew attempted to circulate the well, they could not get it to circulate. The inability to circulate indicated that there was an obstruction somewhere in the lower part of the casing, likely in the float collar plugging the auto-fill tube and/or in the reamer shoe.

Mr. Kaluza and his team established circulation after nine attempts, continually raising the pump pressure far above designed specifications. The nine attempts to establish circulation were as follows:

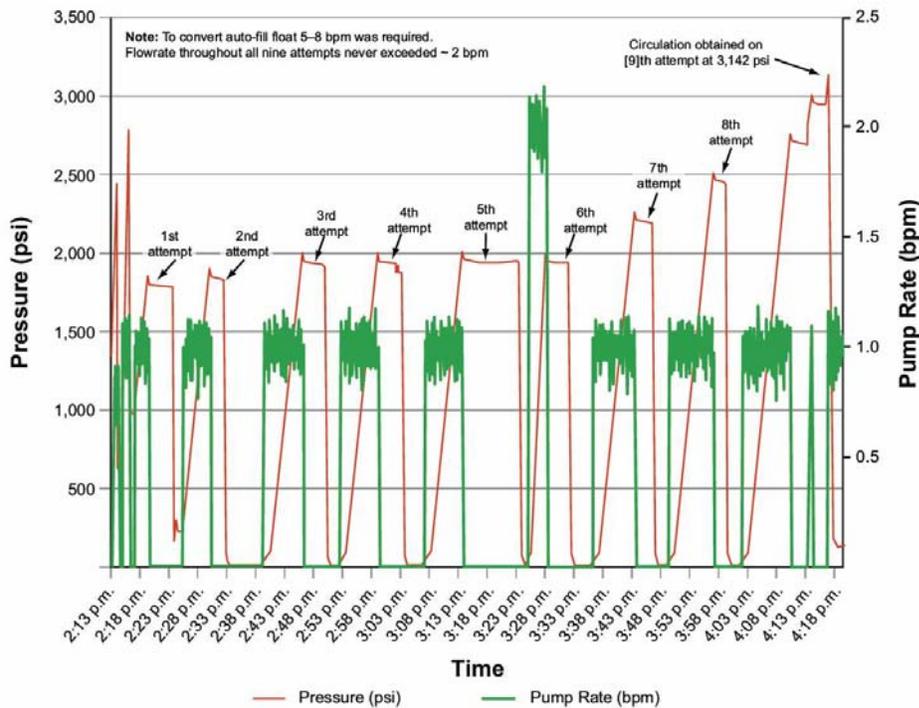
Figure 14: Nine Attempts Prior to Assumed Conversion of Float Collar on April 19, 2010 (Figure 13 from Transocean Report, Alteration Added)¹⁰⁴

Disregarding Weatherford’s advice that the ball could be blown out of the tube at 1,300 psi, BP pressured up the well and established flow at 3,142 psi, which could have ejected the ball or otherwise damaged the float collar, casing, or reamer shoe.¹⁰⁵ At the time, although BP’s Kaluza was worried that they had blown something up, instead of stopping to determine what could have been blown up he and his team pushed forward.¹⁰⁶ Kaluza confirmed BP’s disregard for Weatherford’s advice in his interview with the BP investigation team, stating “To shear out we had to gradually ramp up - I called town as I wasn’t sure how high to go (Weatherford said 7

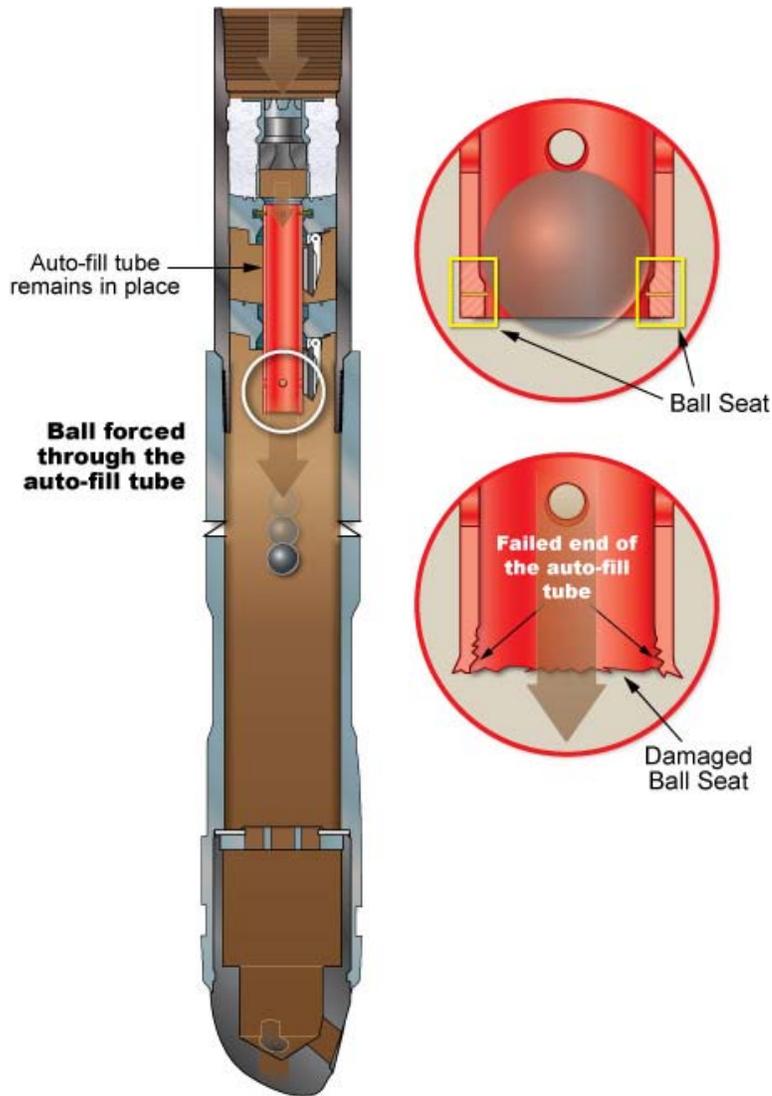
Figure 15: Failure to Convert the Float Collar

the blowout, particularly with barite or other debris holding the auto-fill tube in place.¹¹⁵ The ball seat failure is illustrated in Figure 15:

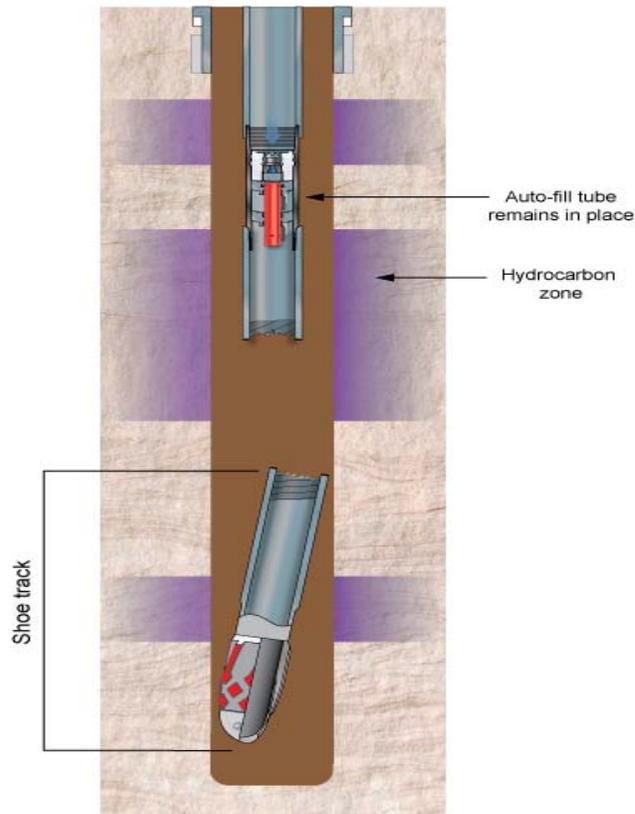
Figure 16: Shoe Track Blowout

If the shoe track separated from the long string production casing, there would have been no shoe track cement to act as a potential barrier to hydrocarbon flow. All of the cement, including the shoe track cement, would have been pumped up the annulus, leaving the main pay zone exposed and forming a free path for hydrocarbons to flow up the long string production casing through the damaged and unconverted float collar. The shoe track including the float collar and reamer shoe could have also failed in various other ways, compromising the cement job.

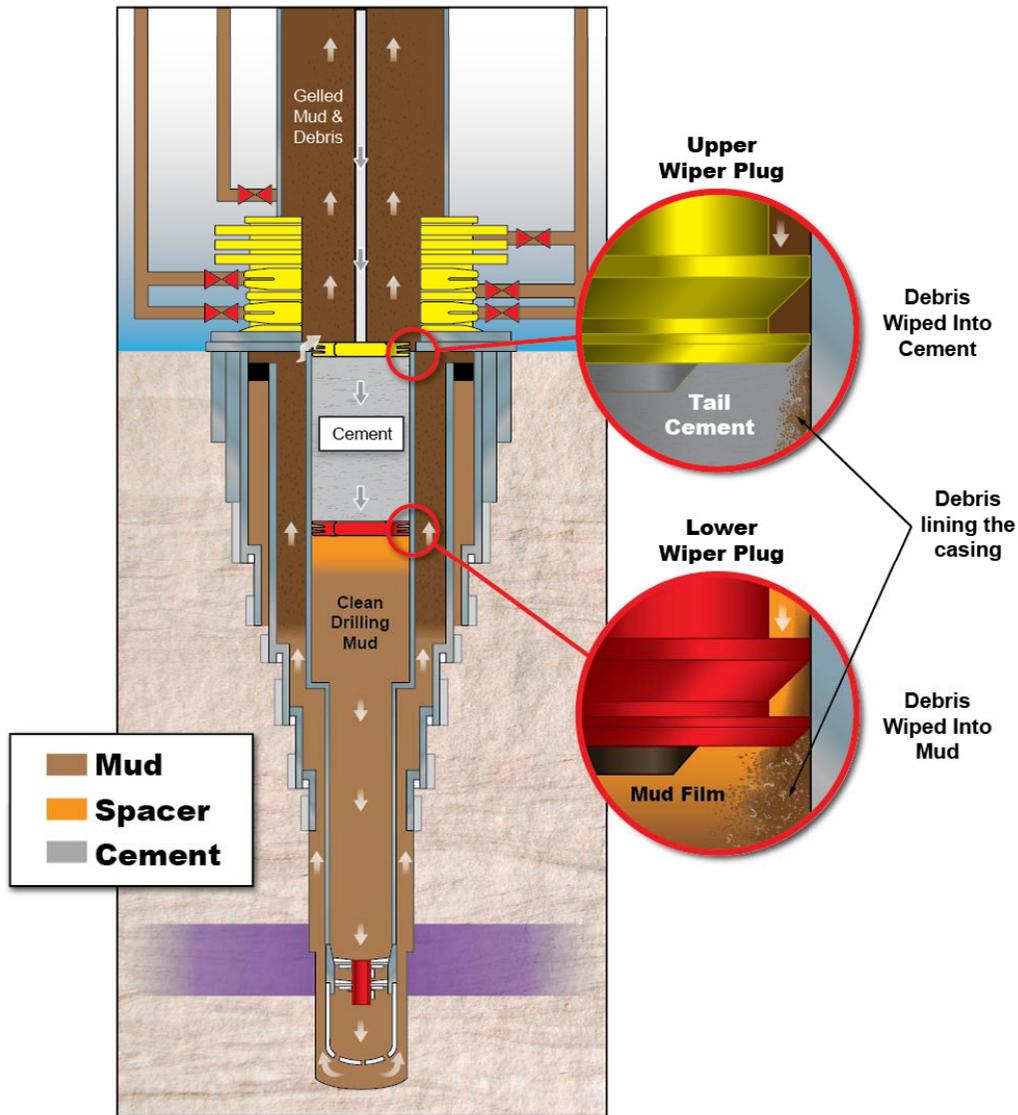
Figure 17: Shoe Track Cement Contamination

Also, at least one of the cement plugs appears to have landed early.¹²⁹ This suggests that oil-based mud may have been trapped below the upper cement plug, contaminating the shoe track cement. Contamination by oil-based mud, as shown Figure 17 below, could have extended the setting time of the cement.

All of the aforementioned issues arose because of actions or inactions on the part of BP. Accordingly, in my opinion, to the extent shoe track cement isolation was compromised, it was the fault of BP and not the fault of Halliburton. As noted above, given that the annular cement performed as intended, the shoe track cement (absent the failures by BP) should have also performed as expected.

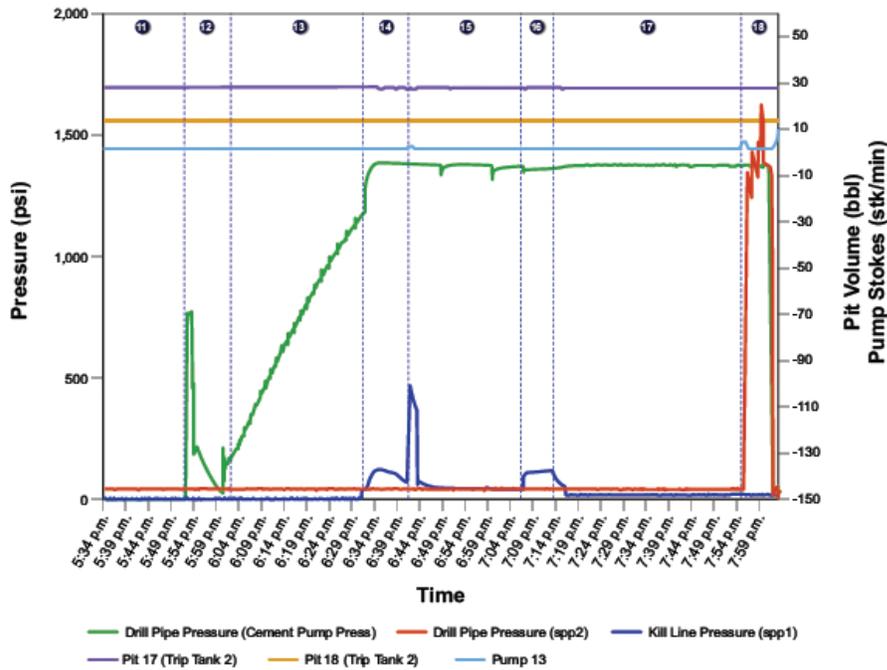
Figure 18: Overview of Events during the Negative Pressure Test from 5:34-8:02 p.m.¹⁴²

The negative pressure test was designed to achieve approximately 2,350 psi of differential pressure on the wellbore. Interpretation of the negative pressure test can be reduced to a single simple observation: Because the test was set up with the kill line and the drill pipe full of seawater and in pressure communication, once the test starts, the pressure at the surface of each component must be equal and must be zero. Any other combination of pressures indicates a problem and requires further investigation.¹⁴³

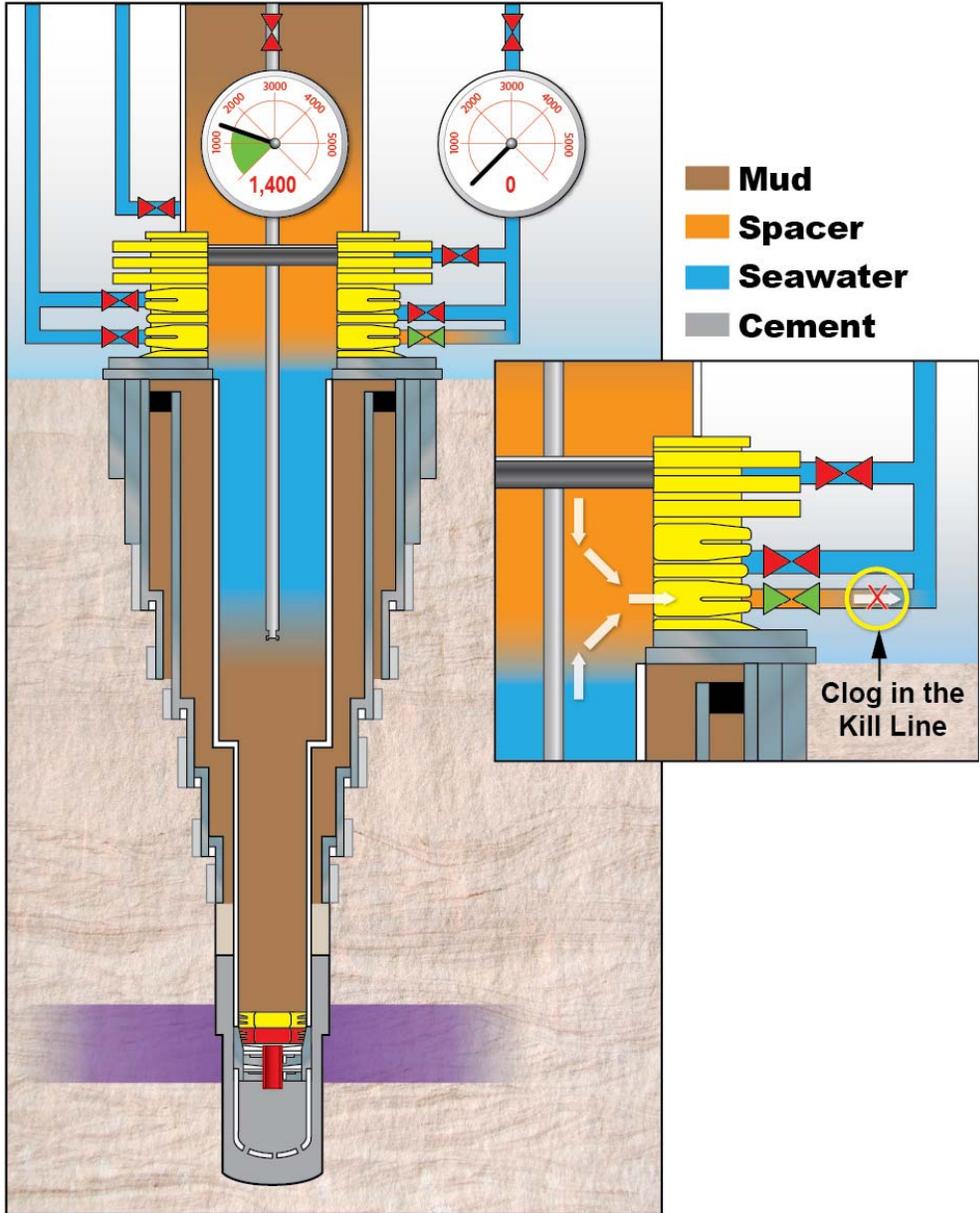
Figure 19: The Negative Pressure Test

accommodate a cement plug that was to be set in seawater. This displacement of mud was performed with lost circulation material (acting as spacer) followed by seawater. The Transocean crew displaced the synthetic oil-based mud and spacer such that the spacer was intended to be above the blowout preventer. The Transocean crew then shut in the well with the blowout preventer in preparation for the negative pressure test. Unfortunately, some of the lost circulation material leaked back below the blowout preventer, as shown in Figure 19 below.¹⁴⁸

The leak was detected as the crew noticed a drop in the riser fluid level. The Transocean crew pumped 50 barrels of drilling mud into the riser to re-establish the desired fluid level.¹⁴⁹
