**IN RE: OIL SPILL by the OIL RIG
“DEEPWATER HORIZON” in the
GULF OF MEXICO,
on APRIL 20, 2010**

**AMENDED REBUTTAL EXPERT REPORT OF
GLEN STEVICK, Ph.D., P.E.
ON DESIGN AND MAINTENANCE OF THE BLOWOUT PREVENTER**

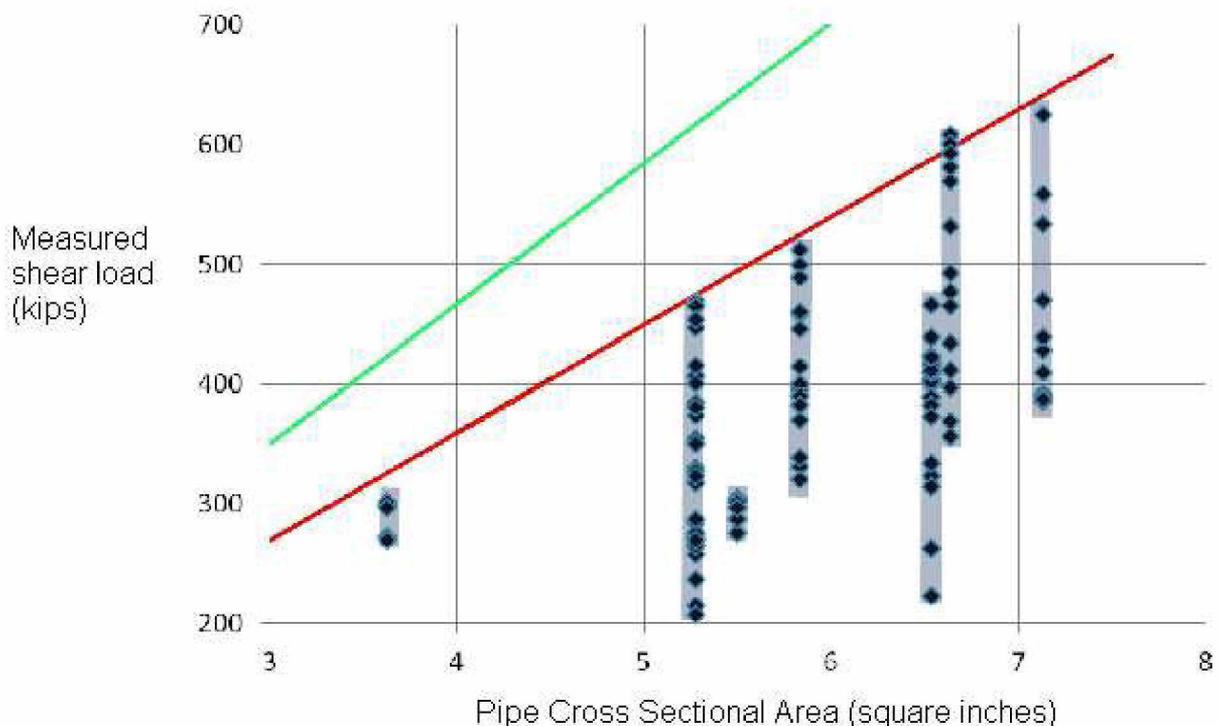
Fig. 1. Test data measured shear force as a function of pipe cross sectional area. The data within each vertical grey bar corresponds to a single pipe size and weight. The red and green lines are a plot of equation 1 from Appendix D of the author's main report for a safety factor of 1.0 and 1.3, respectively.

This variation in necessary shear loads shown in the West Engineering data would also be true of Cameron's data and Transocean's test data. In fact, the Cameron capacity chart can be reconstructed using the equation describing the red line in Fig 1 above.¹³ The red line in Fig. 1 provides a good fit to the upper bound of the test data, but provides no additional margin for unexpected conditions.

In my opinion, the DWH BSR should have been designed with a minimum safety factor of 1.3. A safety factor of 1.3 is represented by the green line in Fig. 1. Such a safety factor provides a clear design margin to account for dull blades, friction, higher than expected well pressure and high end material properties. A minimum safety factor of 1.3 relative to the upper bound is not an excessive design burden. As described in Appendix B of the author's opening report, this could easily be met with the technology available at the time the DWH was designed.¹⁴ Almost everything around us from the chairs we sit in to the pressure vessels and piping on the DWH, have a safety factor greater than 2 (e.g., the code for escalators in one state called for a safety factor of 14).¹⁵ For piping and pressure vessels it's actually in the 3-4 range.¹⁶ This is significantly higher than the safety factor

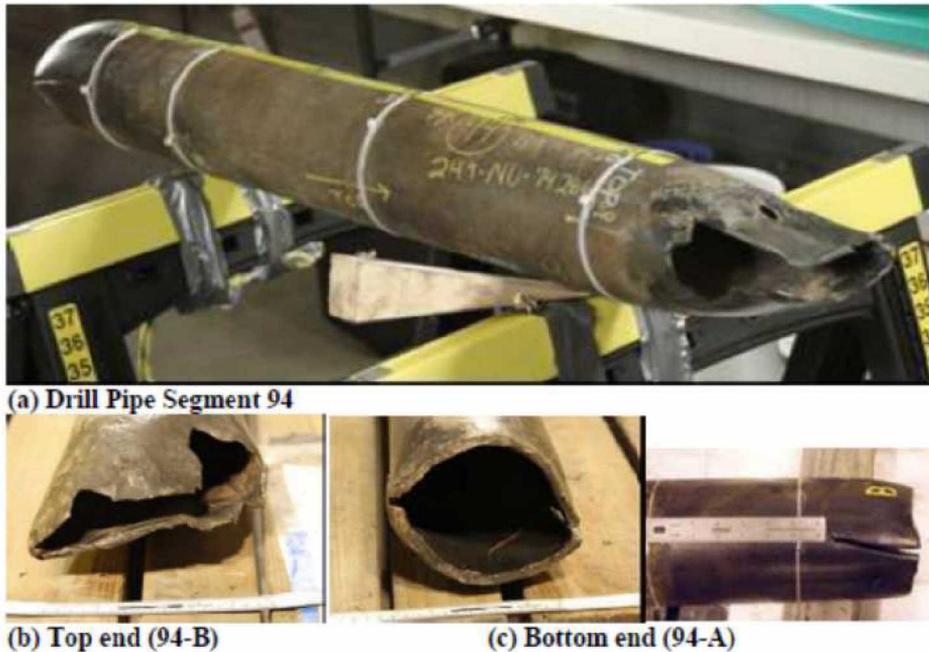
Fig. 2. Pictures of the drill pipe segment recovered from between the BSR and CSR, taken from the DNV Report.⁴⁶

The above photographs of the drill pipe segment recovered from within the BOP and the below laser scan images of drill pipe segments and the BSR blocks show that the shapes of the severed ends of the drill pipe and the shapes of the deformed BSR blocks are consistent with the BSR closing on the drill pipe while the drill pipe was off-center.

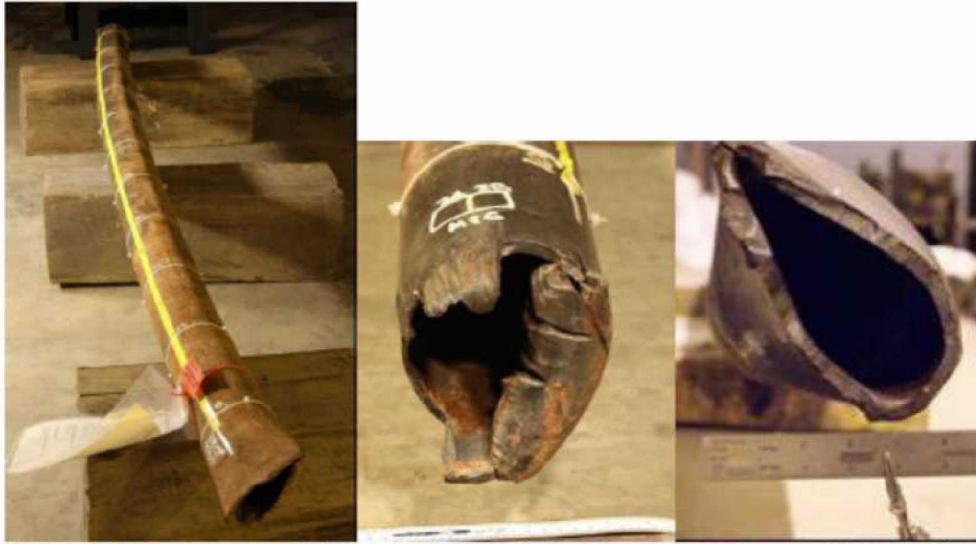
(a) Drill Pipe Segment 39 (b) Top End (39-E) (c) Bottom End (39-F)

Fig. 4. Pictures of drill pipe segment 39, taken from the DNV Report.⁵³

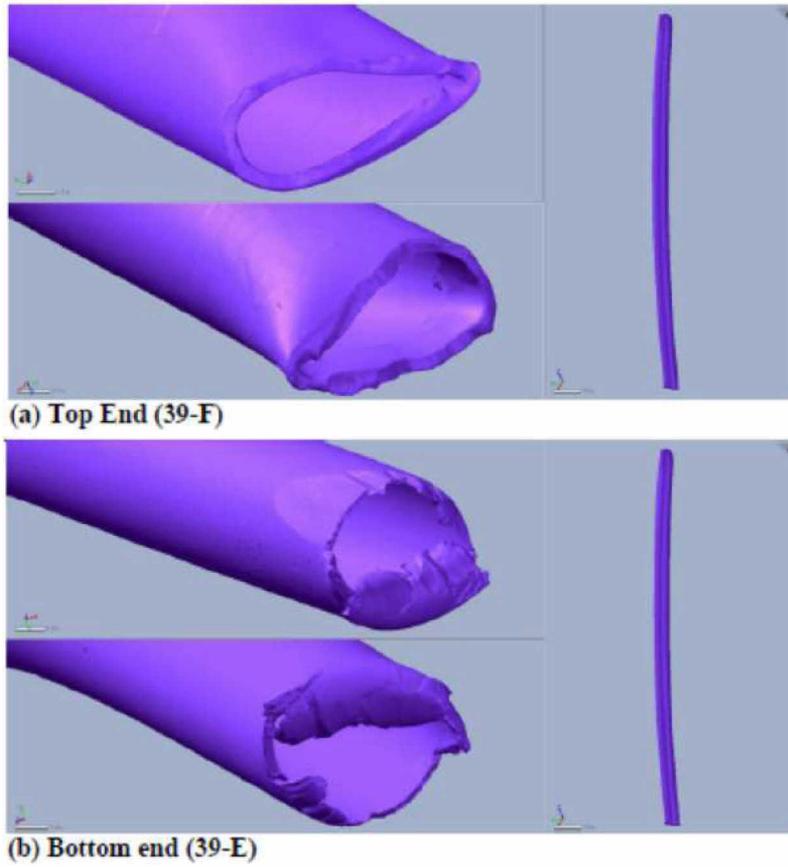
Fig. 5. Laser scan images of drill pipe segment 39, taken from the DNV Report.⁵⁴

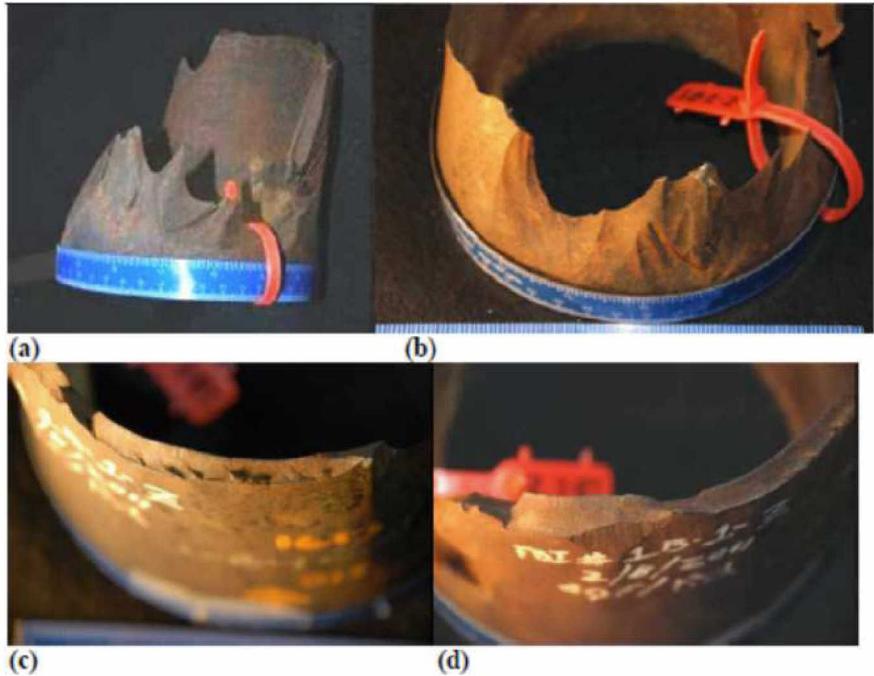
Fig. 6. Pictures of drill pipe segment 1-B-1-E, which is the matching end to 39-E, taken from the DNV Report.⁵⁵

However, the plastically deformed lower end, 39E, is not reflected in or matched in its mating pipe section end, 1-B-1-E, just above the tool joint. As shown in the images of DNV's laser scan modeling, 1-B-1-E shows no such compressive plastic deformation.⁵⁶

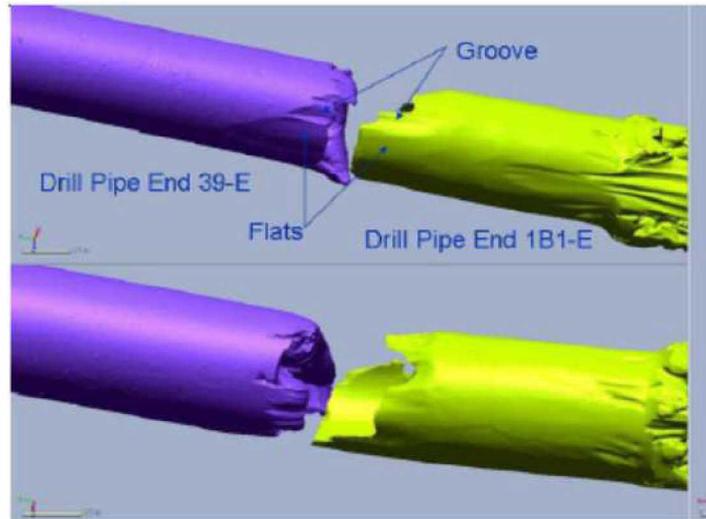
Fig. 7. Laser scan images of drill pipe segment 1-B-1-E and matching end 39-E, taken from the DNV Report.⁵⁷

Thus, the high compressive load on pipe section 39 occurred after the pipe sections 1-B-1 and 39 had separated and had no continued load path downward to the BSR location. The bottom of section 39 was deformed as it was pushed downward into the top side of the upper annular away from its mating section of pipe.

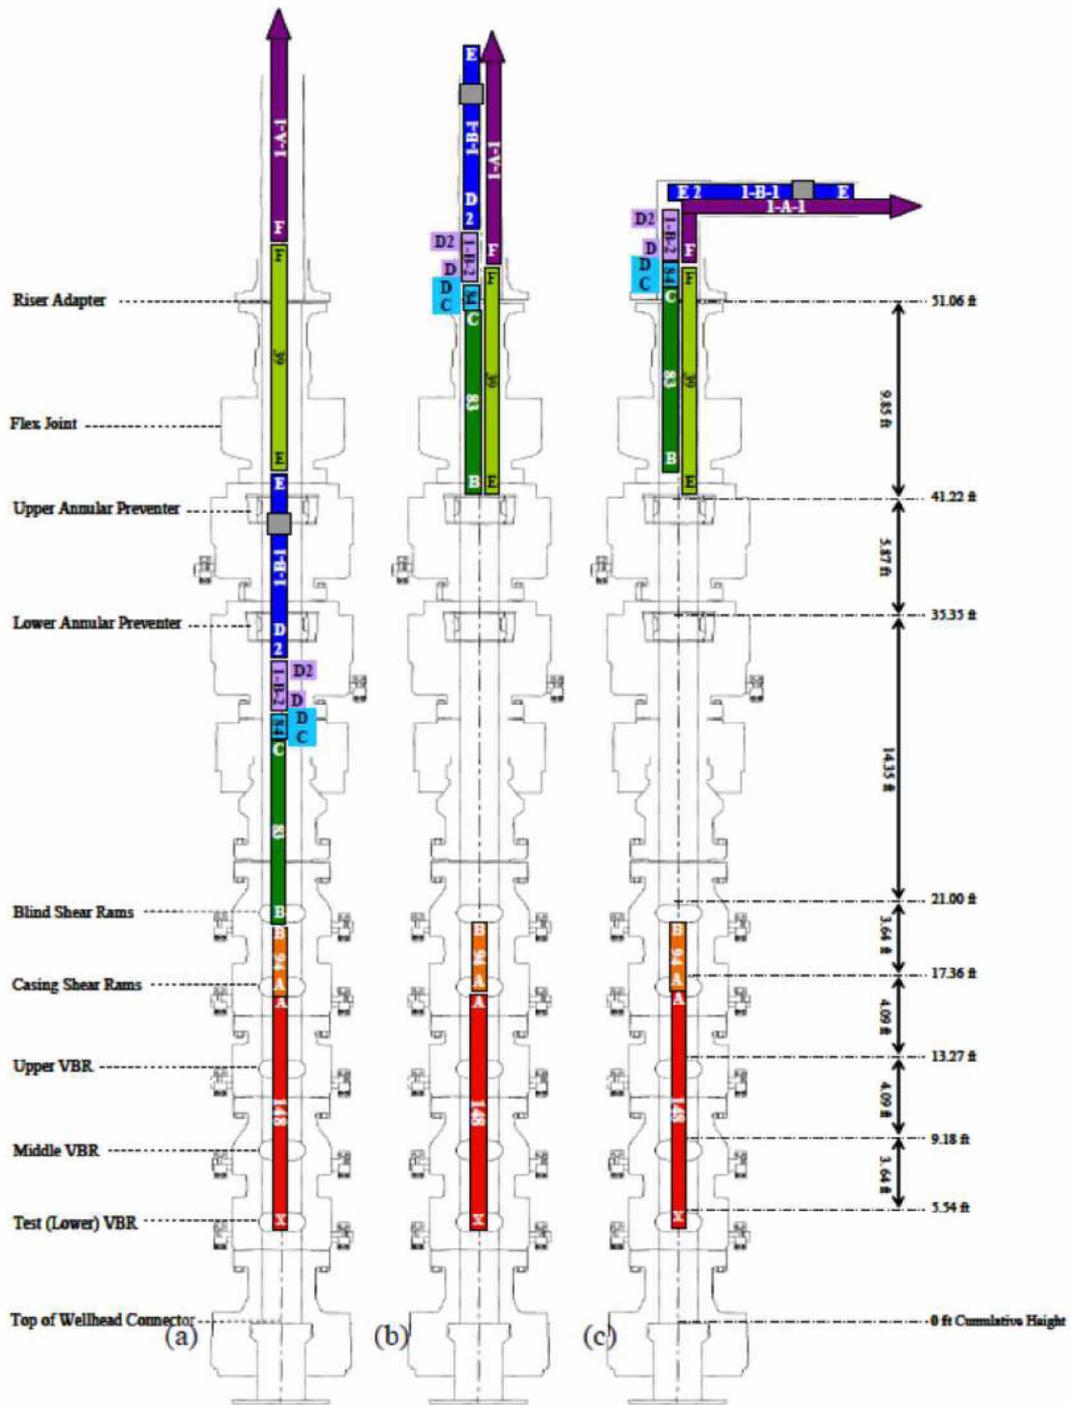
The bending noted in section 1-B-1 is not particularly uniform indicating it occurred when it was located up in the riser where the riser bend occurred.⁵⁸

Fig. 8. Diagram of sequence of drill pipe segment movement from (a) prior to incident, (b) following break at point E and point B, and (c) following sinking of rig, taken from the DNV Report.⁵⁹

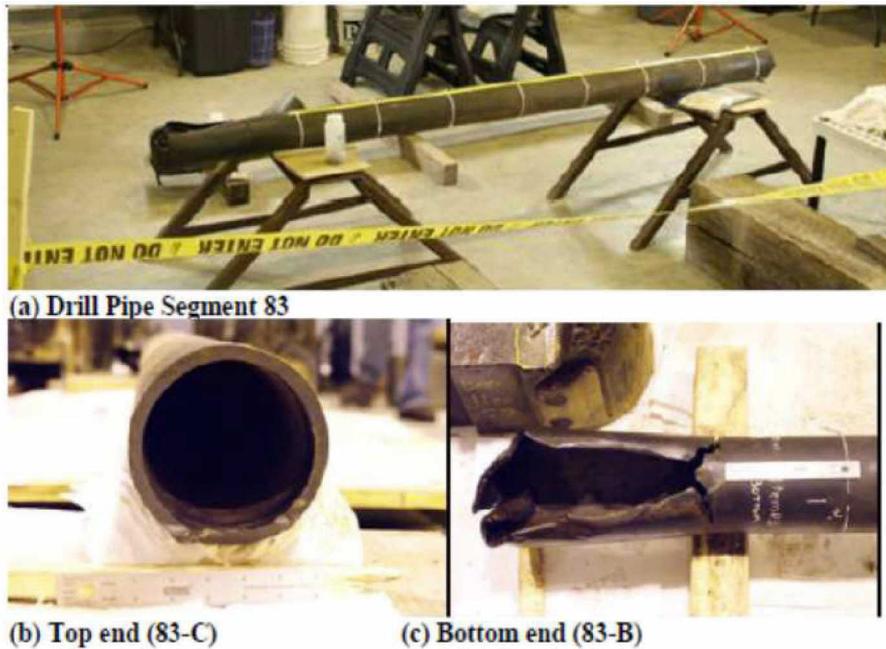
Section 83 just above the BSR also shows no curvature indicative of high compressive loading.⁶⁰

Fig. 9. Pictures of drill pipe segment 83, taken from the DNV Report.⁶¹

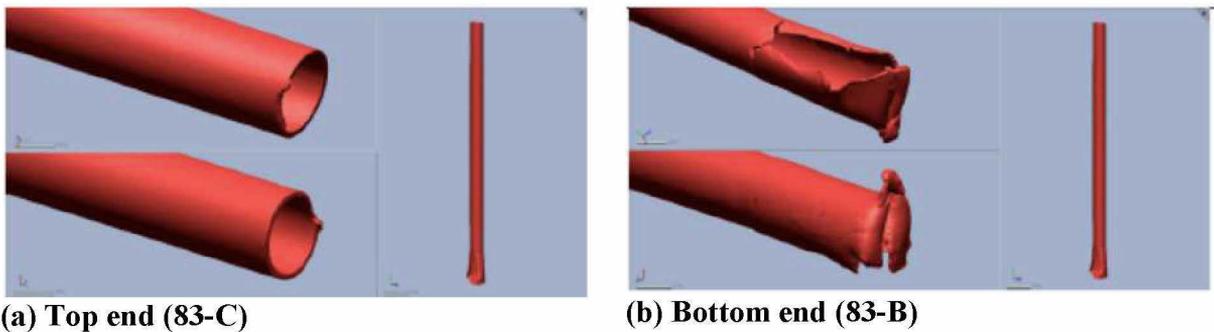
Fig. 10. Laser scan model of drill pipe segment 83, taken from the DNV Report.⁶²

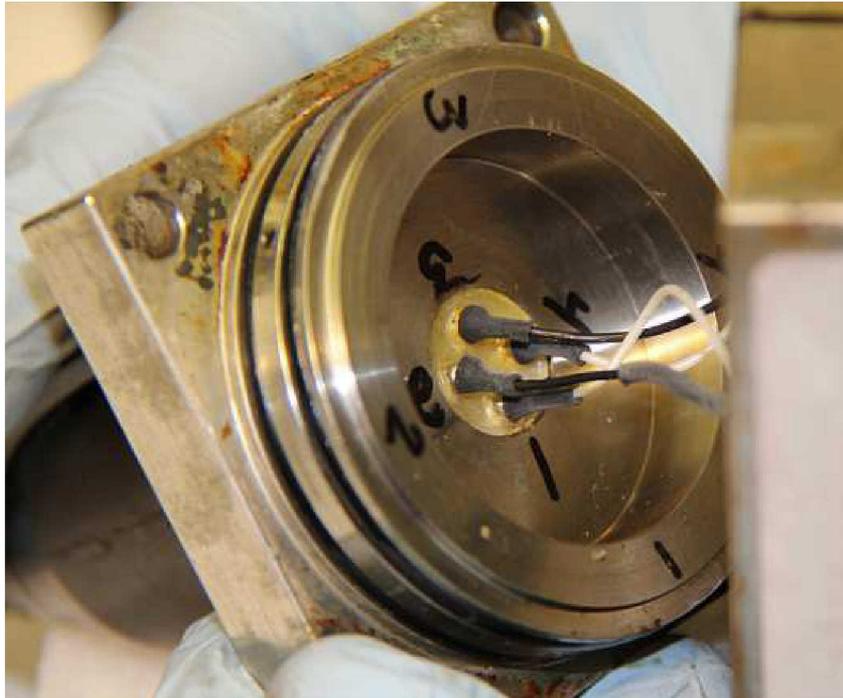
Figure 11. DNV IMG_0458, showing the solenoid coil positions, including positions 3 and 4 where the wires were reversed.⁷⁶

Post incident DNV testing of solenoid 103Y and additional Cameron tests of other incorrectly wired solenoids have shown that an incorrectly wired solenoid such as 103Y is unlikely to activate. During DNV bench testing solenoid 103Y failed to activate either SEM from the yellow control pod when both solenoid 103Y coils were energized via a 24 volt DC power source.⁷⁷

The incorrectly wired yellow pod solenoid 103Y is unsurprising in light of Transocean’s flawed condition-based maintenance program because the incorrect wiring could not be measured remotely and therefore would not have been identified as a problem until the device failed during operation.
