Subject: Final Report WEST Job 3940 GSF DD II

Subject: GSF Development Driller II

Reference: Acceptance of Well Control Equipment

GSF Development Driller II, Job #3940; 14 May to 10 June 2010 Section 3: WEST Recommendation Summary and Disposition ISO 9001:2008 Certified Prepared for BP

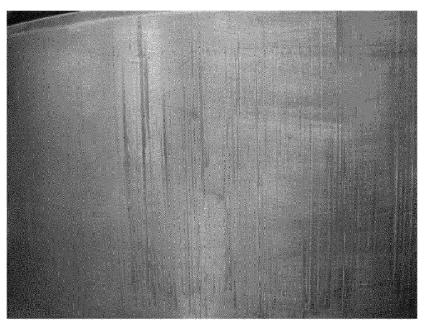
Figure 2.1 shows the outside diameter of the lower annular piston. The scoring and scratches shown are typical and extend around the full periphery of the piston; these scores were dressed out as far as possible. The open/close operating chambers will be pressure tested after re-assembly to 3,000 psi as per Transocean

Transocean should consider replacing the Hydril GX lower annular piston at the earliest opportunity.

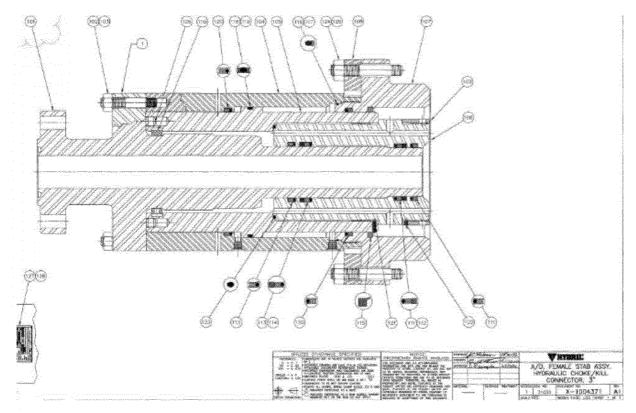
Attachment A

Diagram of the LMRP female choke/kill stab assembly. Both the stabs on the LMRP are leaking internally from the retract to the extend side operating chambers.

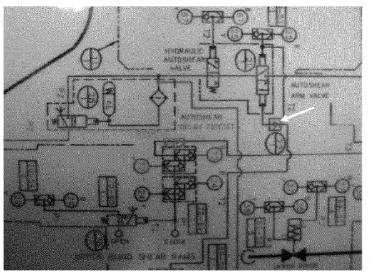
Figure 12.01: shows part of the auto shear circuit hydraulic schematic. The arrow indicates the POCV which is included in the circuit to keep a positive 'arm' pressure on the autoshear arm valve, when the pilot pressure to the 'arm' side of the valve is lost, i.e. in a dead man/auto shear situation. From testing with hotlines to the pilot side of the 'arm' valve it was proved that if the POCV should leak and release the positive 'arm' pressure to the valve, the arm valve will begin to close and 'chatter', thus preventing correct operation of the auto shear system.

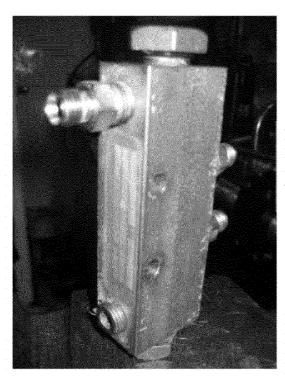
Figure 12.02: shows the suspected leaking POCV removed from the auto shear hydraulic circuit. This valve will be replaced.

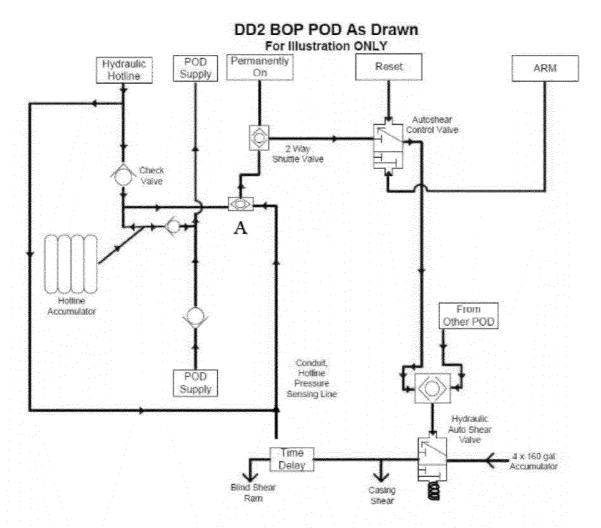
Attachment A shows the as built hydraulic schematic of the pods. Because of the position of the hotline pressure sensing take off below the check valve in the hotline supply, to shuttle valve A it would be impossible for the pilot pressure to the hydraulic auto shear valve to bleed off, due to the check valves in the system, accumulators etc, and activate the dead man sequence in case of a catastrophic failure of the riser system and loss of all hydraulic and electrical supplies.

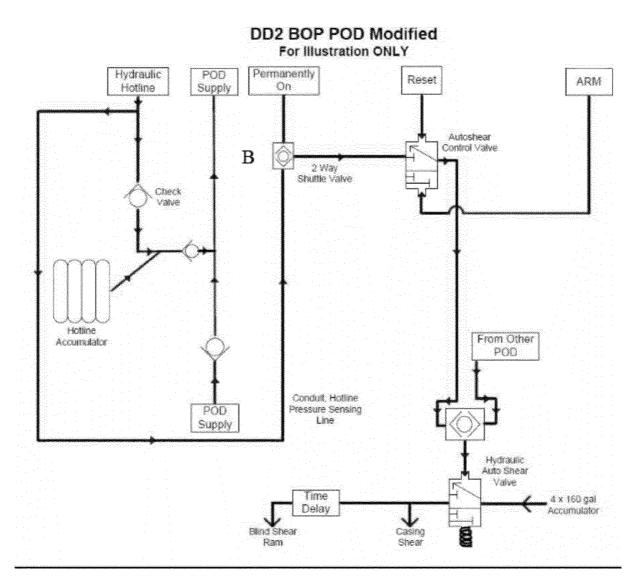
Attachment B shows the hydraulic schematic after removal of shuttle valve A and attachment of the pressure sensing line directly into shuttle valve B. This will allow the system to operate as designed. The system was proved to function correctly after this modification.

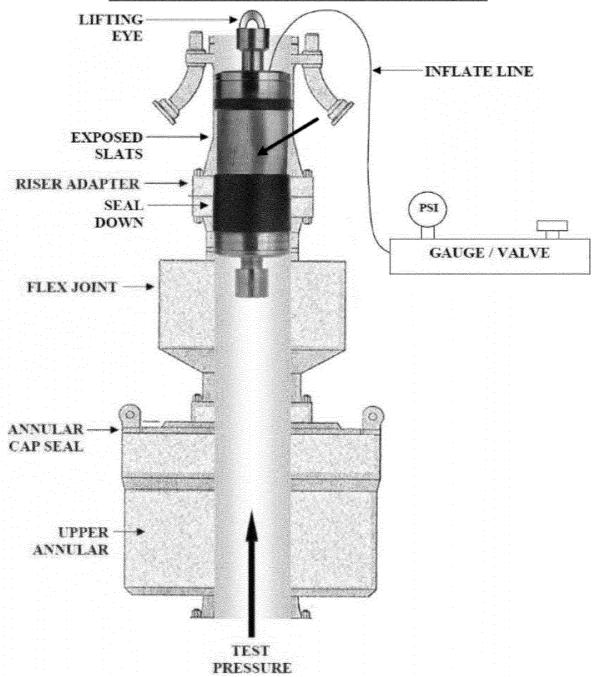
If the seal were to leak subsea, the only option would be to retrieve the LMRP to surface to affect a repair. See Figure 17.01 and 17.02 below.

Figure 17.01: Upper annular cap seal, also see Figure 17.02, being tested using a TAM packer before the BOP is run. This is one method of testing this seal during stump testing. The flex joint and flange connection to the upper annular are also tested using this method.

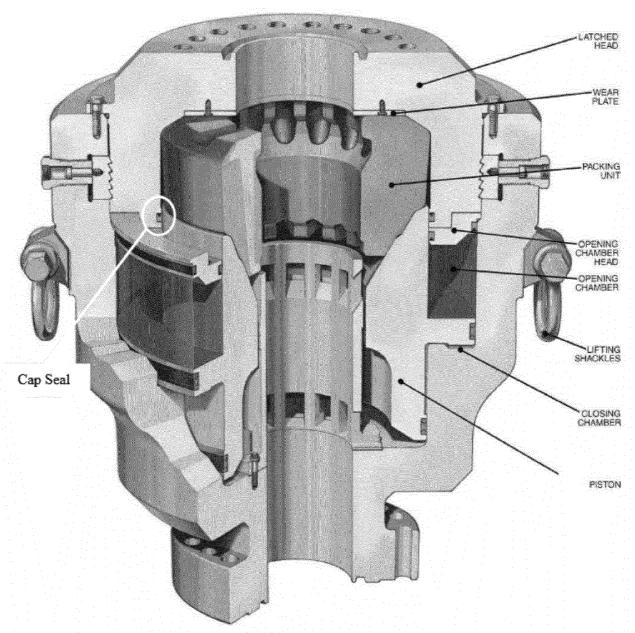
Figure 17.02: The cutaway shows the annular, which uses a TAM packer before the BOP is run for testing.

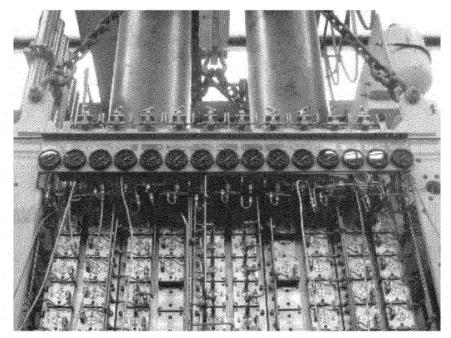
With reference to recommendation #3, the Hydril Controls MUX control pod relies solely on electrical pressure transducers to monitor the critical operating pressures within the pod. If any of these transducers were to fail subsea, there is no way of monitoring the pressures within the pod. Analogue gauges on the pod would allow the ROV to monitor critical pressures and ensure the pod was functioning correctly. This could avoid the need to pull the LMRP to effect repairs to the pod. See Figure 18.01, below.

Figure 18.01: This shows a typical MUX pod with ROV observable analogue gauges fitted for all critical functions
