Continuing Erosion Did Not Affect Flow Rate: Phase One Evidence Confirms that Erosion Happened within *Minutes*

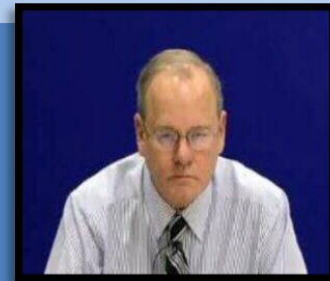
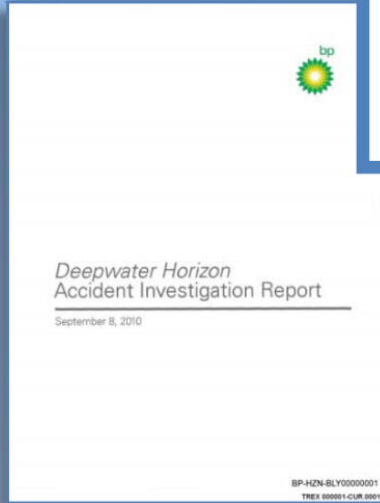
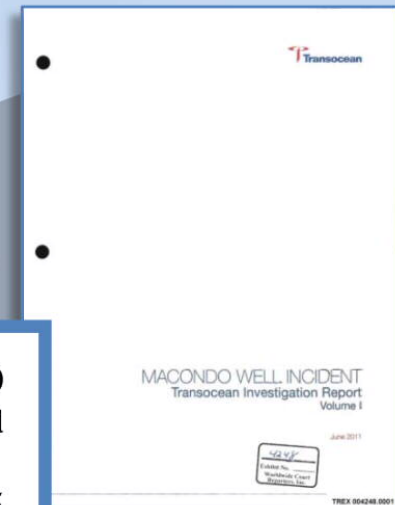
“There are eyewitness accounts stating that the top drive fell onto the rig floor . . . **The drill pipe likely had already failed at the eroded section by this time**, as it was being pulled upwards due to increasing vessel offset.”

Q. This is a picture from your report showing the section of the drill pipe that was found by the upper variable bore rams. Do you recall that?

Q. **And you testified that you believe this erosion of the pipe here occurred in less than a second; isn't that true?**

A. It would be something of that timeframe.

“At the BOP stack, the internal drill pipe pressure at the upper annular continued to climb above 8,000 psi. **Within minutes, the forces ruptured the drill pipe above the upper annular where the pipe had been weakened by severe erosion.**”
