# BP's Analysis of Top Kill's Failure

## Scenario #3:

HC flow is up 9.7/8" casing (and possibly annulus as well) dominant mud flow though failed 16" rupture discs

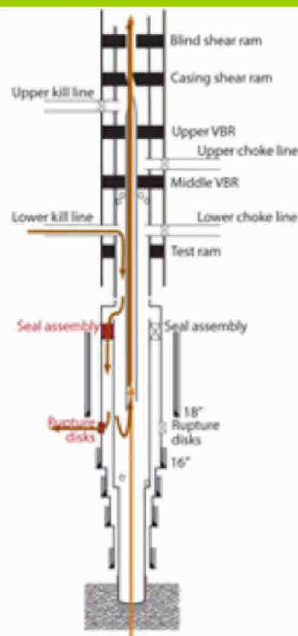
- HC are flowing through 9.7/8" casing and possibly also through the 9.7/8" x 16" annulus.
- The casing hanger has lifted off its seat due to temperature and/or pressure and one or more rupture discs in the 16" casing failed during the initial event.
- Mud flow is down the casing and back up the drill pipe, and also down the 9.7/8" x 16" annulus. Because the annular flow path is open to the formation, this limits the maximum pressure that can be applied and prevents a successful kill.

- Supporting evidence consistent with all Defining Observations 1 to 5.
- Max flow rate up drill pipe < 25 bpm.
- Max flow rate through 7/8" rupture disc openings ca. 60 bpm (six discs failed).
- HC flow continues up drill pipe throughout killing operations.
- Inconsistencies:
  - Pressure during remedial activities have been insufficient to fail discs. Disc(s) would need to have failed during the initial event.

**Conclusion: Possible and Plausible**
