BP Macondo – Deepwater Horizon  
Report for the United States of America

Richard Heenan, P.Eng.

Heenan Energy Services

2011/08/26

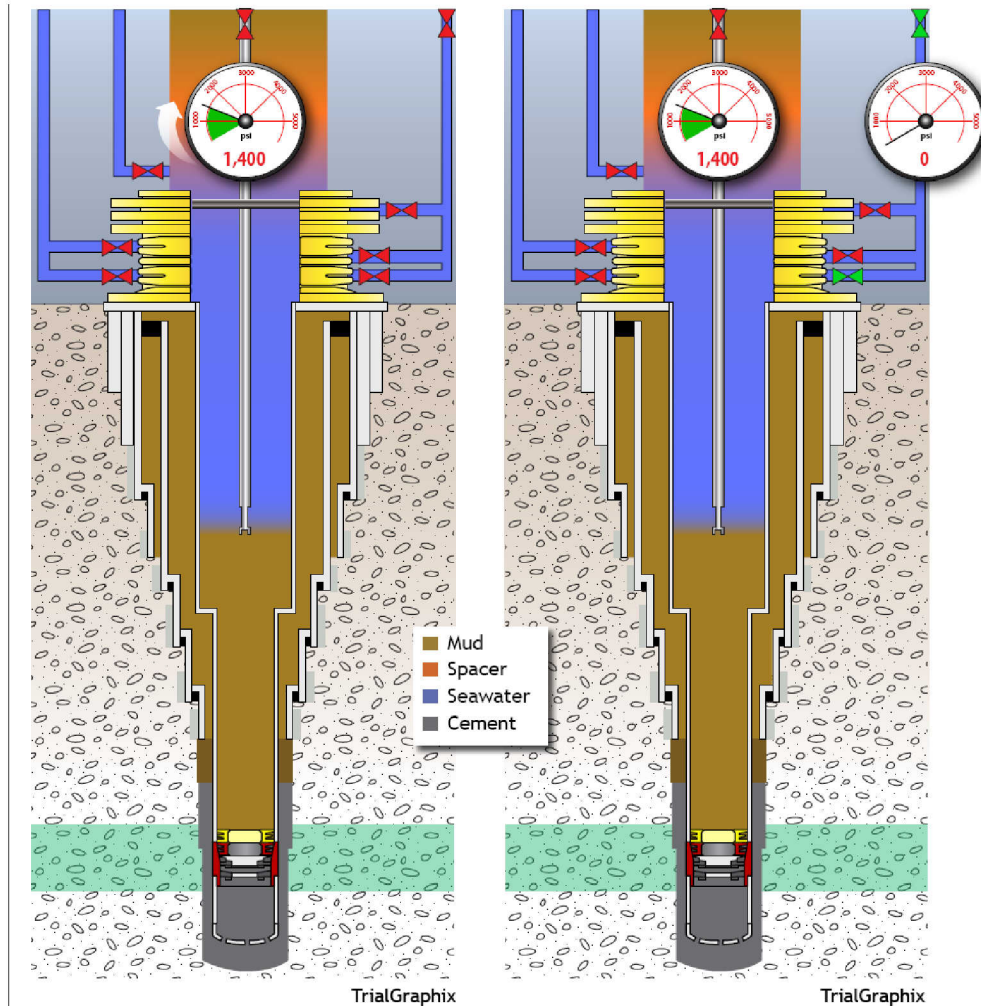
**First Negative Pressure Test**

Both flow paths (annulus and kill line vs. drillstring) should have been hydrostatically identical (completely full of sea water), i.e. they should have both read the same pressure (zero if the test was successful). Faced with two different pressures, the personnel rationalized it as the “bladder effect” or “annular compression”, explaining away the 1,400 psi on the drillpipe as a transmission of pressure from the heavy drilling mud in the riser through the annular BOP element. Other than in connection with this incident, the author has not ever heard of such an effect, nor has BP, Transocean, or other investigative bodies.<sup>28</sup>

The personnel on the rig (operator and contractor), and in town (BP engineering) were presented with two conflicting pieces of information (kill line pressure of 0 psi and drillpipe pressure of 1,400 psi). One of the explanations for this, and as it transpired, the correct one, was that the negative pressure test failed, that the well integrity had failed, and that formation fluids were trying to enter the well (or had already done so).

Annular preventer is closed to isolate hydrostatic pressure from the riser fluid.  
Seawater from 8,367’ to surface via drillpipe shows 1,400 psi  
Kill line is closed (0 psi)

Annular preventer is closed to isolate hydrostatic pressure from the riser fluid.  
Seawater from 8,367’ to surface via kill line (now open) shows 0 psi, but...  
drillpipe (still full of seawater) shows 1,400 psi

Good Oilfield Practice and common logic indicate that BP and Transocean should have resolved the cause of the difference, and determined the correct value(s) before proceeding. Instead, they chose to believe the result that they wanted and expected to see, and ignored the clear danger signal from the well. At the time that the rig personnel determined the negative pressure test was successful, the well was already (temporarily) underbalanced and prepared to flow (if in fact influx had not already occurred during attempts to bleed off pressure after 16:55). The failure to resolve the conflict with the data, explaining it with a non-existent phenomenon (the “bladder effect”), and finally declaring the test a “success,” was a gross and extreme departure from the standards of Good Oilfield Practice by both BP and Transocean.
