INCIDENT REPORT

Drift Off and Emergency Riser Disconnect

Transocean Horizon

June 30, 2003

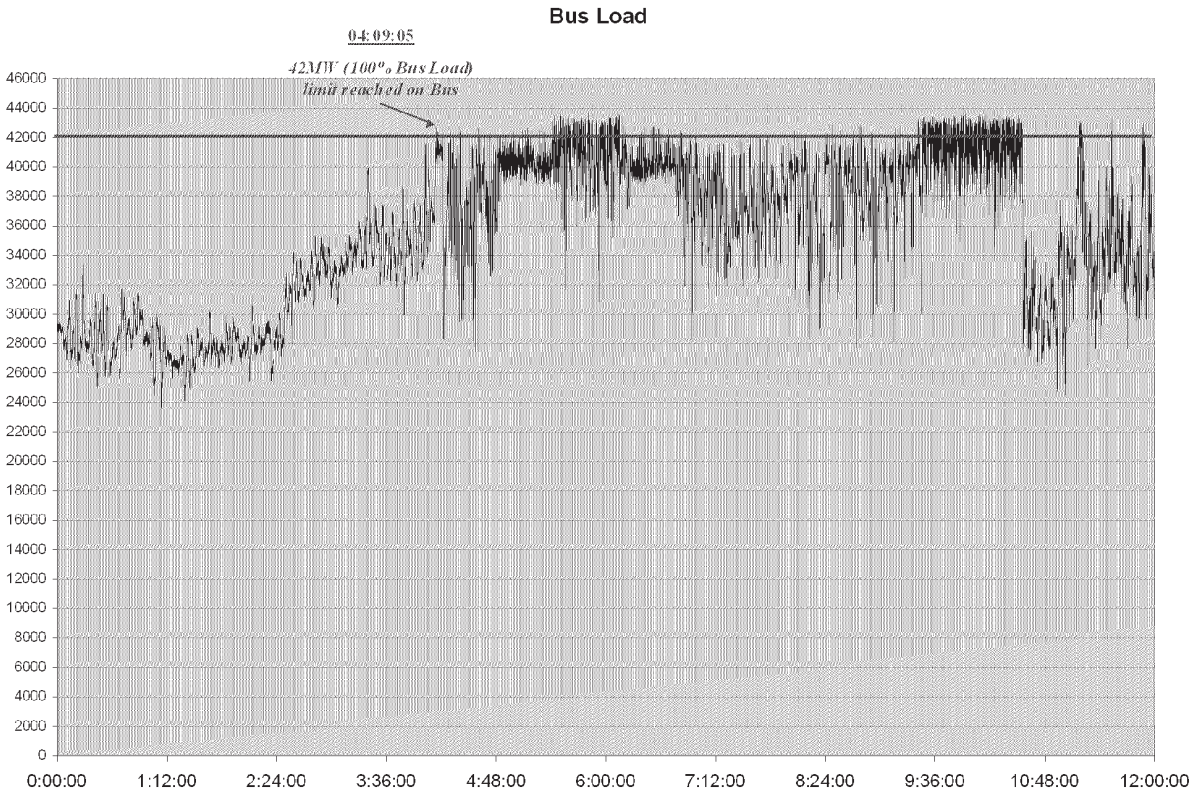
- **04:09:05** - 42MW (100% of maximum load on bus) reached on Bus

The Deepwater Horizon is fitted with six 7MW generators. That's a total of 42MW power available. The two main power consumers are Drilling and Propulsion. Propulsion is made of eight 5.5MW thrusters (total of 44MW). Both groups are using variable frequency drives. Because the Deepwater Horizon is a dynamically positioned vessel priority is given to thrusters in power phaseback situation.

In this case the DP system detected that the system load on the bus was over 100% of the available power and therefore limited the thruster speed command. Please note that the Simrad Vessel Control system is also able to send a power limit signal (4-20mA) to the ABB thrusters drives when the 105% limit is reached. That limit (44.1MW) was not reached during this incident¹.

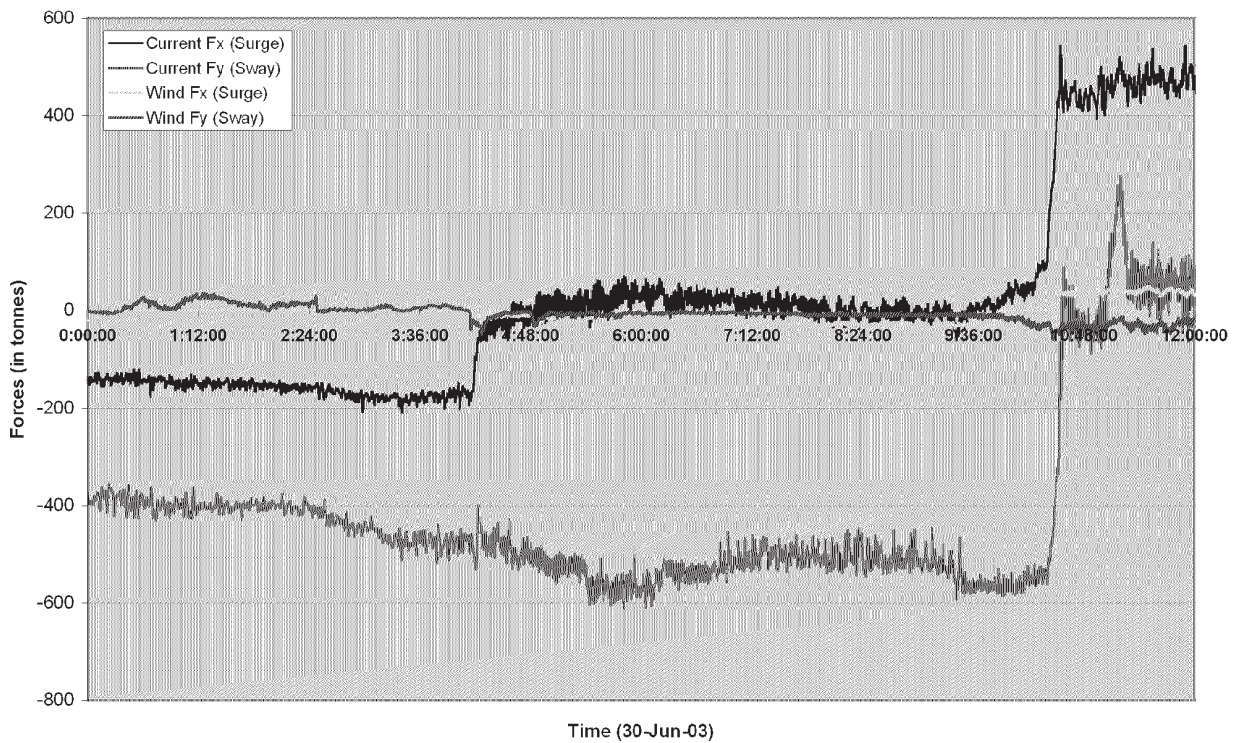
Wind and Current Forces on the Vessel

What caused the power limit to be reached? The strong environment acting on the vessel, mainly current which hit the vessel on the beam. This can be verified when looking at the forces acting on the vessel (increase in sway force acting on the vessel).

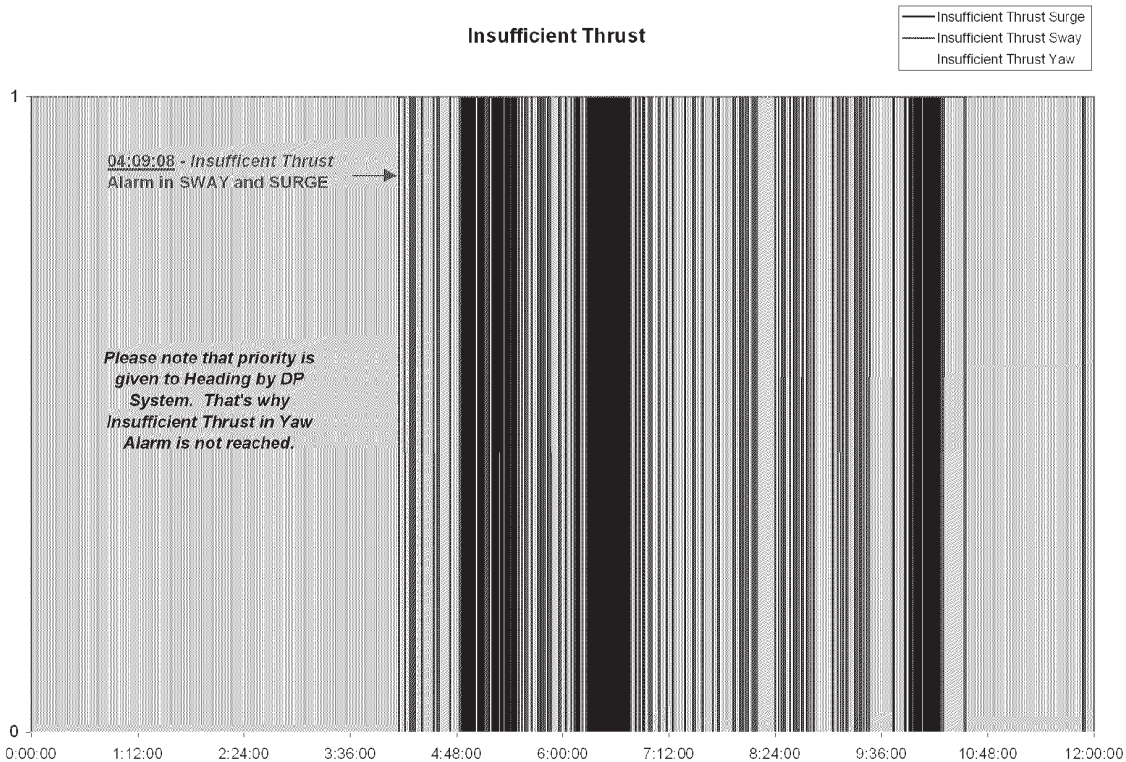
- **04:09:08 -** *Insufficient Thrust Alarms in Surge and Sway*

These alarms are triggered when the obtained thrust is different from the demanded thrust (beyond limits set in the system). That means that full station keeping is not guaranteed. Please note that the DP System gives priority to heading. That's why *Insufficient Thrust in Yaw* alarm is never reached during the incident. Whatever power was available to the thruster, the DP system always tries to satisfy yaw before thinking about surge and sway.

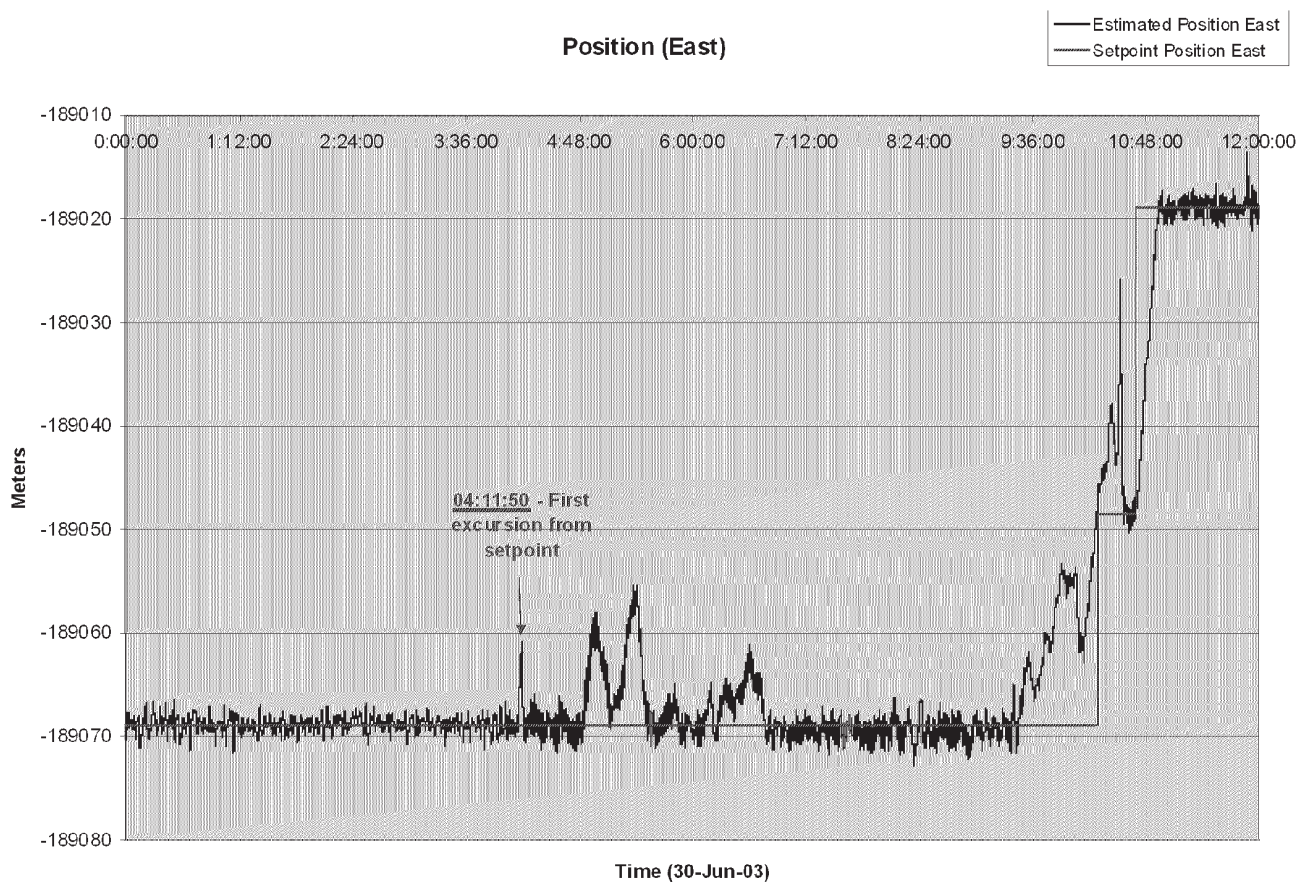
This is a direct consequence from the insufficient thrust in surge and sway. This is indicated on the graphs below: both estimated positions in East and North differ from the setpoint at 04:11:50. This excursion is the first of several excursions within the boundaries of the watch circle, but prior to the DP incident.

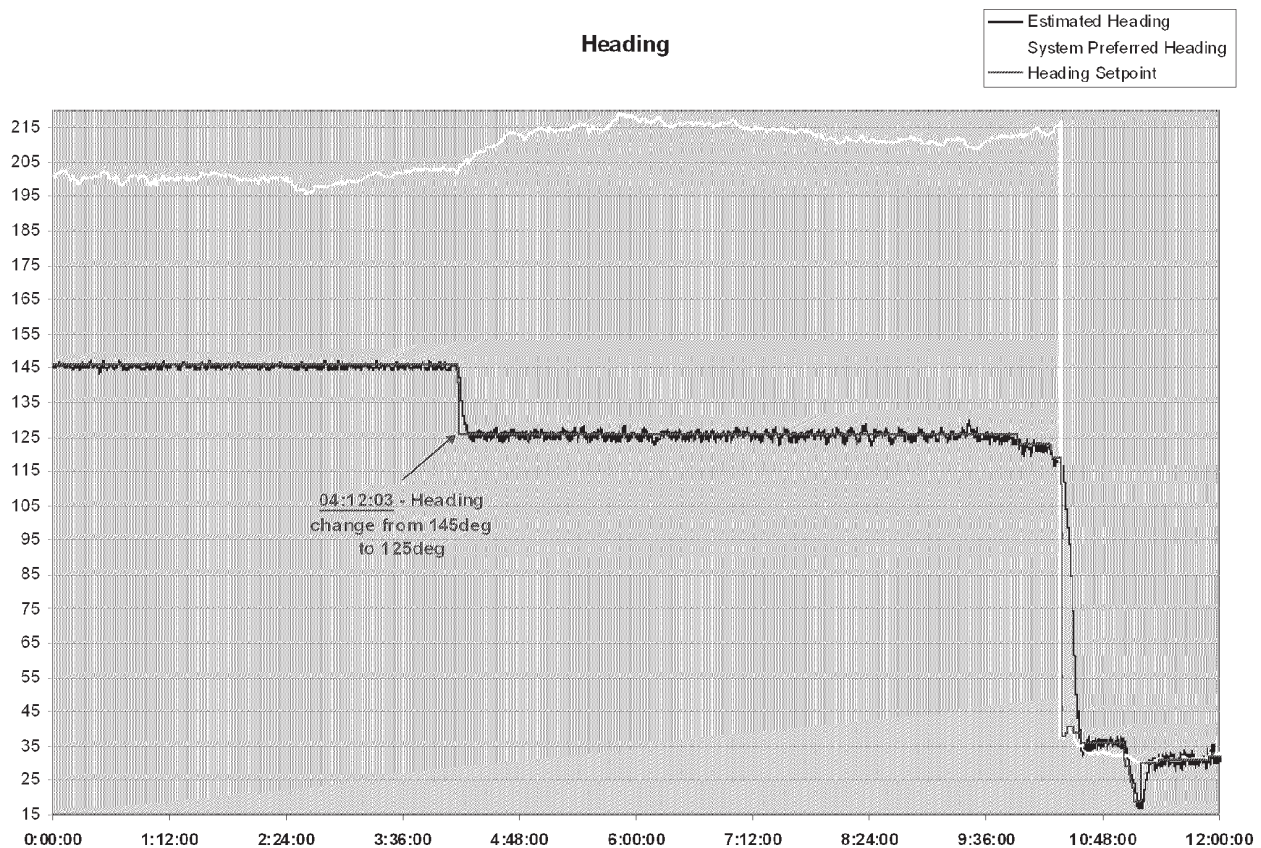
- **04:12:03** – Heading change from 145° to 125°

This heading change was initiated by the crew following the 9m excursion.

Please note on this graph that the System Preferred Heading (referred to as *System Selected Heading* by the SDP system) is different from the heading setpoint. This System Preferred Heading is calculated by the DP system and corresponds to the heading that requires the minimum power to maintain position in the current environmental conditions. It does change with prevailing environmental forces acting on the vessel and is constantly updated by the DP system. Please note that this System Selected Heading is available in a pull down menu, under Change Heading (as indicated below). It is not directly apparent on the DP screen.

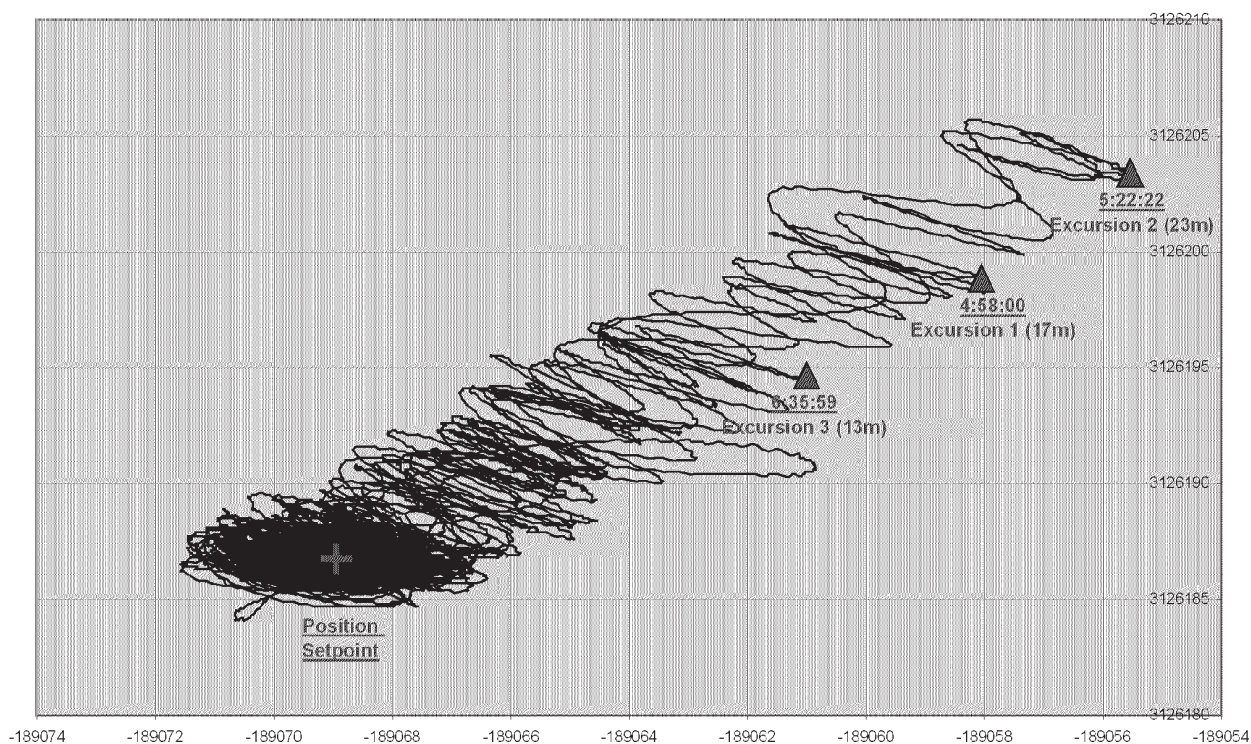
Snail Trail

- 04:58:00 – 17m excursion from setpoint. Rig came back on setpoint.
- 05:22:22 – 23m excursion from setpoint. Rig came back on setpoint.
- 06:35:59 – 13m excursion from setpoint. Rig came back on setpoint.

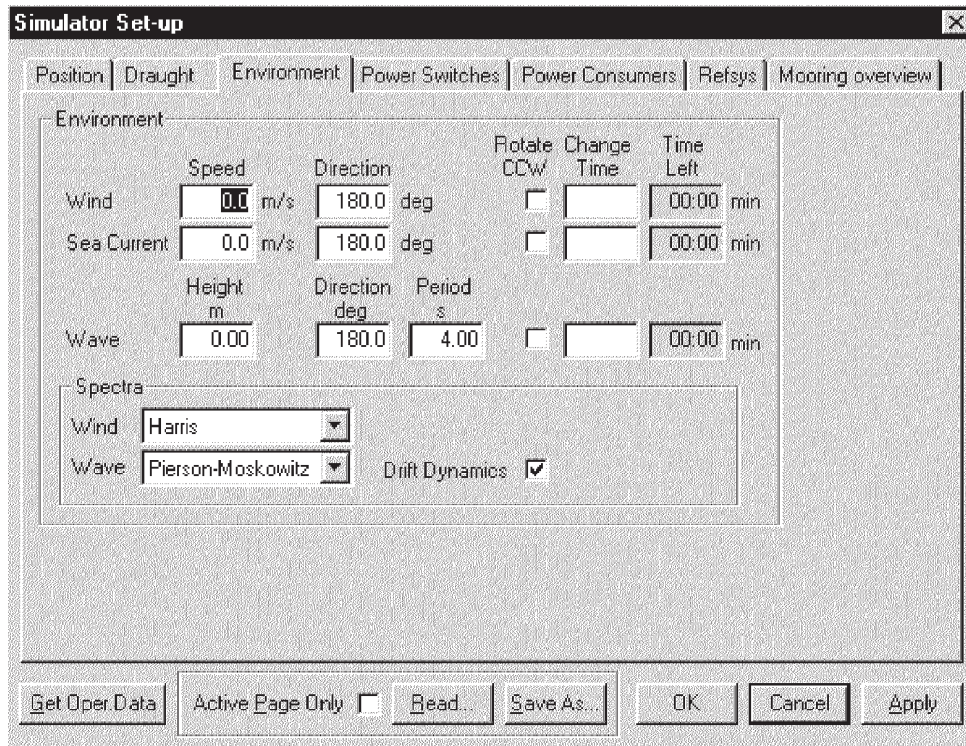
- **Around 06:00:00** – Crew ran simulation to determine if heading change could be made to the System Preferred Heading (215° - rig into current). The simulation indicated an excursion exceeding red limit (36m). Decision was made not to attempt the heading change.

The rate of turn used in the simulation was 5°/min.

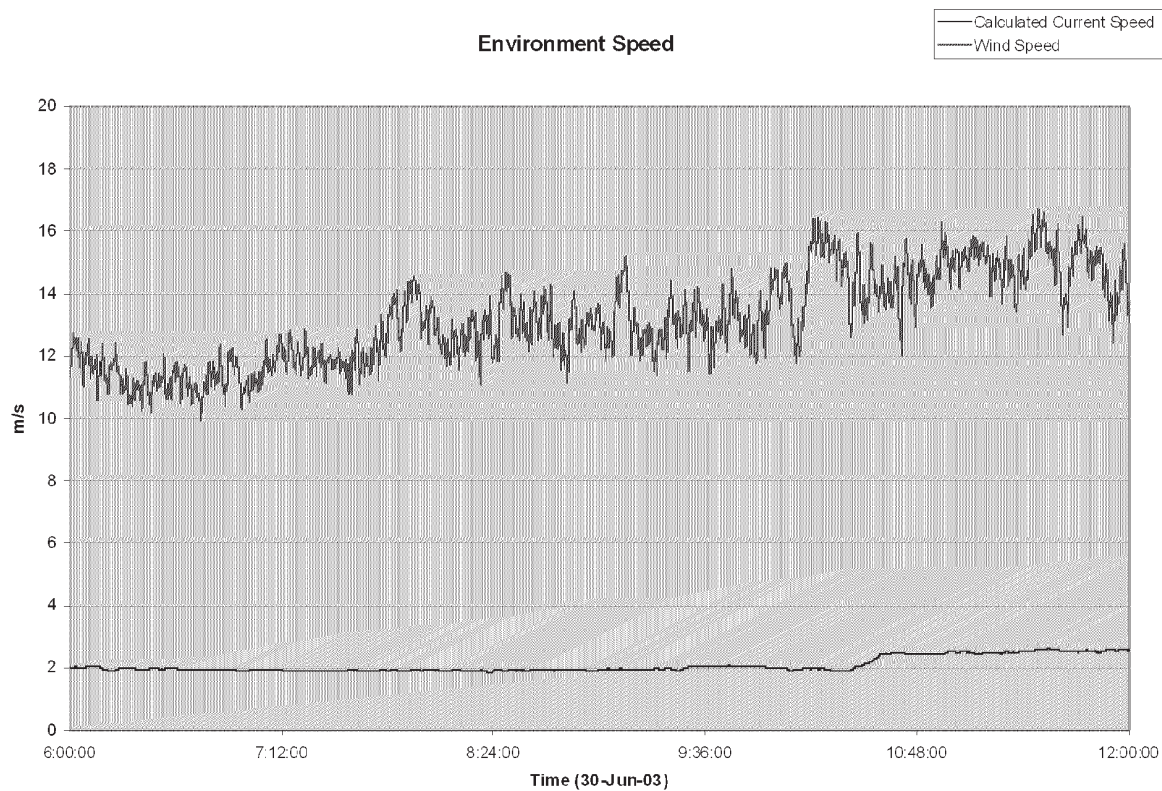
- **From 06:00:00 onwards** – environment slowly picking up. As a result the forces acting on the vessel increased. Power limit (42MW) reached on numerous occasions.

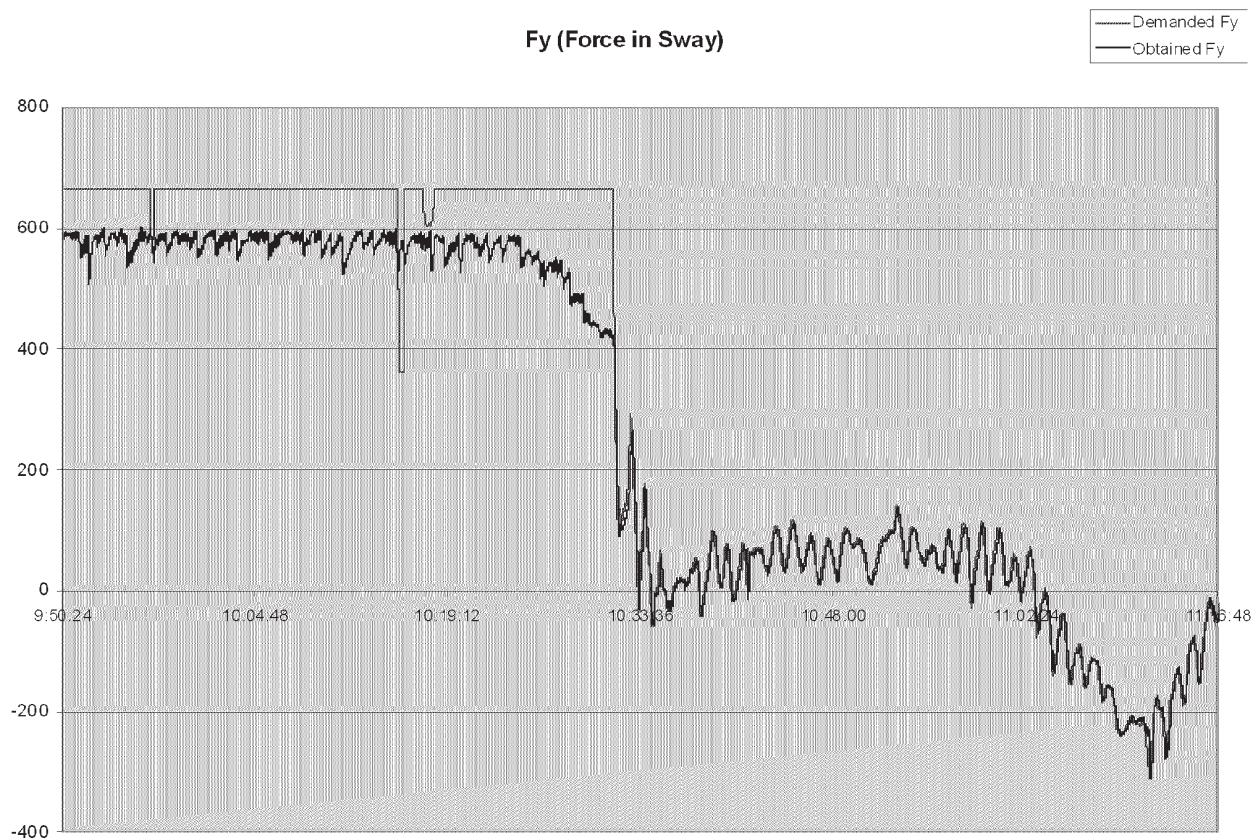
- As a result the obtained forces (especially in SWAY) do not meet the demanded forces.

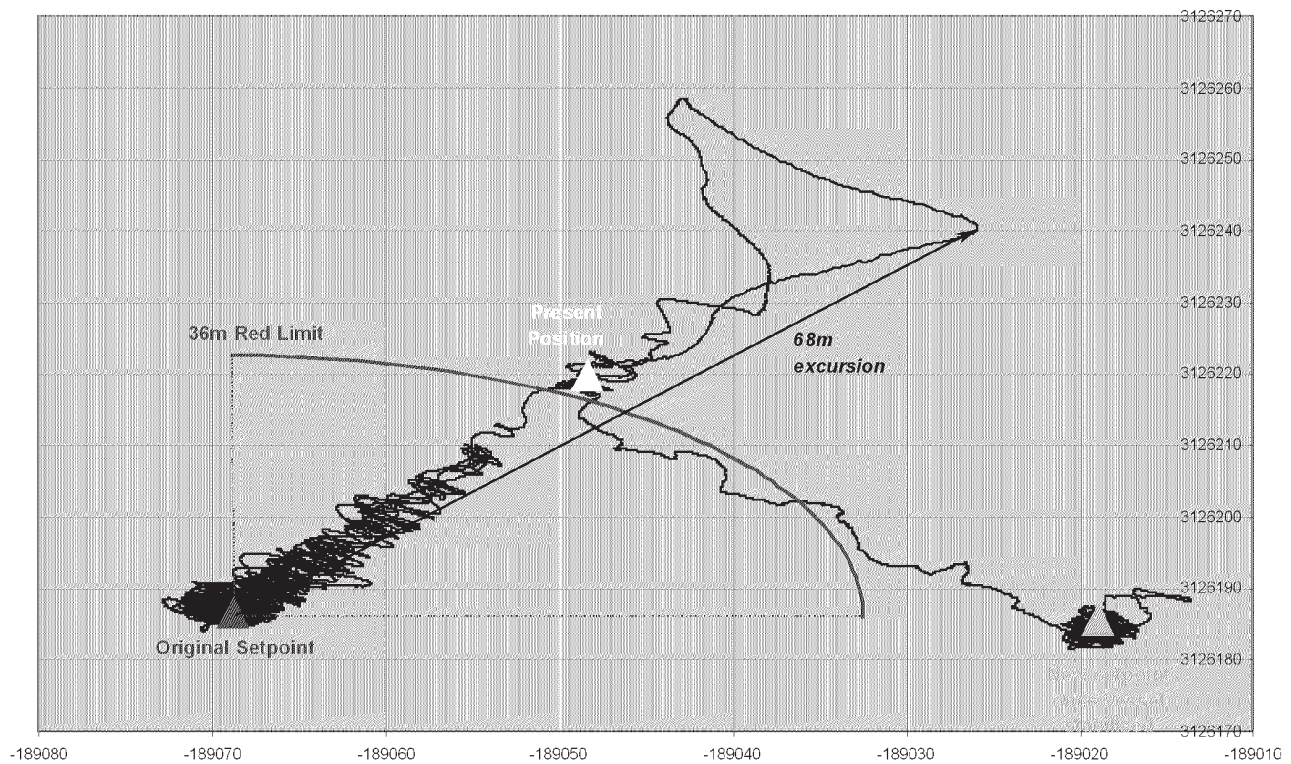
Snail Trail

- As a result the rig drifts off location At 10:16:00, Emergency Disconnect (EDS#1) was initiated

At the time of the disconnect the Kongsberg Simrad Calculated Current was 3.8 kts, coming from 218°. Wind speed was 30.7 kts coming from 145°.

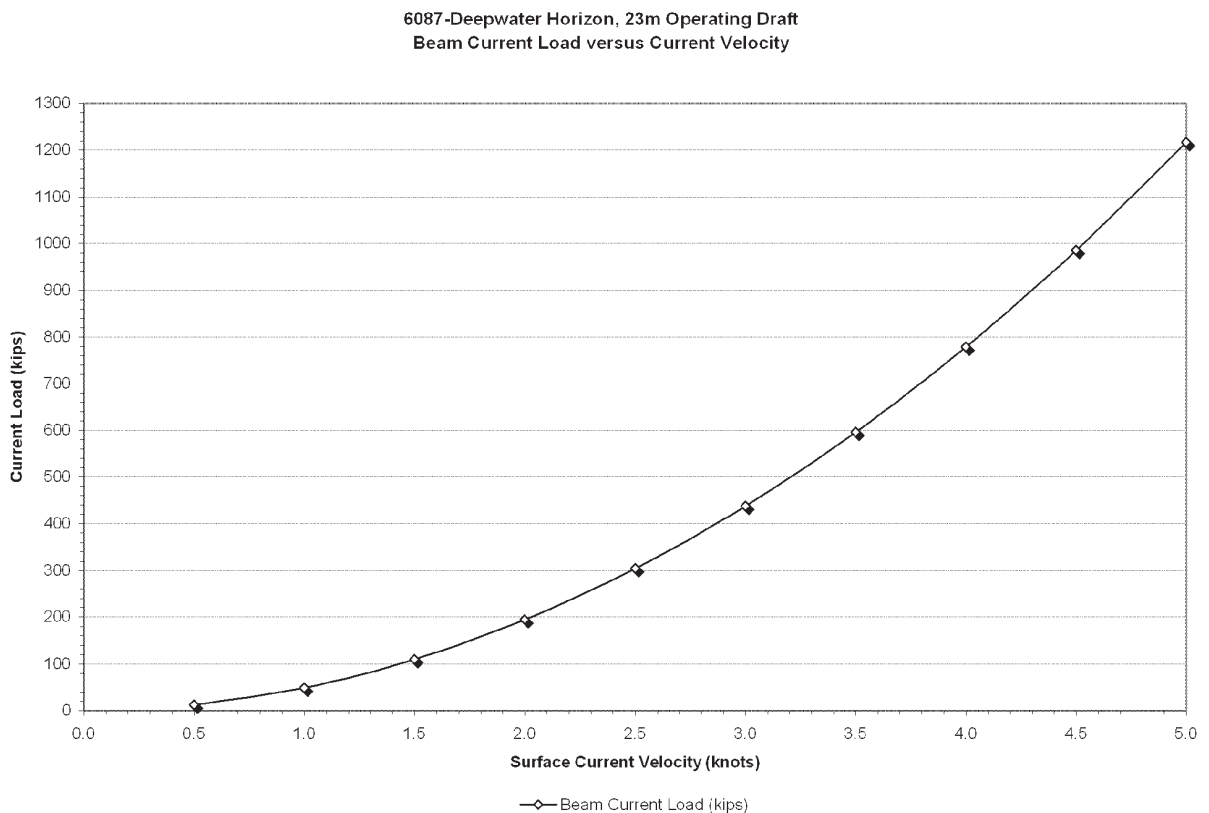
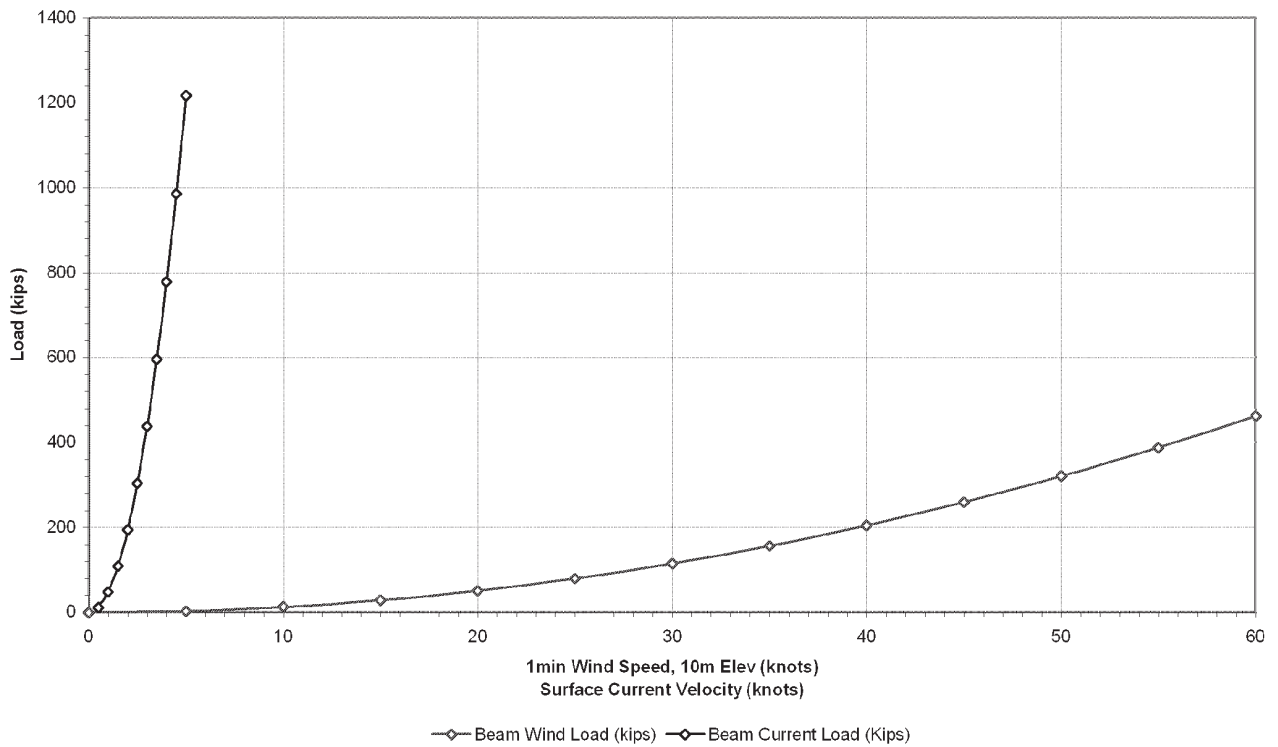
6087-Deepwater Horizon, 23m Operating Draft
Beam Wind Load versus Wind Speed
Beam Current Load versus Current Speed

The following graphs illustrate the Beam Current Load versus surface current speed. The second graph shows both the Beam Current Load and the Beam Wind Load (1 min wind speed 10m elevation). This second graph was just included to illustrate the effect of current compared to wind on the Rig.

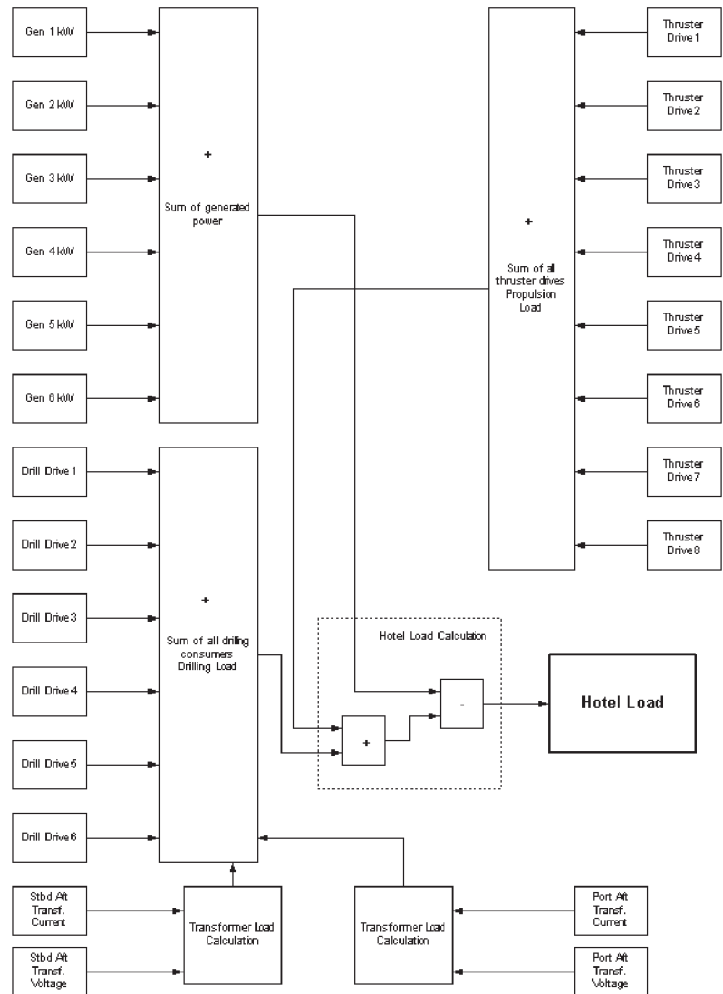
Hotel Load Calculation by Kongsberg Simrad (drawing produced by Jan Simonsen, Kongsberg Simrad)

Please note that investigation is ongoing on the SVC system at this point in time. The mis-calculated hotel load is what has been found so far.
