**Deepwater Horizon
Follow Up Rig Audit, Marine Assurance
Audit and Out of Service Period
September 2009**

Executive Summary

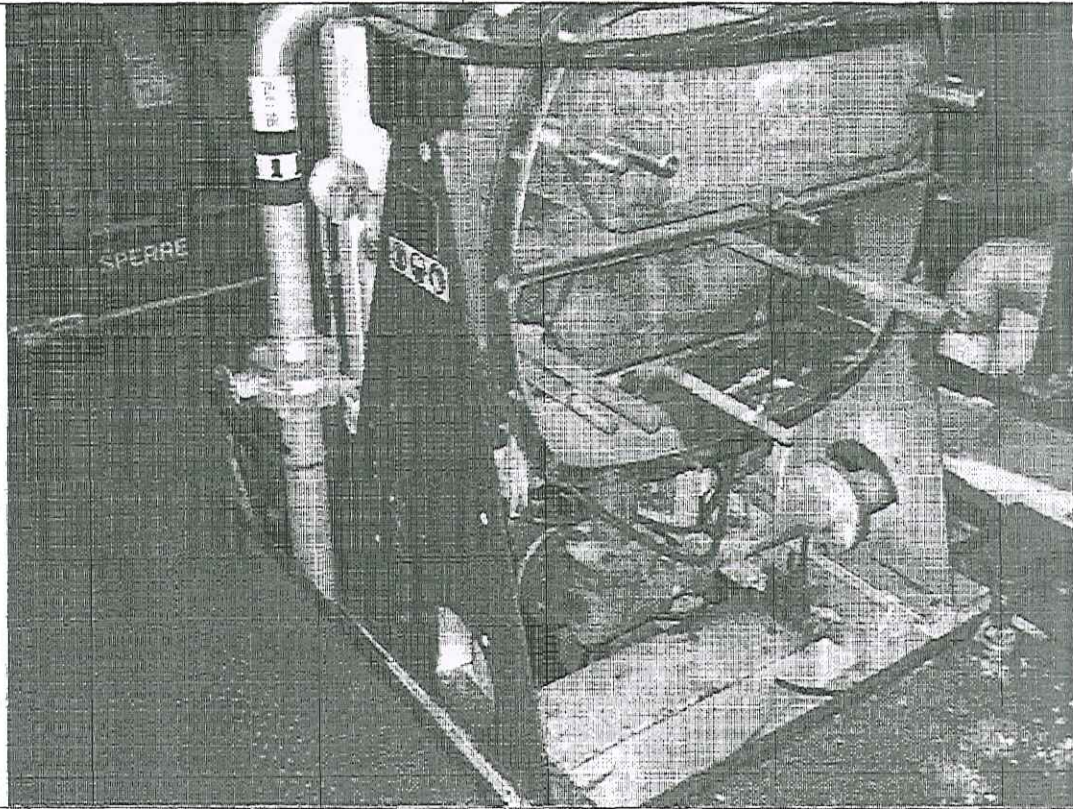
Rig Name:	Deepwater Horizon
Date:	September 2009
ARAS Reference:	1.1.5

1.1.5	Several instances where mechanical isolations had not been identified or suitable locked and tagged out. Examples include discharge valve on air start compressor #4 during motor replacement and failure to lock out / tag out the jacket water and seawater inlet and outlet valves during disassembly of water maker #5.	Mechanical isolations to be considered for each job involving energy isolation. An effective system of tag and locks to be employed and details included on the Isolation Certificate. Golden Rules of Safety	Immediately

Maintenance on watermaker #5, note the front of the unit is opened up but none of the jacket water or seawater valves have been locked or tagged shut.

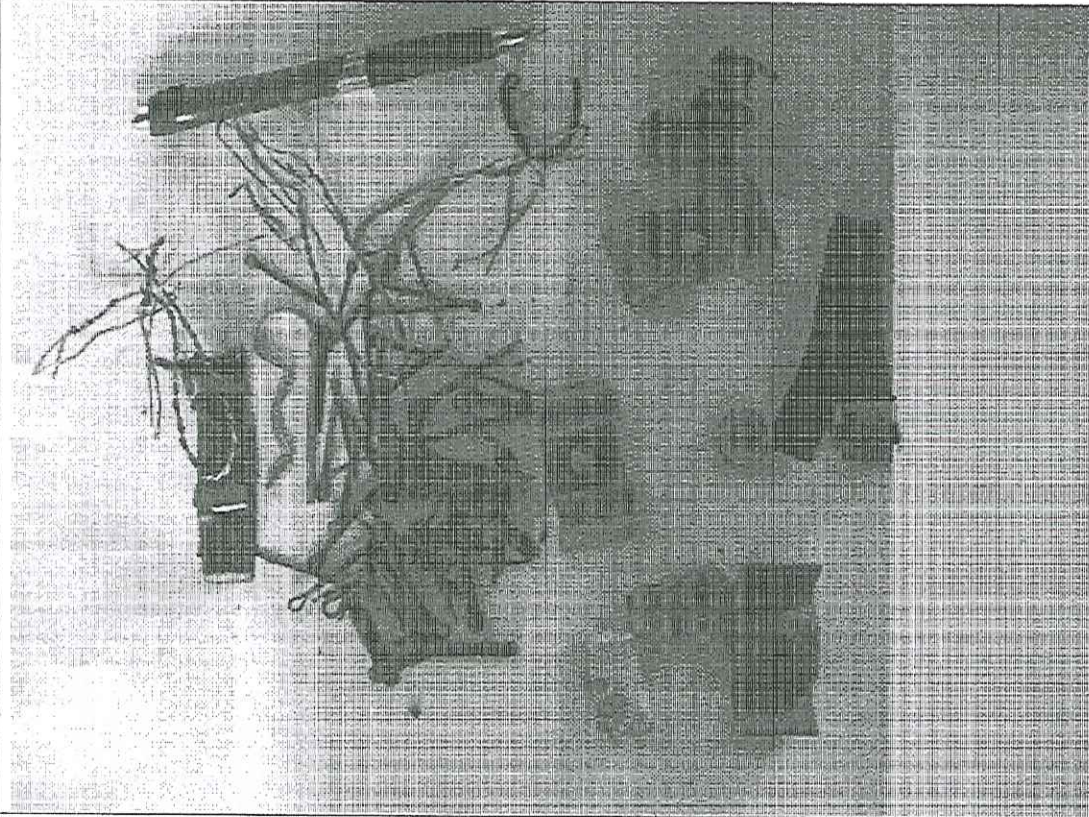
Rig Name:	Deepwater Horizon
Date:	September 2009
ARAS Reference:	2.2.5

Observations or Comments:	
Trash and loose items recovered from the derrick. The rig crew had made a derrick inspection the shift before our inspection was performed.

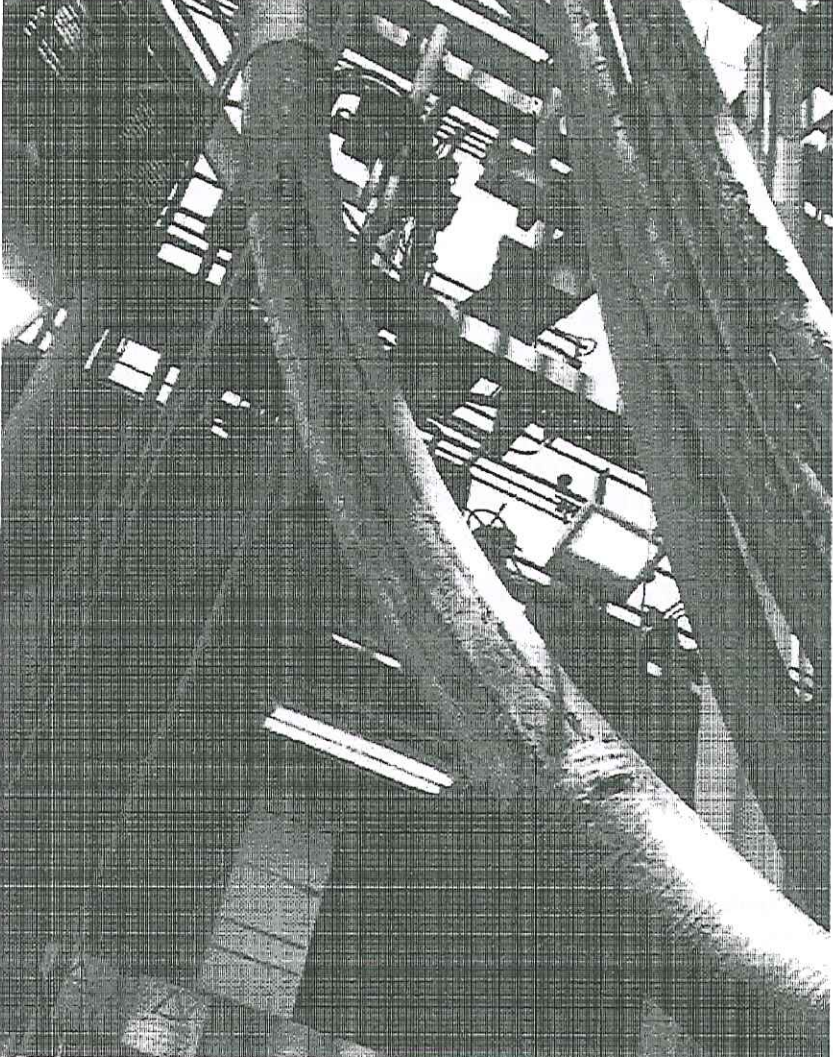
Rig Name:	Deepwater Horizon
Date:	September 2009
ARAS Reference:	2.2.8

Top drive maintenance was reported as up to date with no outstanding issues, it was however noted that it had been omitted from the recent drilling load path inspection and condition of the mud hose was unacceptable.

Observations or Comments: Poor condition of mud hose and top drive service loops
