Expert Report - Macondo

Gregg S. Perkin, P.E.

RE: DEEPWATER HORIZON Explosion on April 20, 2010
Report of Gregg S. Perkin, P.E.

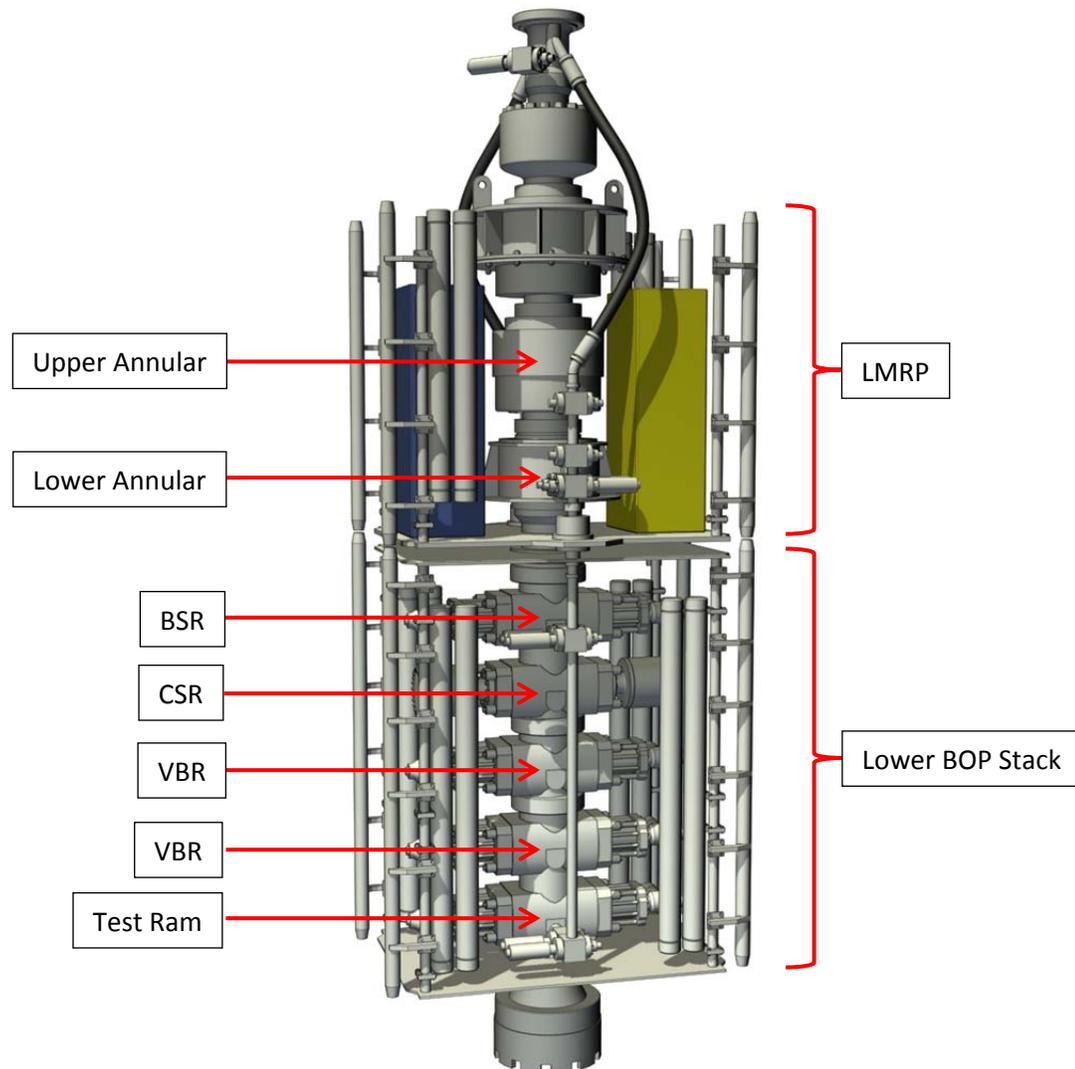
8. The HORIZON's BOP included a Lower Marine Riser Package (LMRP) and a Lower BOP Stack. The LMRP included two annulars. The lower BOP stack included the single BSR, a casing shear ram ("CSR"), two variable bore rams ("VBR") and a test ram as well as various connectors mounted to a structural frame. Refer to the figure below. Also, a more complete explanation of the BOP, its components and how it works is contained in the Appendices.
