**Deepwater Horizon
Technical Rig Audit
January 2005**

.....
Kevan Davies, Rig Audit Group
24 January 2005

.....
Norman Wong, Head of Rig Audit
29 January 2005

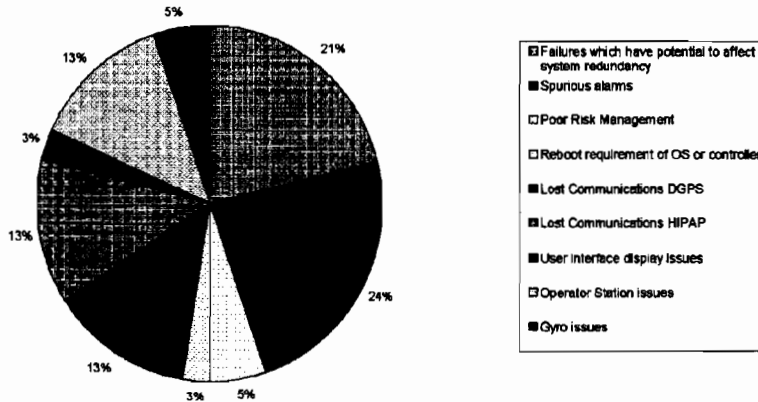
Subjective Analysis of Anomaly log

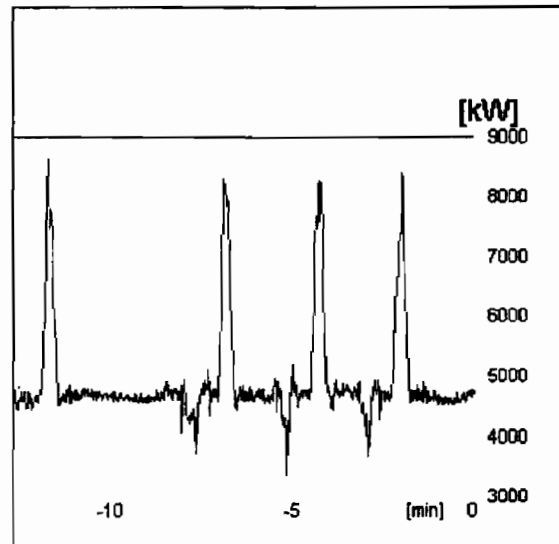
Schematic 1 Screen shot of total power demand whilst running casing, (14 MW available)
