Deepwater Horizon Follow Up Rig Audit, Marine Assurance Audit and Out of Service Period September 2009

Executive Summary

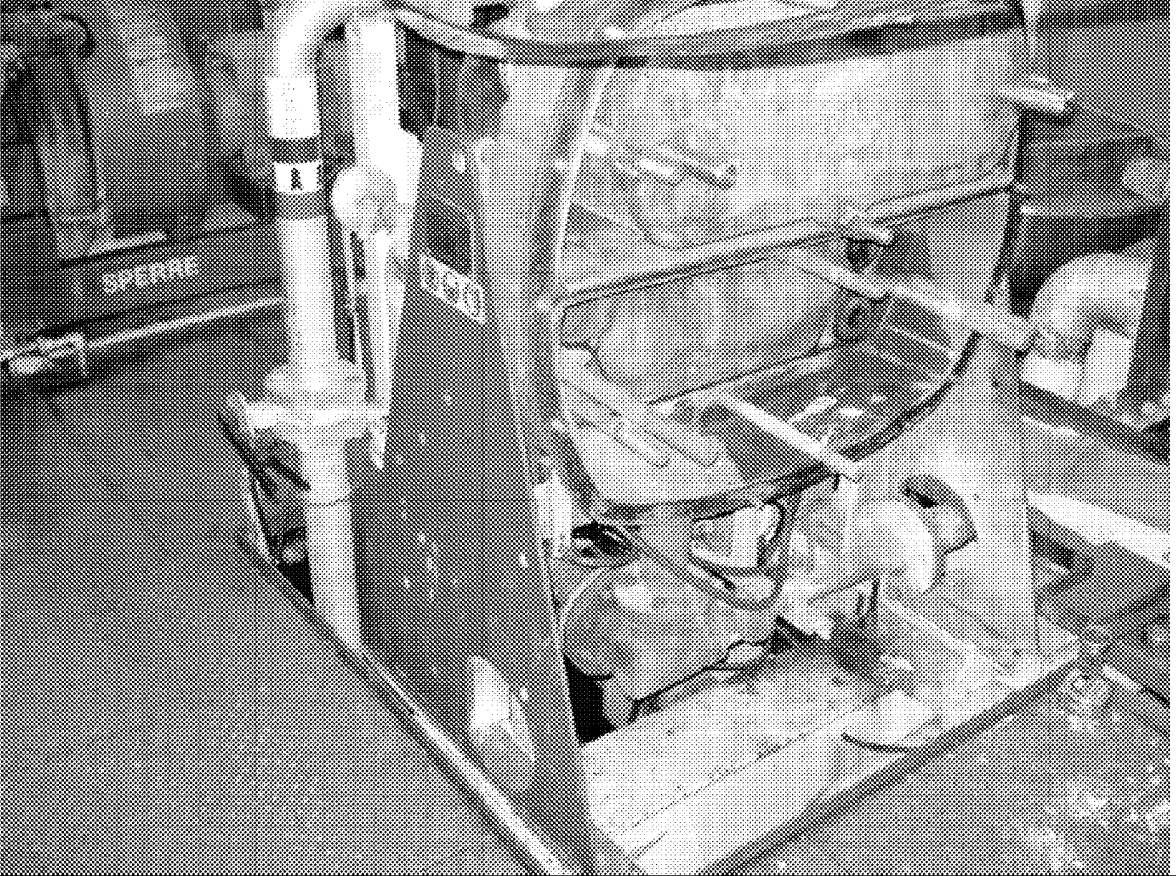
Rig Name:	Deepwater Horizon
Date:	September 2009
ARAS Reference:	1.1.5

1.1.5	Several instances where mechanical isolations had not been identified or suitable locked and tagged out. Examples include discharge valve on air start compressor #4 during motor replacement and failure to lock out / tag out the jacket water and seawater inlet and outlet valves during disassembly of water maker #5.	Mechanical isolations to be considered for each job involving energy isolation. An effective system of tag and locks to be employed and details included on the Isolation Certificate. Golden Rules of Safety	Immediately

Observations or Comments: <p>Maintenance on watermaker #5, note the front of the unit is opened up but none of the jacket water or seawater valves have been locked or tagged shut.</p>

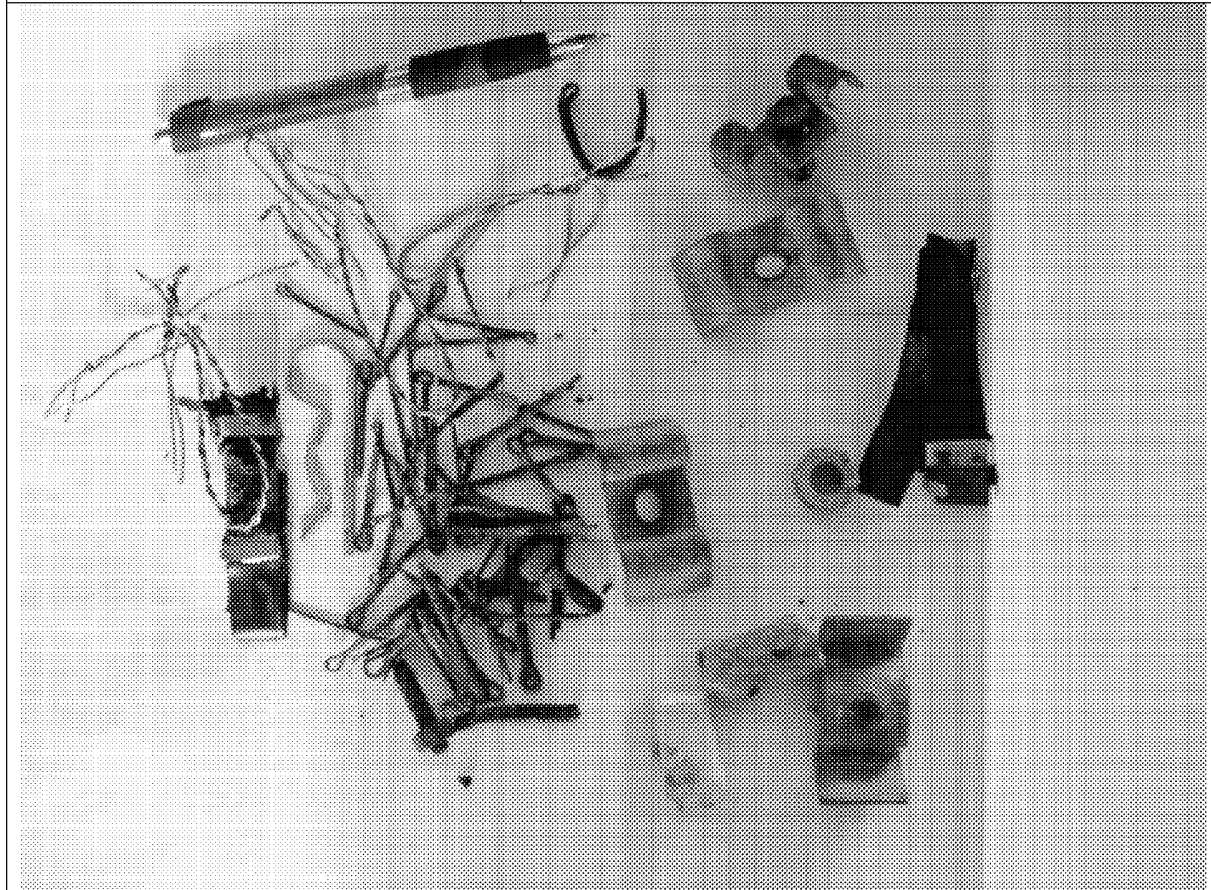
Rig Name:	Deepwater Horizon
Date:	September 2009
ARAS Reference:	2.2.5

Trash and loose items recovered from the derrick. The rig crew had made a derrick inspection the shift before our inspection was performed.

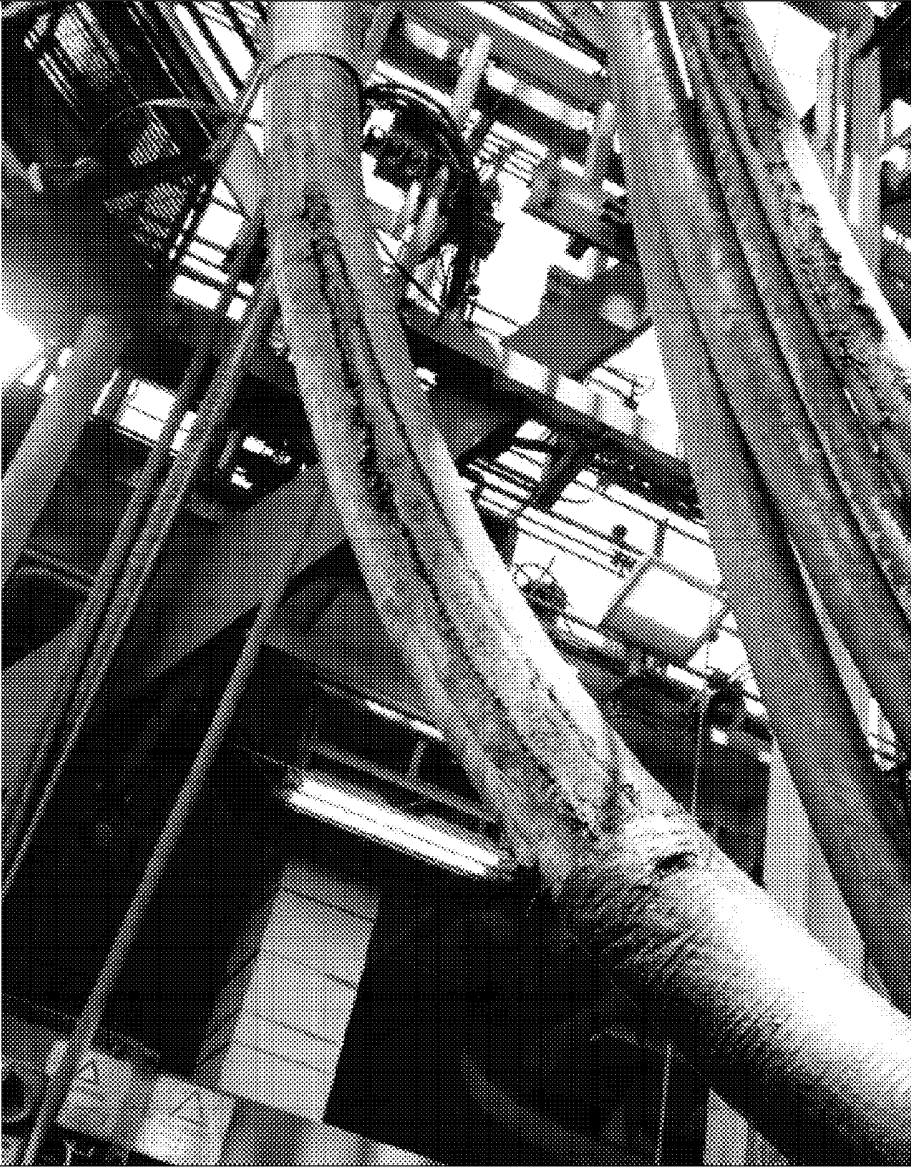
Rig Name:	Deepwater Horizon
Date:	September 2009
ARAS Reference:	2.2.8

Top drive maintenance was reported as up to date with no outstanding issues, it was however noted that it had been omitted from the recent drilling load path inspection and condition of the mud hose was unacceptable.

Observations or Comments: Poor condition of mud hose and top drive service loops
