**IN THE UNITED STATES DISTRICT COURT FOR
THE EASTERN DISTRICT OF LOUISIANA**

*In re: Oil Spill by the Oil Rig Deepwater Horizon in the
Gulf of Mexico on April 20, 2010 (MDL No. 2179)*

REBUTTAL REPORT OF GREG CHILDS
Blowout Preventer (BOP)

Submitted by Transocean Offshore Deepwater Drilling, Inc.

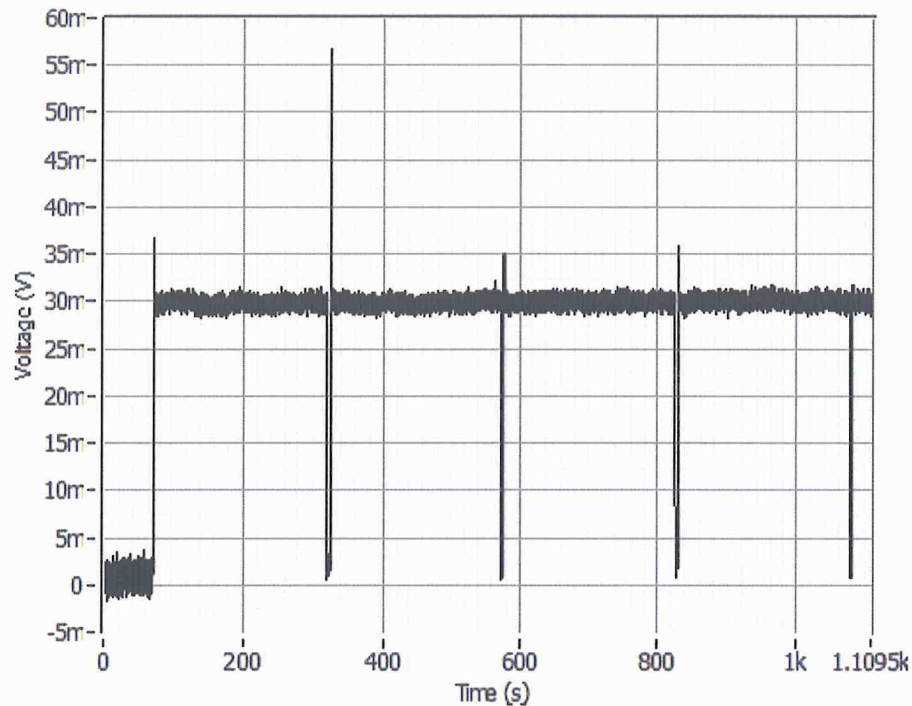
GRAPH 1

Similar tests were conducted through December 13, 2010, changing different variables on the power supplies to reflect battery conditions that may have been present on April 20, 2010 (adequate, weak, and/or inadequate). On December 13, 2010, the test results were recorded using a device that reads currents and voltages and from which a graph of the testing data was created. The figure below shows the December 13, 2010 test results. The vertical lines depicted approximately every 4 minutes and 11 seconds indicate that the rebooting cycle has started over.

December 13, 2010 Test Results Showing that Approximately Every 4 Minutes and 11 Seconds the Rebooting Cycle Started Over.
