**EAU
INCIDENT INVESTIGATION REPORT**

OER-MGH-09-005

**M.G. HULME, JR.
Well Control Incident – Riser Unloading**

Date: 26 March 2009

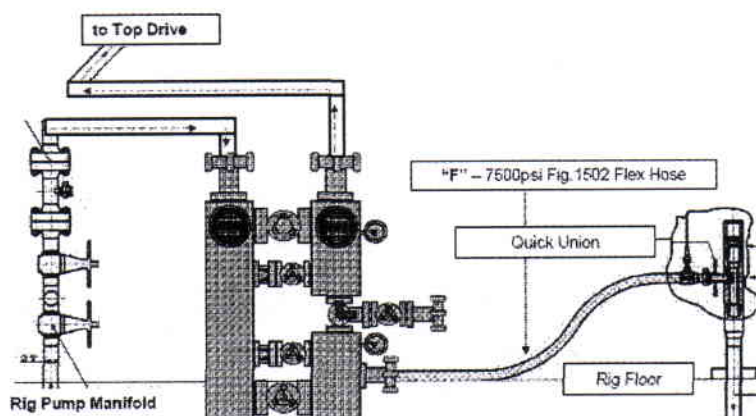
Figure 1: E-CD System

The Eni Circulating Device (E-CD) was in use to ensure continuous circulation. E-CD was utilized on this well to maintain hole stability (particularly on deeper near horizontal sections) and was not planned to be used for well control purposes.

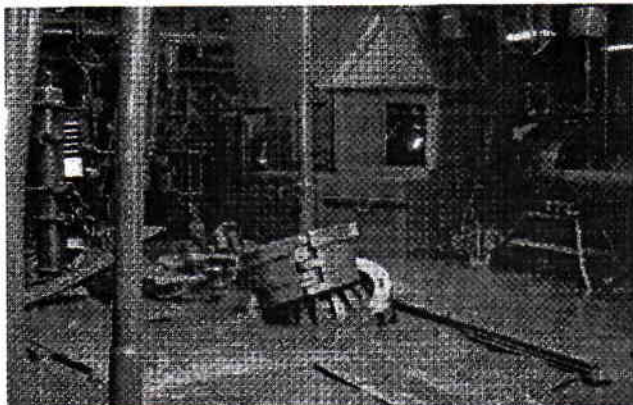
Figure 2: Picture of rig floor after incident

In total approximately 650 barrels of mud was lost, either through the rig floor or to the well, the Diverter element was pushed out of rotary table, and due to the force of the mud exiting fingerboard latches were lifted allowing 2 drillpipe stands to fall across the derrick.

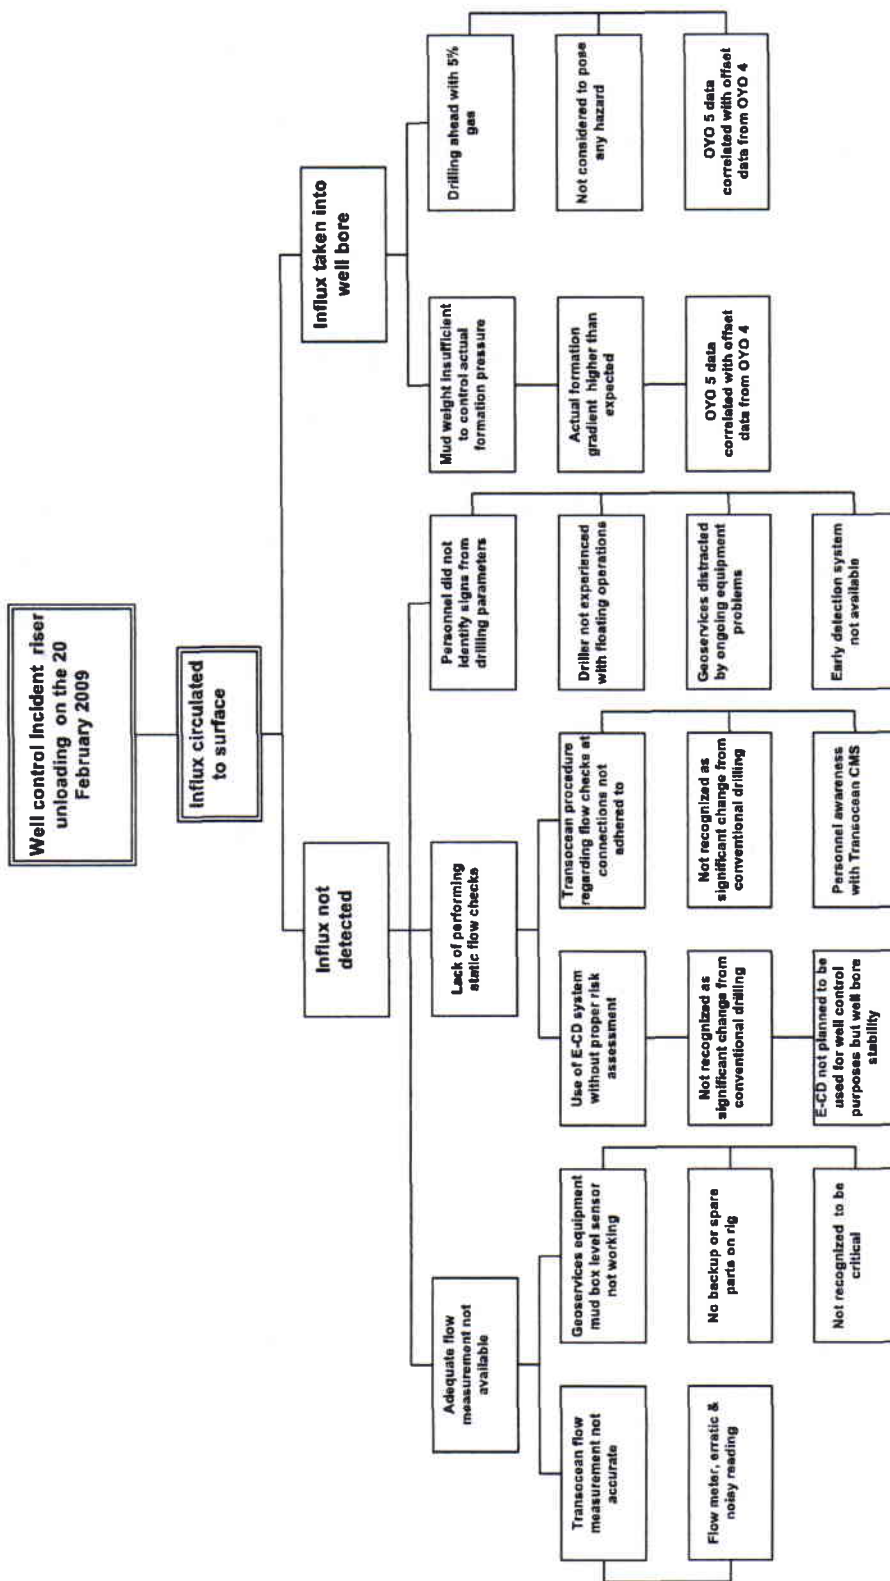
ROOT CAUSE ANALYSIS

Our hypothesis as to the sequence of events is that the gas zone was penetrated earlier than posted on the drillers instructions (but within the error tolerance of the prognosed depth) and before the problem with pump #1. The initial flow from formation occurred when all pumps were shut down for pump #1 problem. It is inconclusive if the influx continued when drilling resumed and ECD may have been sufficient to balance the well again.

As the influx was circulated out of the wellbore the gas came out of solution, expanded, and blew through the rotary table; possibly the reduction in hydrostatic led to increasing underbalance and substantial evacuation of the well.
