Subject: Deepwater Horizon

Reference: Acceptance of Well Control Equipment

WEST Report # 1040

Section 1: Project Summary

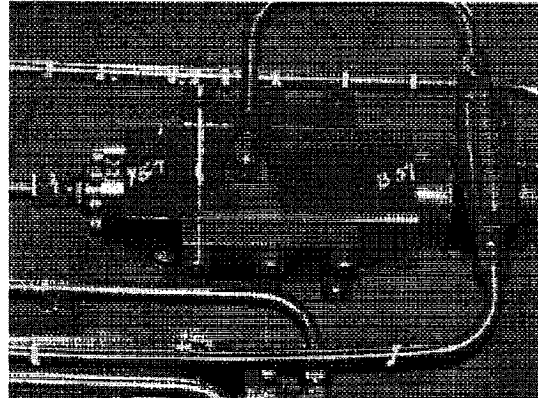
1. The "deadman" circuit should be modified to only close the shear rams and lock the ST locks. This will reduce clutter on the stack, eliminate many unnecessary valves making the circuit more reliable and reduce leak paths. The existing circuit for the deadman also utilizes the Cameron unbalanced shuttle valves that have had problems in the past, as shown at the photo to the right. These will be eliminated with the deadman circuit modifications.

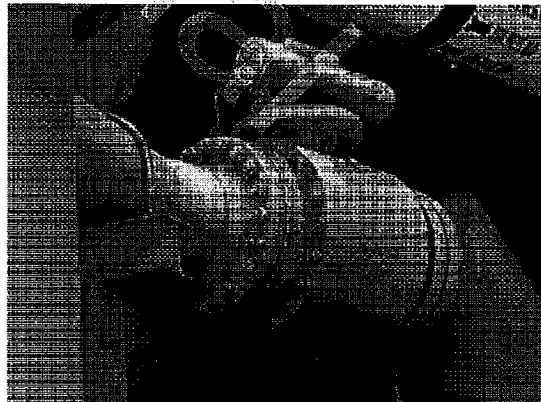
5. The port overboard ball valve leaked and two repair kits were ordered. This should be repaired promptly to be certain no other parts are required to fix the leak (for example, if the ball was damaged, this is not part of the repair kit).

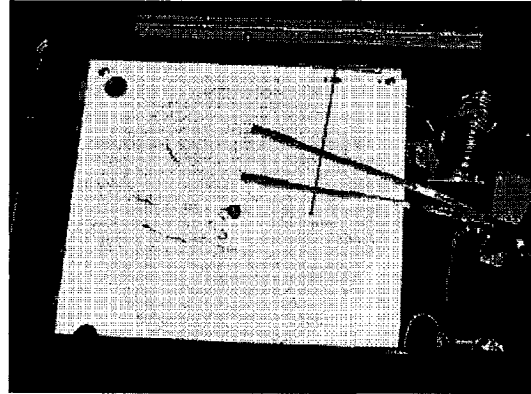
6. A spare chart recorder should be obtained so the one on the unit can be sent in for repair and calibration. The low pressure pen and high pressure pen could not be used together due to interference when a long enough pen was put on the low pressure arm to get it to contact the chart, see the photo to the right. The gauges were also in need of calibration.

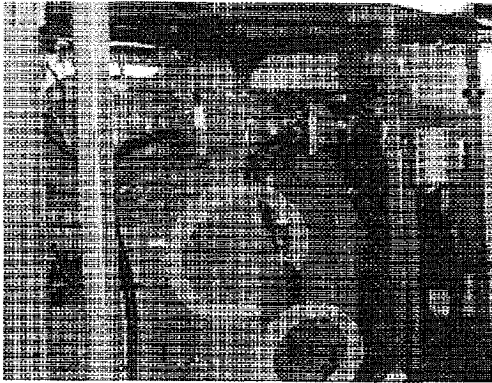
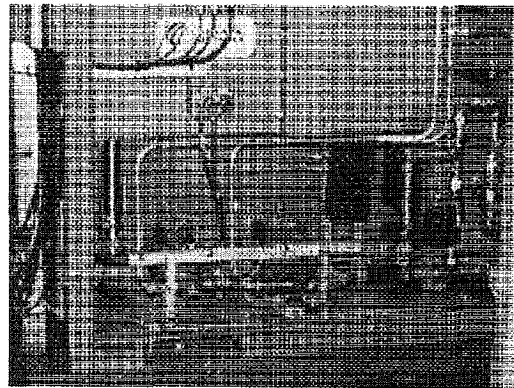
1. The triplex pumps, below left, put out 30 GPM with 3 pumps, which equals 90 gallons per minute. The mix system, below right, will not keep up with a max output of only 30 GPM. This should be corrected and is under review by Cameron. The rig has already taken steps ensure 120 GPM for supply is available from the rig.

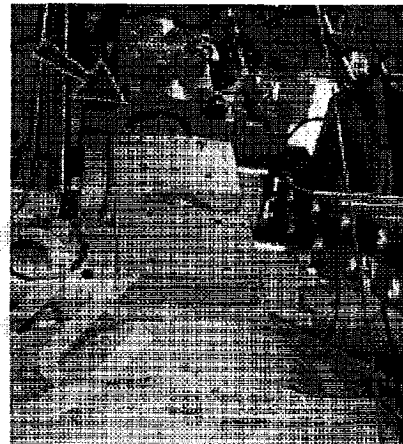
4. Personnel operating the trip saver should be limited to the subsea engineer or toolpushers. They should have training on how to operate the trip saver in the manual mode. Improper operation in manual mode or not paying proper attention could result in major equipment damage. Major damage has already occurred on the Nautilus, according to Peter Keenan.

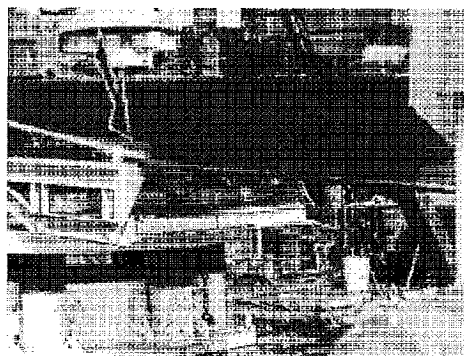
5. The riser spider should be modified to clear the slip joint when picking it up or laying it out. The ideal time to do this would be now, as there may still be an interference problem when running the BOP. The photo below left shows minor damage that occurred. The photo below right shows the interference that caused the damage from the slipjoint. Normally this will be run after the BOP and riser, which should drop the riser spider by a small amount.

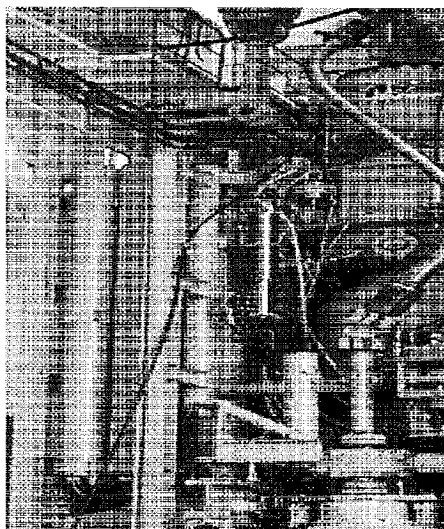
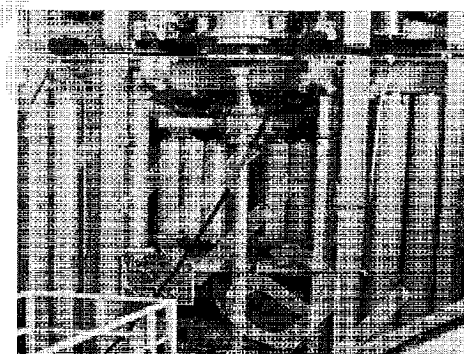
6. Work platforms should be installed on the tow from Singapore, as the BOP stack was in dire need of them. As shown below, there is nowhere to stand when working on the stack.

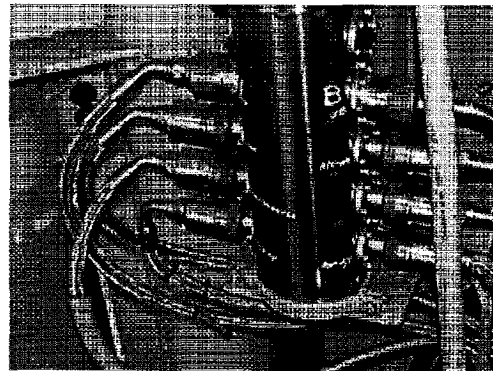
8. The riser connection box (RCB) as seen to the right should have the latest update with individual fuses that are resettable. This provides redundancy for the system. Also, Cameron is investigating the effect of losing the RCB and how it would effect the full system.

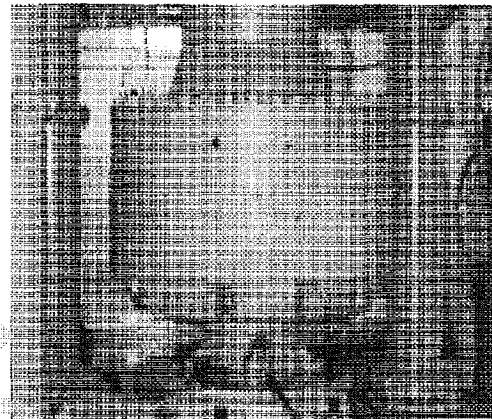
9. All the required modifications to install the Cameron connector should be performed while on the tow to be certain no unforeseen problems arise that require extra time. At present the rig has a Vetco H-4, as seen to the right.

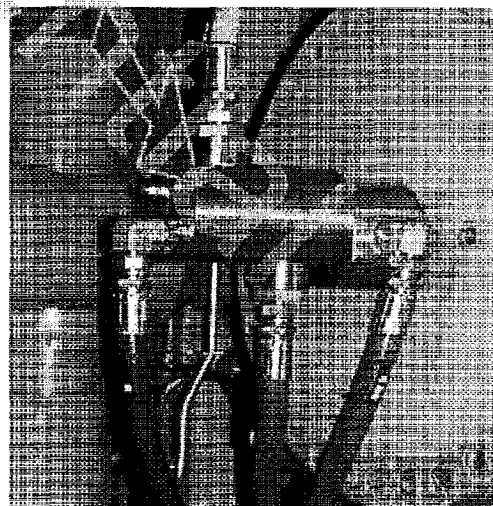
10. Mark II Gilmore stackable shuttle valve on the super shear ram, shown to the right, should have the Mark III HD shuttles installed.

Gilmore Shuttle Valve Switchback (shuttle shifts toward the opposite pod) - Both the Mark II and Mark III 1" shuttle valves have a tendency to "switchback" (the shuttle shifts toward the opposite pod) at the end of venting flow. Gilmore has duplicated the "switchback" in shop testing. Gilmore stated this anomaly was also present in the conventional, rectangular shuttle valves. As of October 4, 2000, Gilmore will no longer support the Mark II valve. The super shear rams have Mark II valves and Cameron has been notified of the need to replace these.

The new Mark III HD shuttle valve eliminates switchback. In shop tests under high flow conditions, the design completely eliminated both switchback and oscillation.

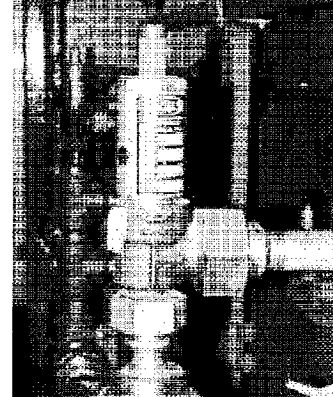
Inadequately Sized Relief Valves on Cameron Hydraulic Power Unit (HPU) Systems – Cameron has designed some of their HPU system with undersized relief valves. Cameron's vendors have supplied new equipment recently with hydraulic pump relief valves incapable of relieving a volume equal to or greater than the pumps deliver. Should the pressure switch fail to turn off the pumps, pressure would continue to increase until a major failure of a component occurred. This is a serious safety hazard. On one rig, the pumps did fail to turn off and seals blew out when the pressure exceeded 7000 psi. The original Cameron part number of the undersized relief valve manufactured by CPV Mfg., Inc was 22511-4. The CPV part number was 158 and the valve had a .219" diameter orifice.

The relief valves on the triplex pumps on the Horizon are CPV as seen to the right, and this issue has been taken up with Cameron. They were to provide calculations to demonstrate the relief valves can handle the pump output by 4-1-01.

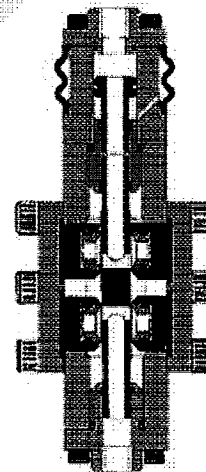
Cameron ½" Unbalanced Shuttle Valves Hydrostatic Lock - A problem with hydrostatic lock was witnessed on one rig. The problem was isolated to either the ½" unbalanced shuttle valve or a ¾" pilot operated check valve in the same circuit, but could be isolated no further. Both valves were removed and replaced with different types of components and the problem did not recur. It should be pointed out that these same valves are currently in use on other rigs separately and have not caused problems.

The ½" unbalanced shuttle valves should be closely monitored to ensure hydrostatic lock does not occur. The ½" unbalanced shuttle valve can be seen to the right.

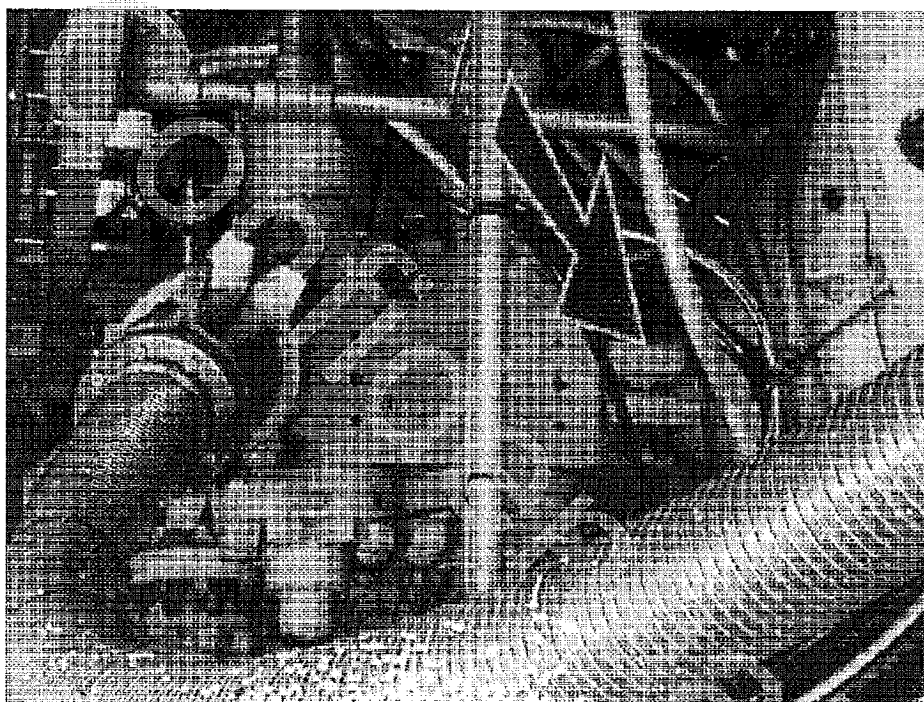
6.1 The arrow to the right points to the outlet on the lower annular bleed valves requiring AX gasket change out due to a leak found during wellbore pressure testing. This outlet and the connection shown below are the ones affected by the 1/4" upward movement when the choke mini connector is unlatched. Cameron is supposed to demonstrate why the 1/4" movement is acceptable.

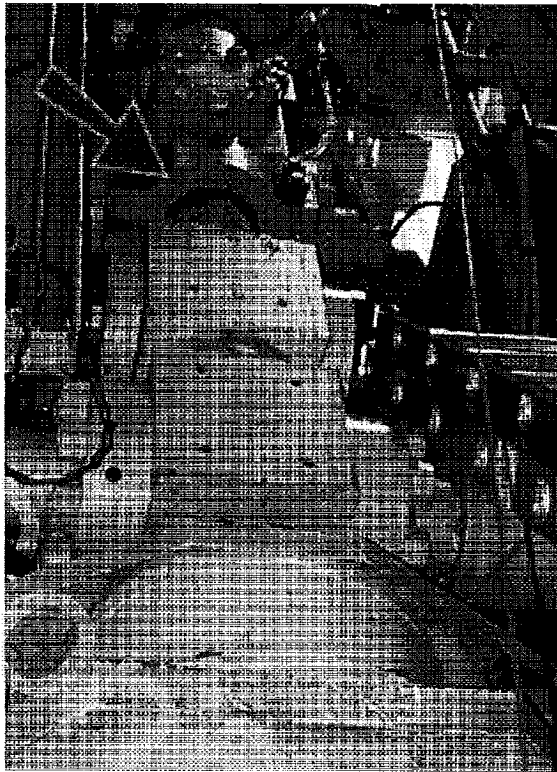
6.2 The arrow points to the other connection opened to change the AX gaskets.

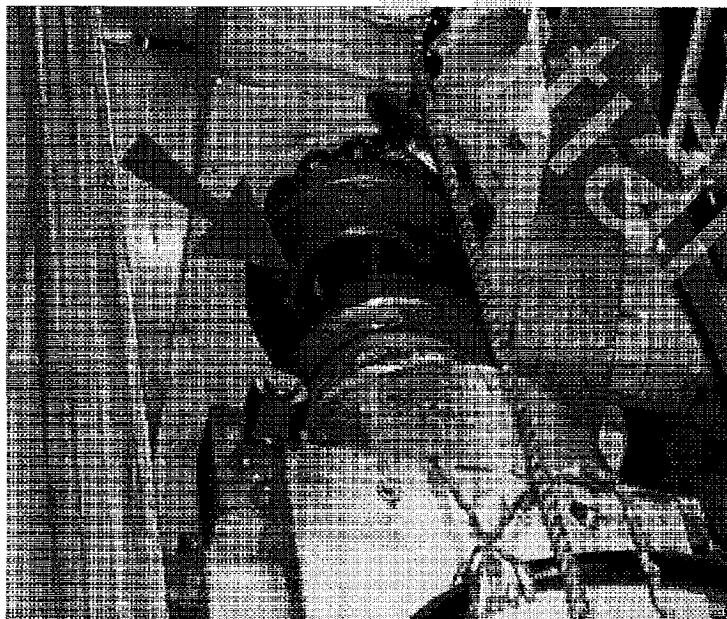
6.3 The process of replacing the AX gasket

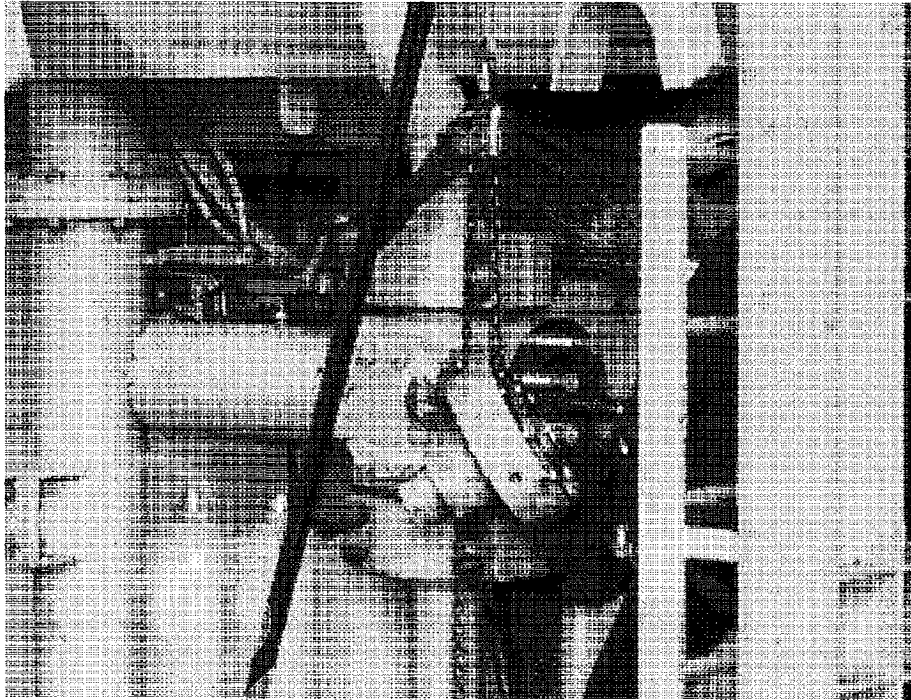
6.4 The flange was pulled off the upper outer kill valve to do a dimensional check of the ring groove.

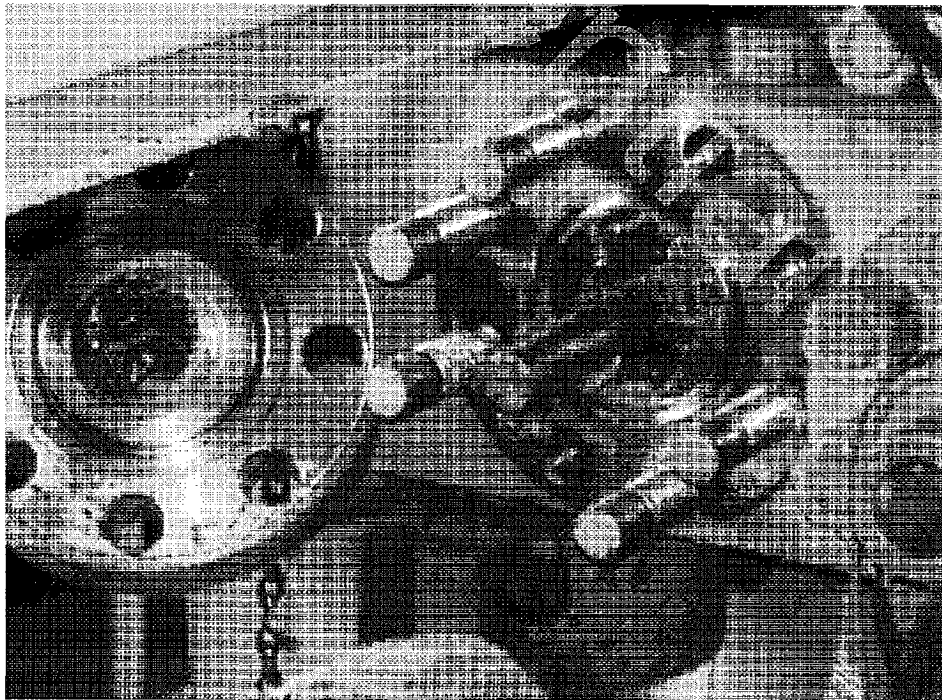
4. All bonnet and flange ring grooves should be checked by Cameron and new ring gaskets should be installed. These should be torqued to proper specifications and should then be retorqued after pressure testing. The ring grooves checked were within the proper tolerances. As a result, this leaves only a bad ring gasket or improper torque as a reason for leaks.

6.5 A close up of ring groove on flange. The bonnet and gate were pulled to do dimensional checks on the ring groove. This valve had leaks on both the flange side and the bonnet side during wellbore pressure testing.

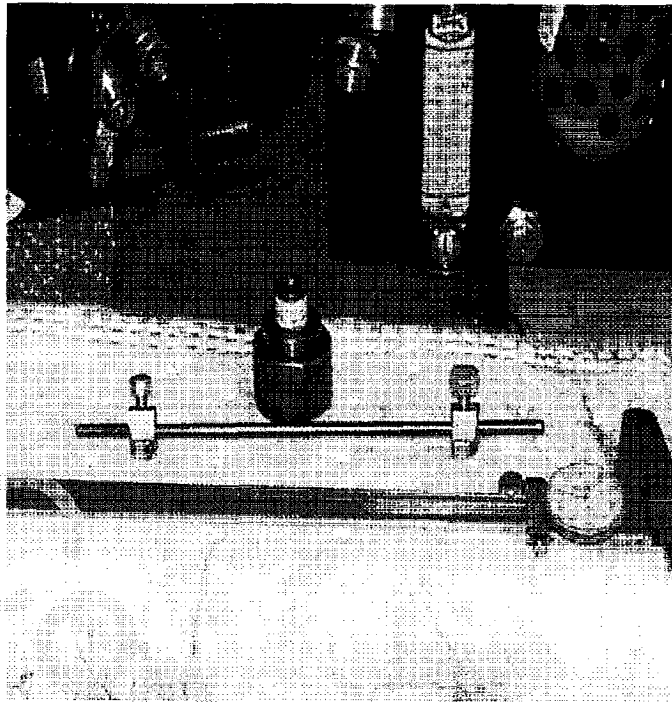
6.6 The ring groove was checked out dimensionally by the Cameron service representative, Alton Dupre, using a button type go/no go gage and a ball as shown. The ring groove was dimensionally correct.

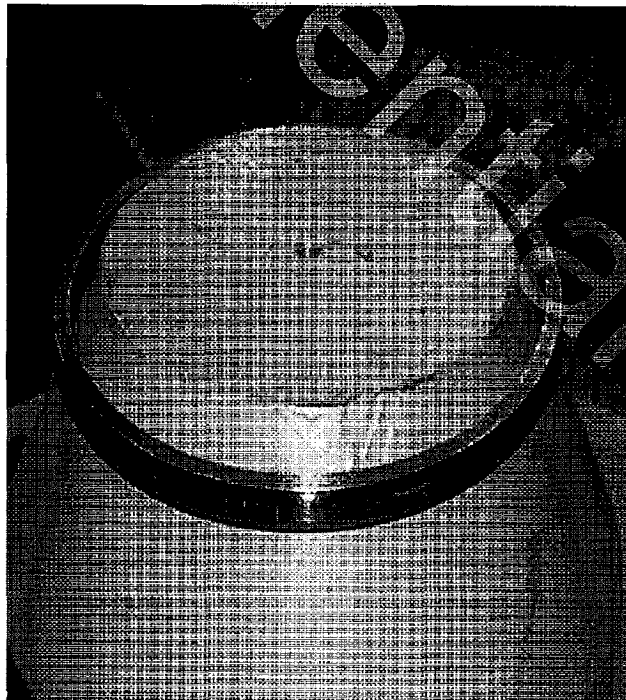
6.7 The old ring gasket that was removed. It was to be hand carried to Houston to be checked. A bad ring gasket or incorrect torque are possible reasons for the leak

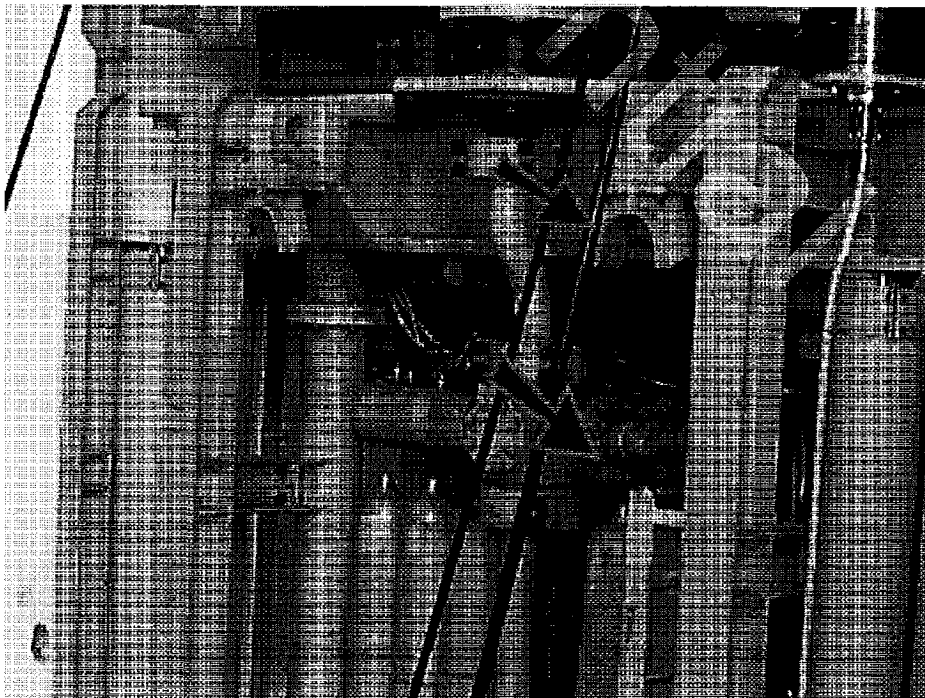
6.11 The ladder on the stack was cut for clearance when landing on the pins.
