Leadership Focus Areas for Upcoming Rig Visits  
Updated 4/15/10

## Talking Points for Horizon Rig Visit

**INCIDENT:** Fall from Top of Riser

**INCIDENT:** Caught Between Finger Injury  
**TYPE OF INCIDENT:** Medical Treatment  
**BUSINESS UNIT:** GoM Drilling & Completions  
**LOCATION OF INCIDENT:** Discoverer Enterprise  
**COUNTRY:** United States  
**Tr@ction No:** 2010-IR-3364864  
**DATE OF INCIDENT:** January 7, 2010

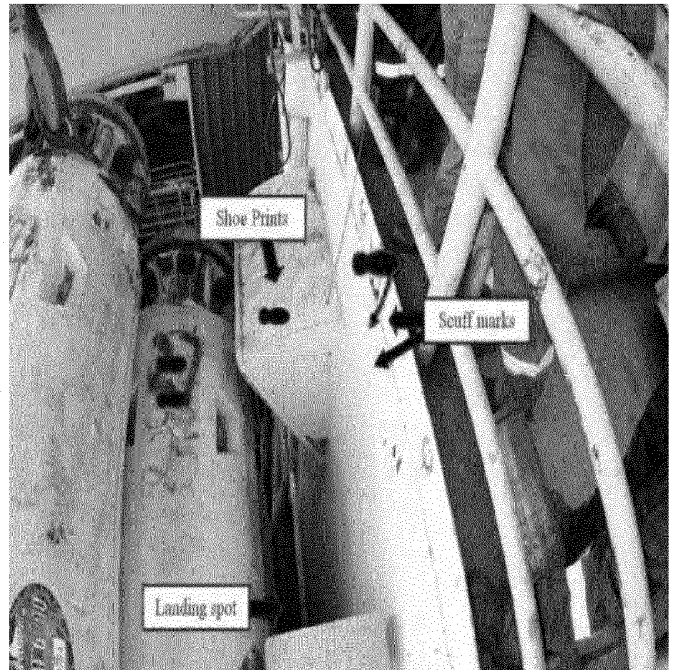
While moving three joints of riser from the port riser bay to the starboard riser bay with the gantry crane, a Roustabout (IP) fell 27 feet from top of riser to the deck.

The IP had just attached the web slings from the gantry crane to the 2<sup>nd</sup> joint of riser. After securing the slings, he was seen falling between the stacked riser joints and the shaker house bulkhead. He was attended by the rig medic and medivaced to a hospital onshore. IP suffered chest and shoulder injuries. He was released from the hospital on November 20, 2009.

- The information gathered during the investigation indicates that the IP was not tied off when he fell. There was no damage to harness or lanyards and shock absorber was not extended.

- The investigation results also indicate that the IP did not use ladder on stanchion to exit riser as noted in job plan. IP was positioned on opposite side of riser joint than would have been expected and may have been attempting to leave riser bay by climbing over the handrail to the shaker house deck. Footprints on port and starboard vents outside of handrail indicate others had moved between deck and riser bay in the past.

- Work area was difficult to access. The height of riser stacked in the bay prevented easy access to the top of the riser from the stanchion ladders. Normal procedure for handling riser is to access it with a scissor lift and tying off to a self retracting lifeline. Due to riser being stacked too high, scissor lift could not be used to install rigging on riser.

- Supervisors did not fully identify the inherent risks in the procedures being used (location

of anchor points for fall protection and difficulty in accessing the work site) when riser was stacked to the top of the stanchions.

- Revise procedures for working with riser to ensure that a suitable fall arrest system is in place or other mechanism to reduce fall risks.
- Define maximum height of riser joints which can be stacked in the riser bay to provide safe access and mark stanchions accordingly. Ensure this height is referenced in procedures.
- Reinforce the role of supervisors to identify hazards associated with Management of Change and ensure that appropriate controls are put in place
- Re-emphasize to all crews the necessity of remaining 100% tied off when outside of handrails and when working at height. Revisit training on tie off procedures, suitable anchor points, and other fall protection procedures.

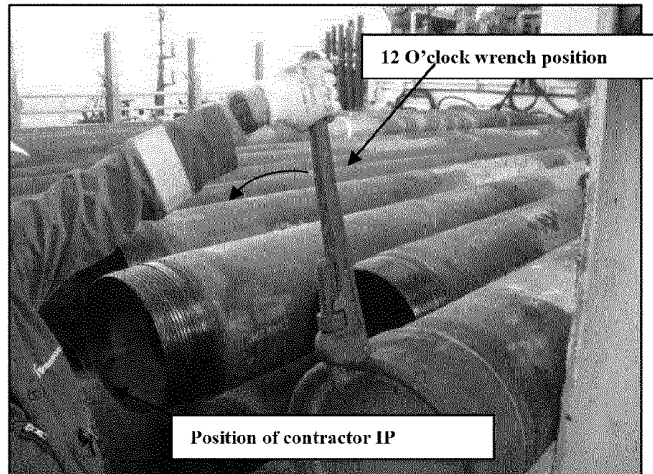
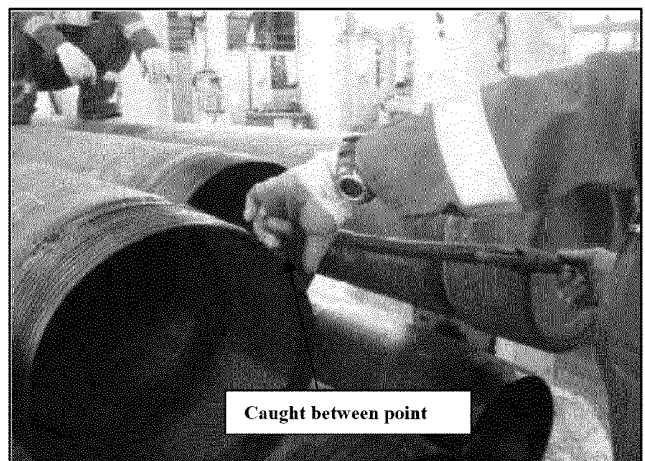
The incident occurred while a Contractor Injured Person (IP) was removing protector caps off of 16" casing. IP used a 24" pipe wrench for the work and held the wrench on a protector cap in the 10 o'clock position. The IP ensured that his hand/fingers were placed lower on the wrench handle, away from a pinch point. The IP could not get the protector cap to break loose and repositioned the wrench to a 12 o'clock position for additional leverage. The IP pulled on the wrench from this position and the protector cap broke free quickly, while the IP's left hand was at the top of the wrench handle. The IP's finger was pinched between the wrench handle and another joint of casing

- Although used frequently, the tool used for the job (pipe wrench) created a pinch point potential
- After planning how to safely accomplish a task by measuring where to place hands, a change in job scope occurred that was not managed correctly. The Injured Person disregarded hand placement when he changed the tool position, placing his hands where they could be injured

- Revise contractor Task Specific Think Plan (TSTP) to include detailed steps for removing thread protectors
- Explore an alternative method / tool to remove casing thread protectors.
