Enterprise BOP: Choke and Kill Line Hoses

DAILY REPORT #3 \ Job

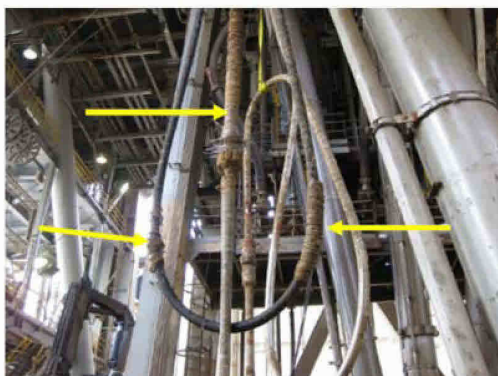
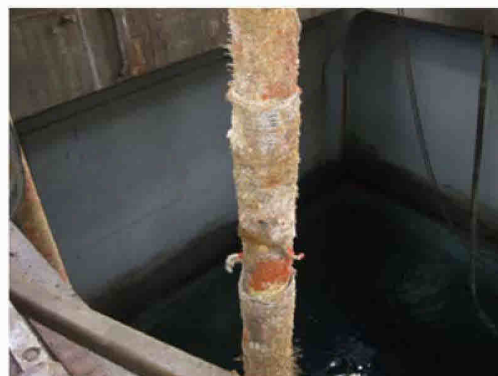
Figure 1: Damaged moonpool hoses

The Coflexip type hoses in the moonpool were observed to have damage to the outer protective sheath, and will need to be replaced.

The Coflexip type hoses in the moonpool were visually inspected. All hoses in the moonpool were observed to have damage to the outer protective sheath, and will need to be replaced.
