Jim Cunningham
Egypt / Mediterranean Sea

**Loss of Well Control and
Emergency Response**

Event: August 20, 2004 at 21:30 hrs

Management Incident Review

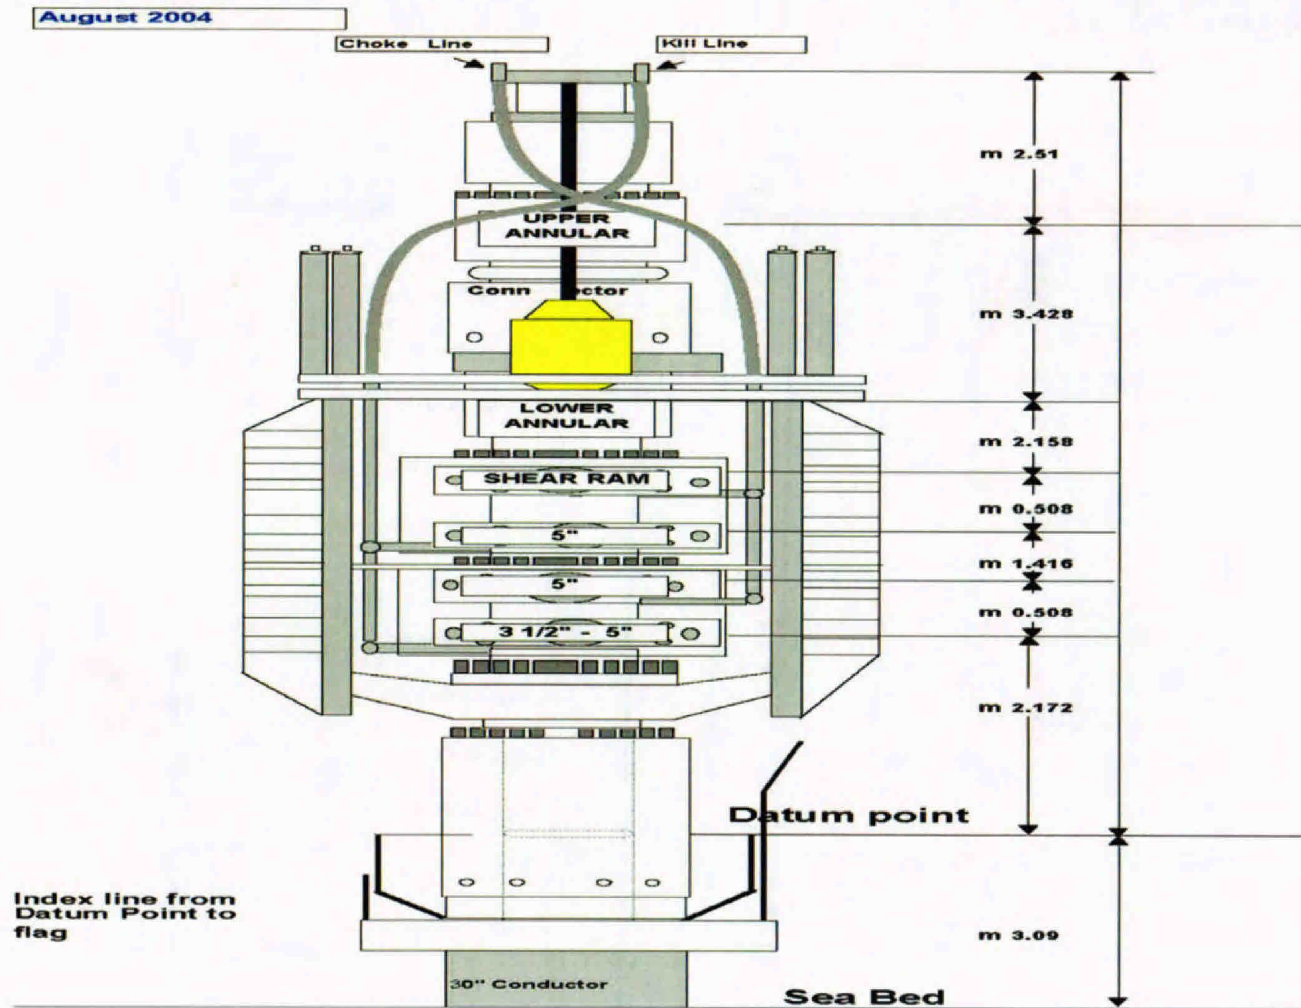
BOP SCHEMATIC

- 2) Shear rams (SR's) closed on tool joint as driller did not have time to space out pipe before blowout. Note: Primary shear function applied 1500 psi manifold operating pressure to 2 chambers of the dual chamber high pressure shear ram. Soon afterward, the secondary shear function was initiated, which bypasses manifold regulator and applies stack accumulator pressure to both chambers (roughly 3000 psi). These high pressure SR's require only 1200-1500 psi to cut 5", 19.5#, S-135 DP.

- **Causation Factors - Emergency Response Problems:**
 - 1) Initial action by TP was to close Shear Ram (SR), which follows rig emergency response (E/R) plan for a blowout. Unknown to team, DP did not shear as SR closed on tooljoint.
