**In re: Oil Spill by the Oil Rig “*Deepwater Horizon*” in  
the Gulf of Mexico, on April 20, 2010**

Expert Report of Iain Adams

**Submitted on Behalf of BP Exploration & Production Inc.**

**May 10, 2013**

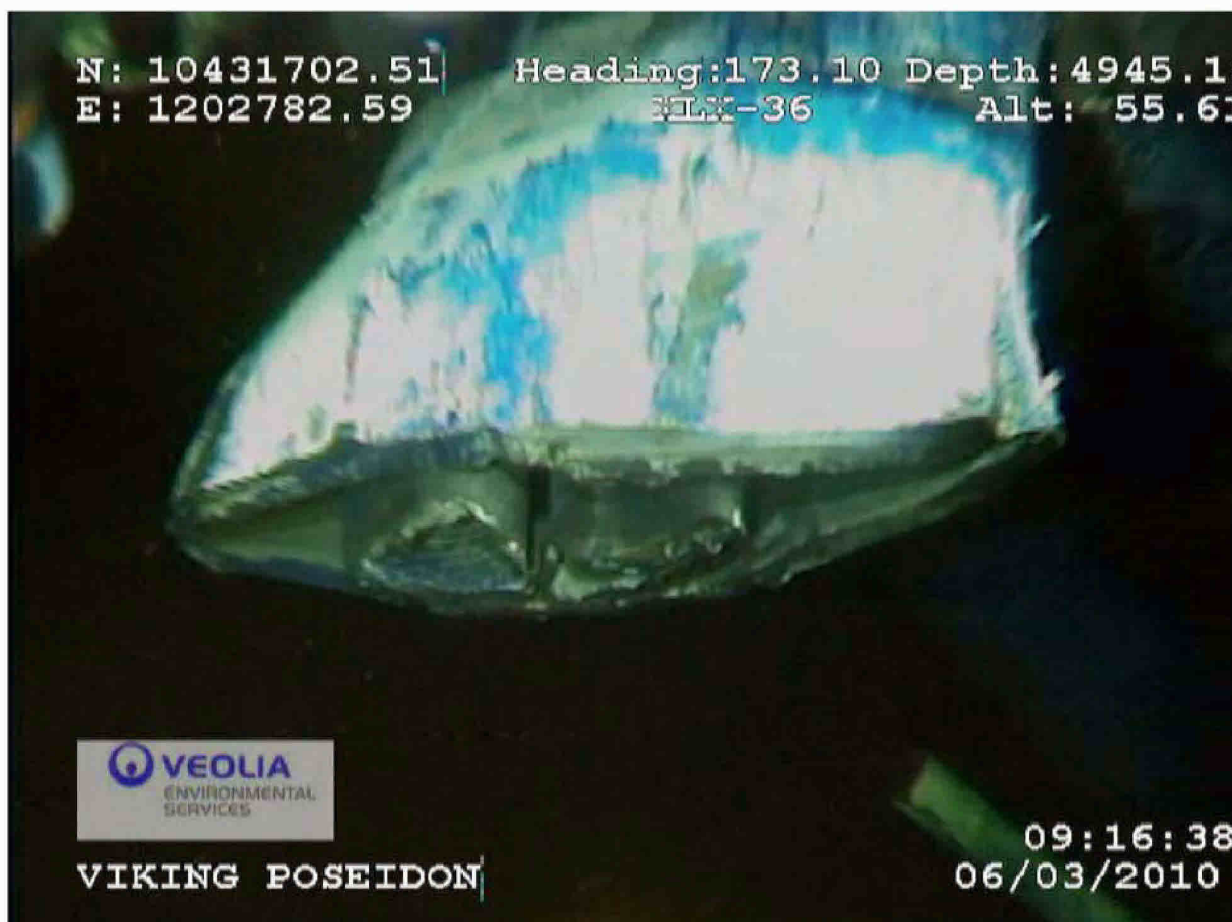
3, 2010, the riser from the LMRP was cut in preparation for Top Hat collection of hydrocarbons to the *Discoverer Enterprise*.<sup>79</sup> After the riser cut, two pieces of drill pipe extending up from the LMRP were observed by ROVs.<sup>80</sup> The unexpected discovery of the two pieces of drill pipe added new risks to any attempt to pull the LMRP -- the first step required for the initial approach to installing a capping stack, as well as the BOP-on-BOP procedure discussed above in Section 3.5.<sup>81</sup>

**ROV Image of Two Pieces of Drill Pipe Inside Cut LMRP Riser  
(CAM\_CIV\_0078104)**

The presence of two pieces of drill pipe in the LMRP introduced yet another unknown into the system geometry, which posed the following complications:<sup>82</sup>
