**Subject: GSF Development Driller II**  
**Reference: Acceptance of Well Control Equipment**

WEST Report #3940

## Section 1: Executive Summary

**Section 3: WEST Recommendation Summary and Disposition**  
**GSF Development Driller II, Job #3940; 14 May to 10 June 2010**  
**Prepared for BP**

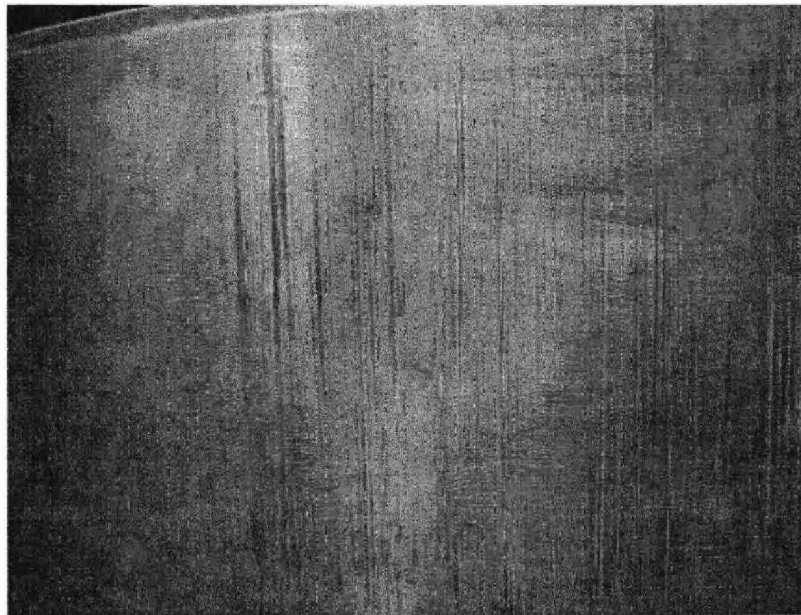
Figure 2.1 shows the outside diameter of the lower annular piston. The scoring and scratches shown are typical and extend around the full periphery of the piston; these scores were dressed out as far as possible. The open/close operating chambers will be pressure tested after re-assembly to 3,000 psi as per Transocean

1. Transocean should consider replacing the Hydril GX lower annular piston at the earliest opportunity.

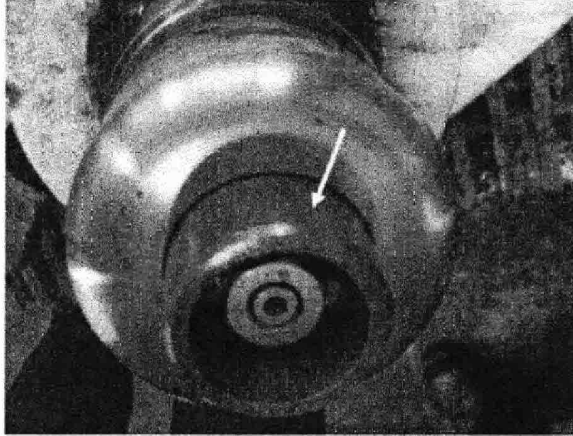
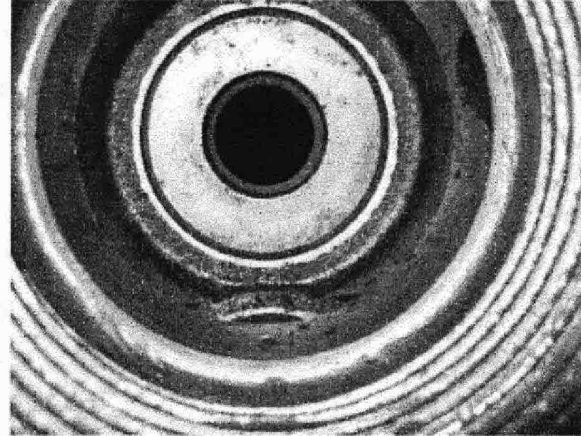
**Figures 4.01 and 04.02:** Above shows the kill side auto choke gate (arrowed) and seat, both were found to be in excellent condition so the auto choke was re-assembled with new body 'O' rings and back up rings.

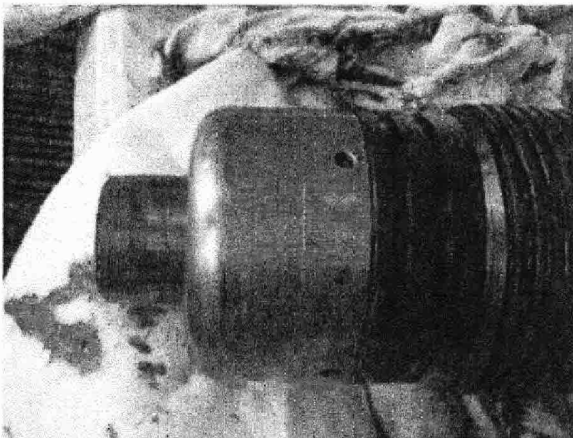
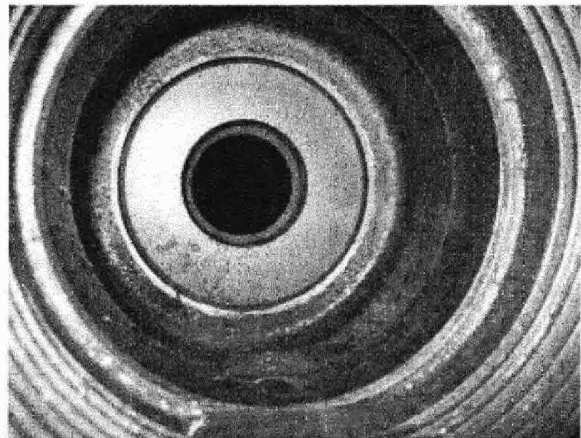
**Figures 4.03 and 4.04:** Below show the choke side auto choke gate and seat, both were found in excellent condition so were re-assembled with new body 'O' rings and back up rings.

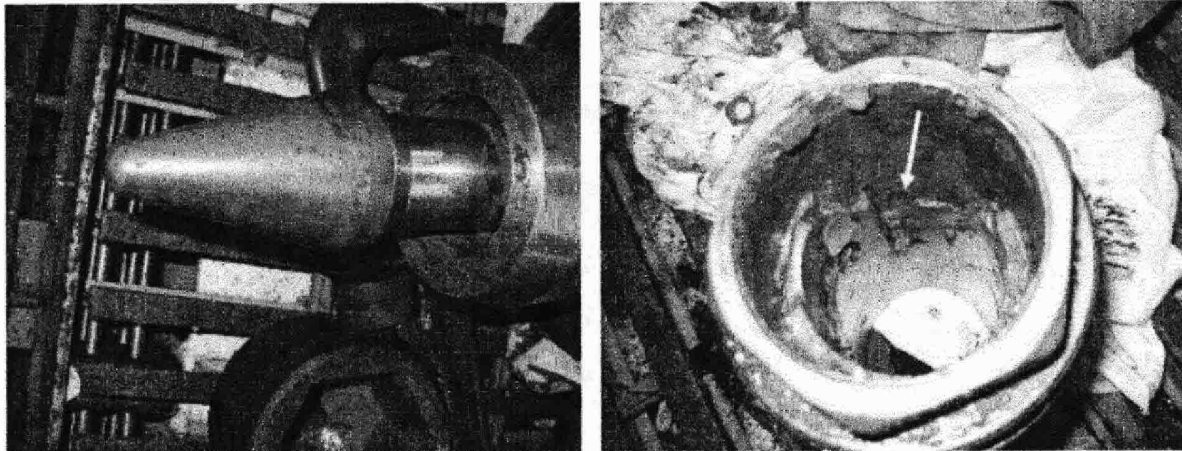
Figures 4.05 and 4.06: Show the manual choke. Both kill and choke side manual chokes were in similar condition, with the gates in serviceable condition, but the seats severely damaged, and requiring replacement. Only one replacement seat was available onboard, another seat will be hot shot to the rig to complete the assembly of the manual chokes.

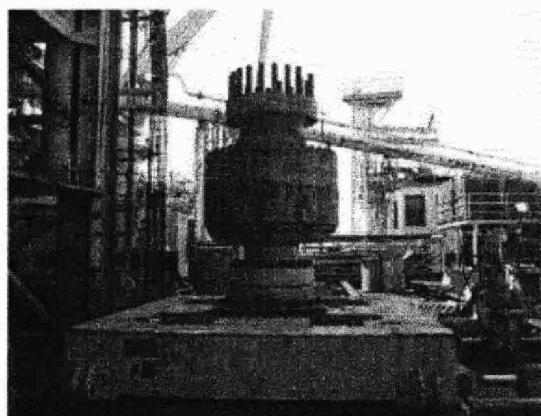
Figure 5.1: Vetco wellhead connector removed from the BOP stack.

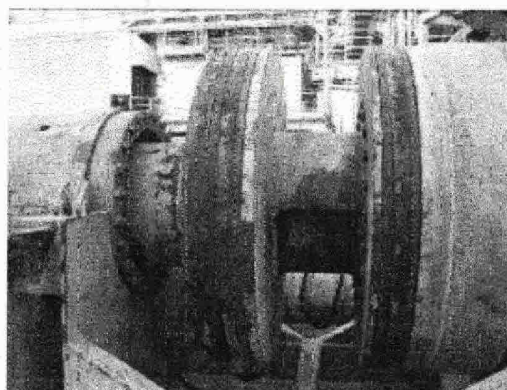
Figure 5.3: Diverter flowline seals.

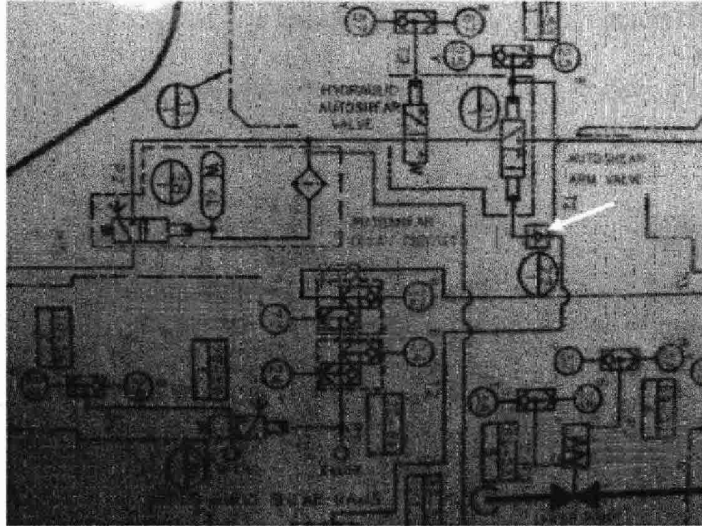
**Figure 12.01:** shows part of the auto shear circuit hydraulic schematic. The arrow indicates the POCV which is included in the circuit to keep a positive 'arm' pressure on the autoshear arm valve, when the pilot pressure to the 'arm' side of the valve is lost, i.e. in a dead man/auto shear situation. From testing with hotlines to the pilot side of the 'arm' valve it was proved that if the POCV should leak and release the positive 'arm' pressure to the valve, the arm valve will begin to close and 'chatter', thus preventing correct operation of the auto shear system.

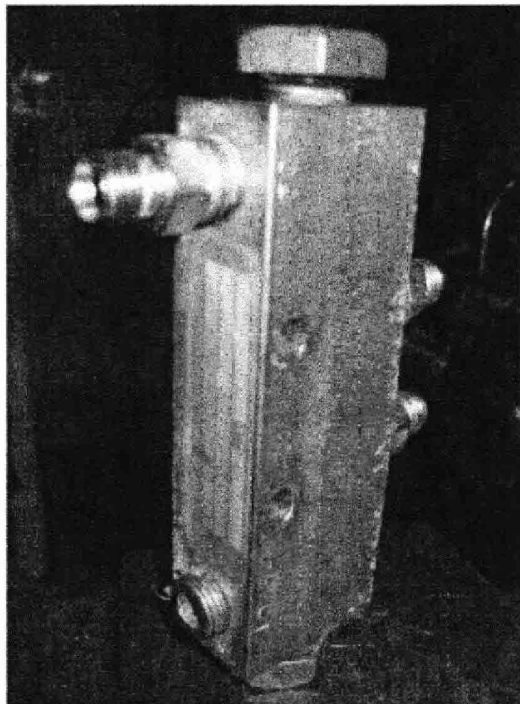
**Figure 12.02:** shows the suspected leaking POCV removed from the auto shear hydraulic circuit. This valve will be replaced.

The system will be re-tested, on both pods, once the POCV have been replaced on both the hydraulic auto shear valves.

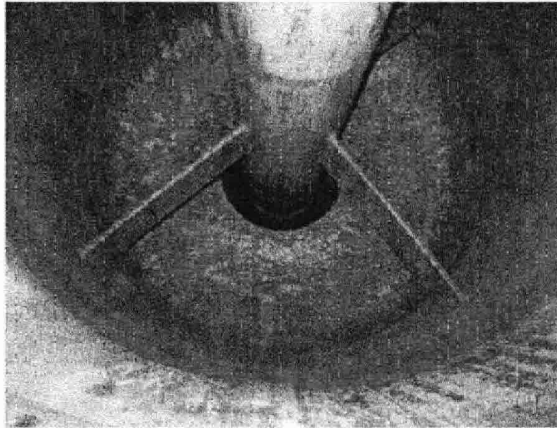
The mud gas separator inspection hatch was removed. WEST performed a visual internal inspection. The mud gas separator was relatively clean. No recent wall thickness inspection reports were obtained. See Figures 14.1 and 14.2 below.

**Figure 14.01:** Internal inspection of the mud gas separator.

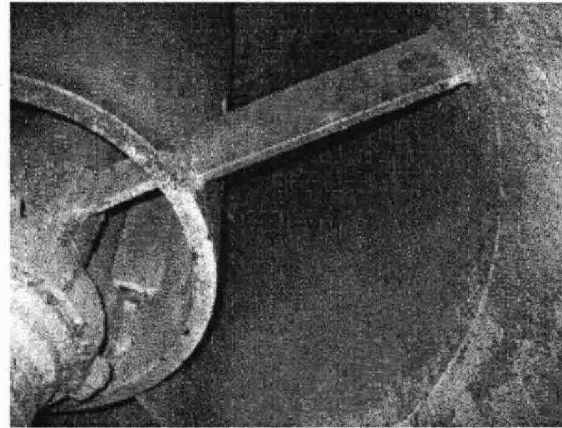
**Figure 14.02:** Mud gas separator internals.

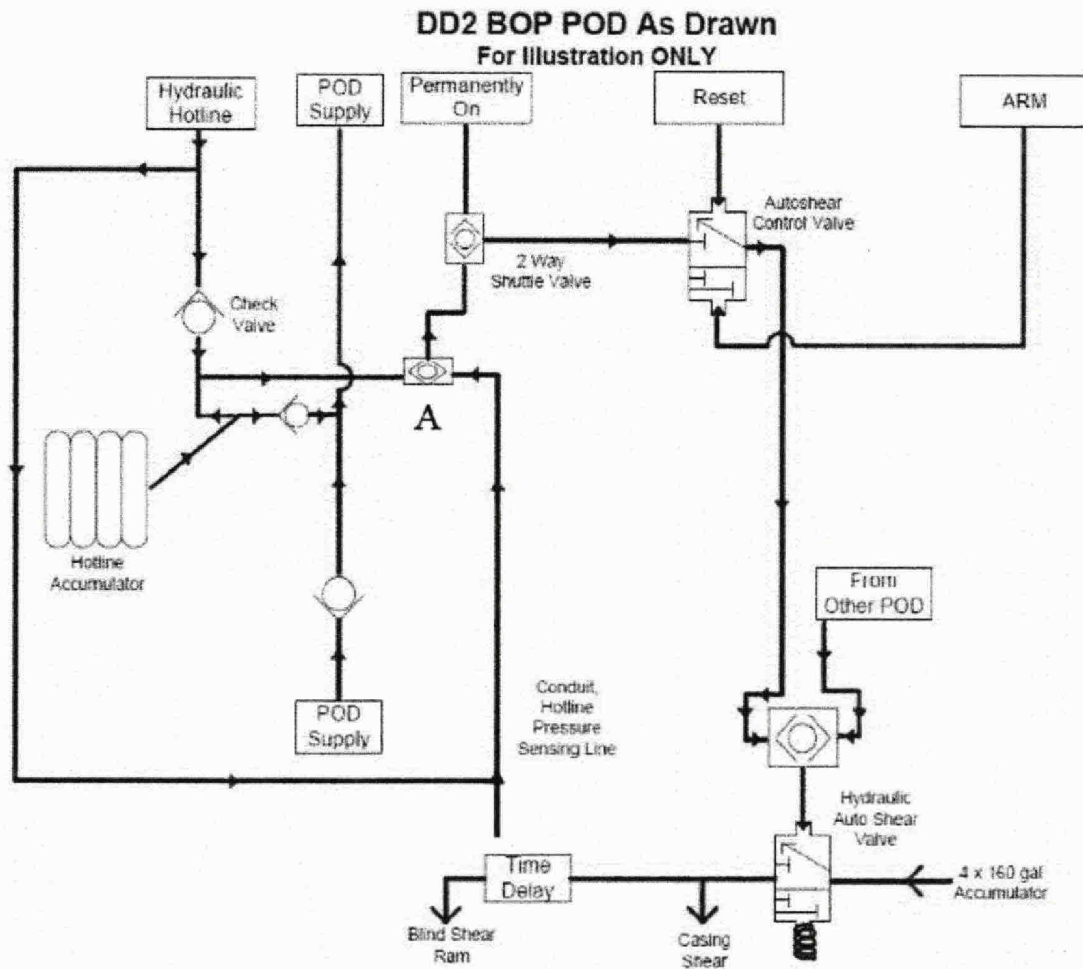
Attachment A shows the as built hydraulic schematic of the pods. Because of the position of the hotline pressure sensing take off below the check valve in the hotline supply, to shuttle valve A it would be impossible for the pilot pressure to the hydraulic auto shear valve to bleed off, due to the check valves in the system, accumulators etc, and activate the dead man sequence in case of a catastrophic failure of the riser system and loss of all hydraulic and electrical supplies.

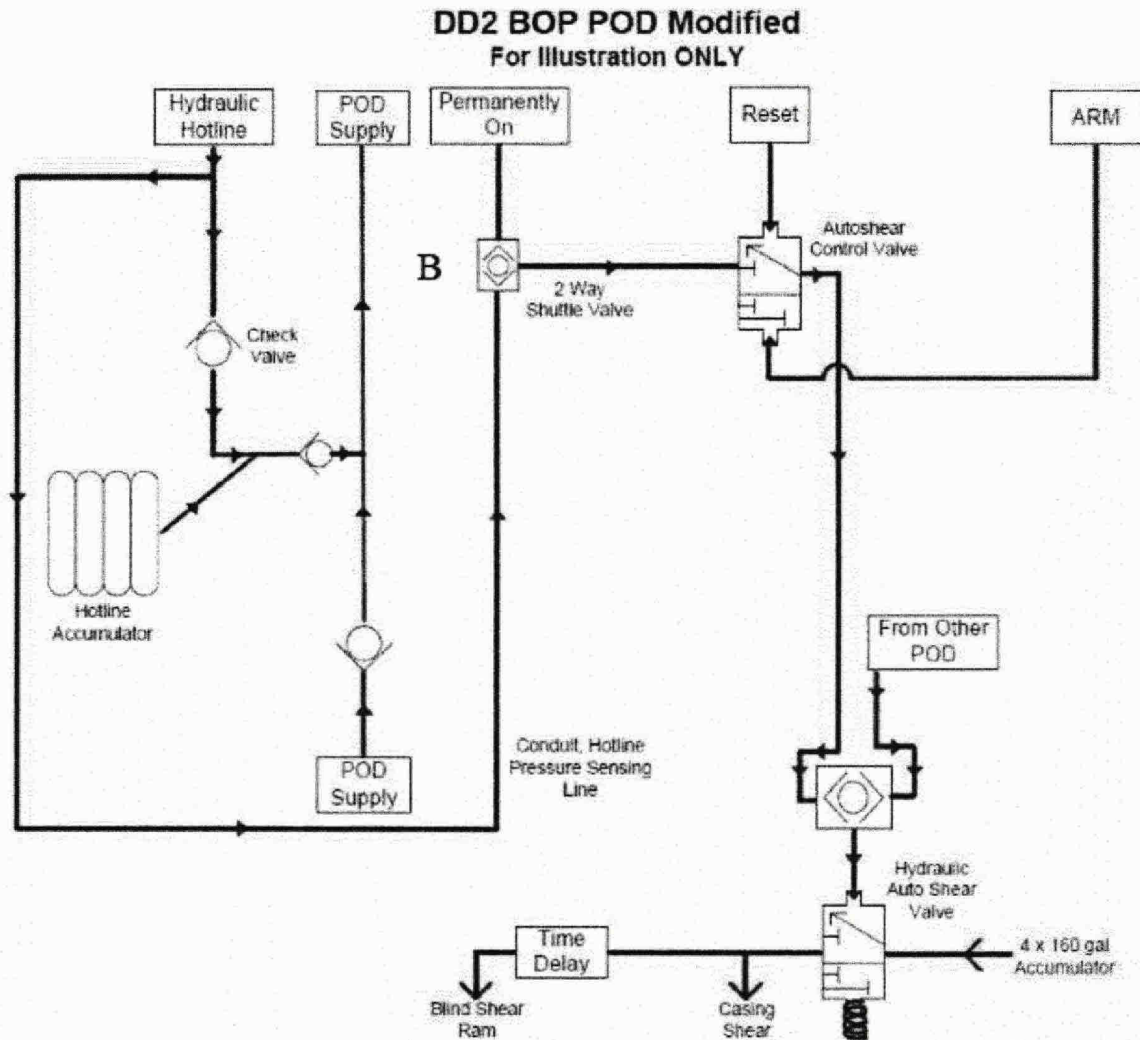
Attachment B shows the hydraulic schematic after removal of shuttle valve A and attachment of the pressure sensing line directly into shuttle valve B. This will allow the system to operate as designed. The system was proved to function correctly after this modification.

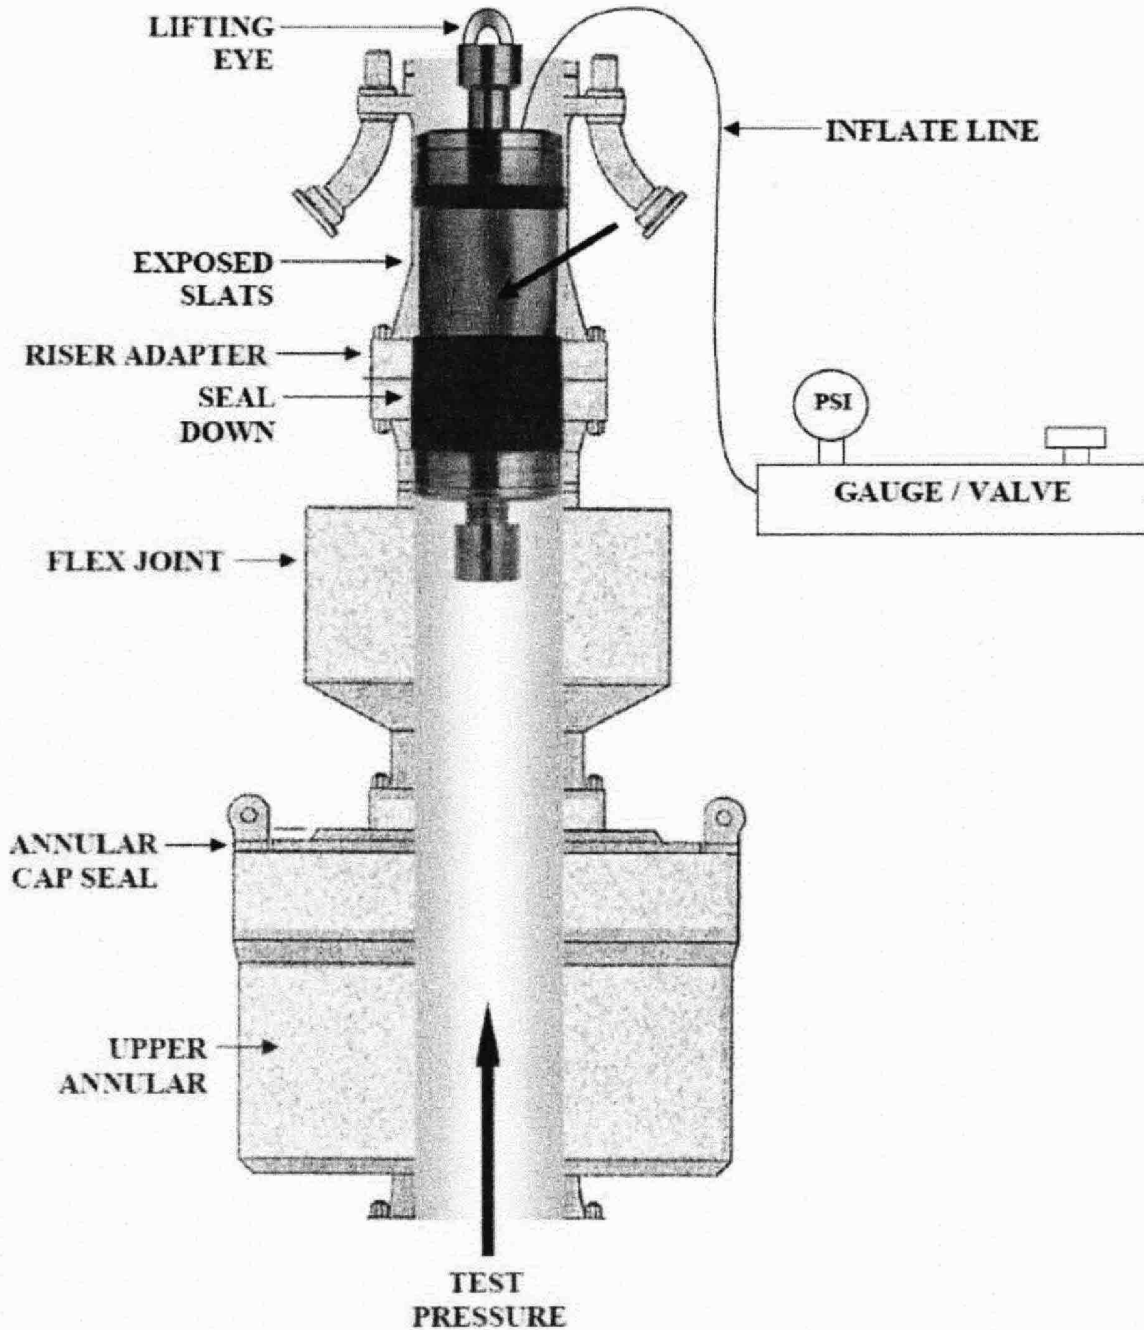
If the seal were to leak subsea, the only option would be to retrieve the LMRP to surface to affect a repair. See Figure 17.01 and 17.02 below.

**Figure 17.01:** Upper annular cap seal, also see Figure 17.02, being tested using a TAM packer before the BOP is run. This is one method of testing this seal during stump testing. The flex joint and flange connection to the upper annular are also tested using this method.

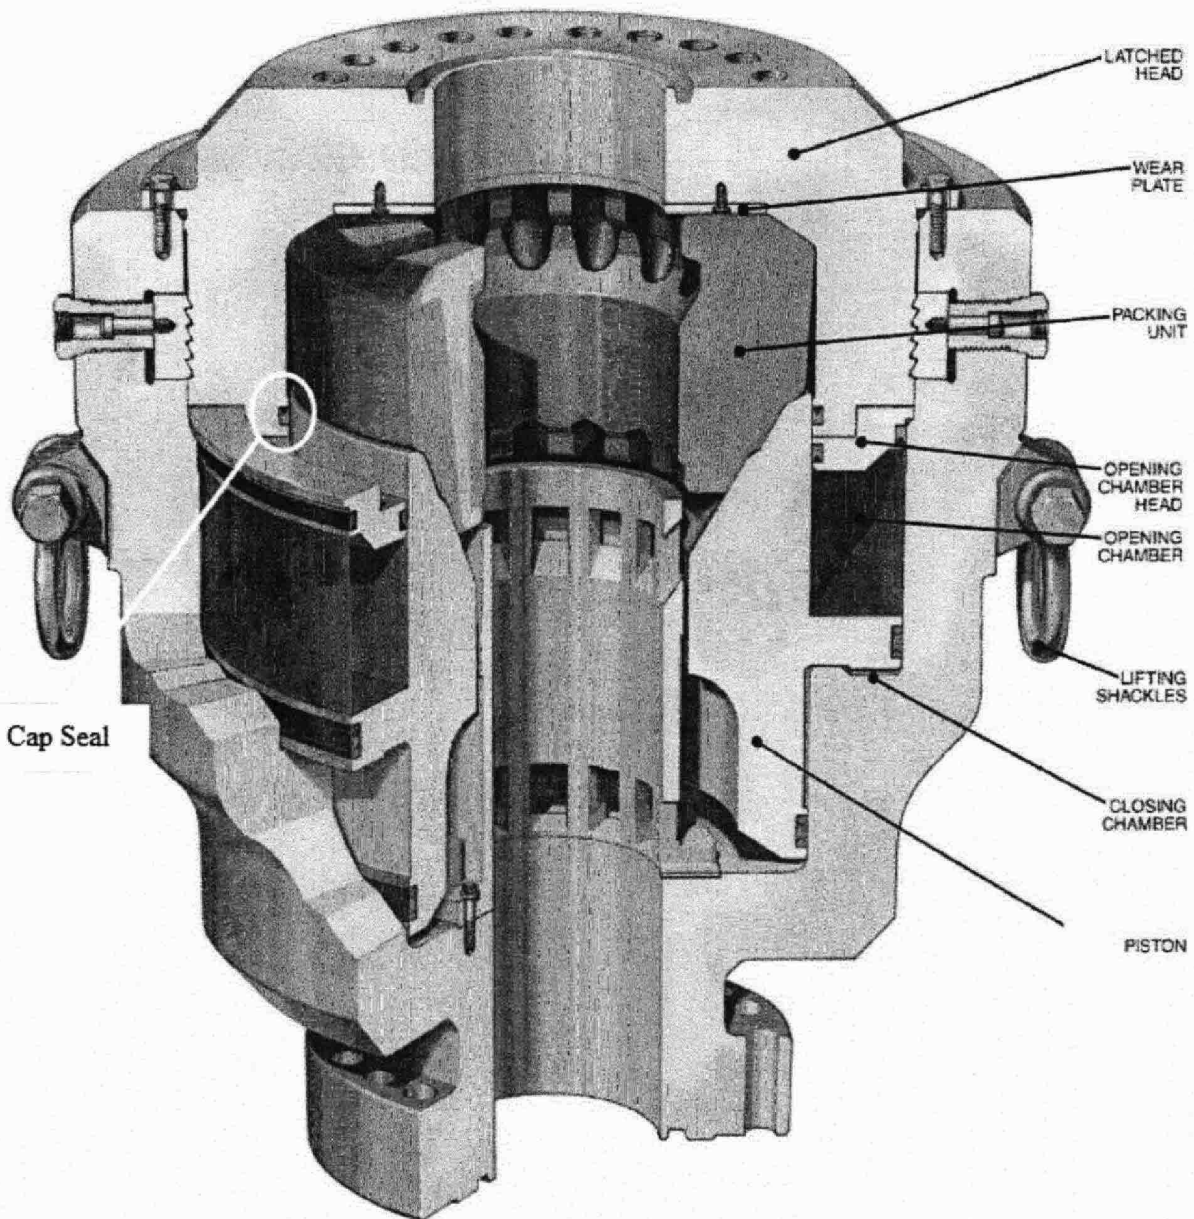
Figure 17.02: The cutaway shows the annular , which uses a TAM packer before the BOP is run for testing.

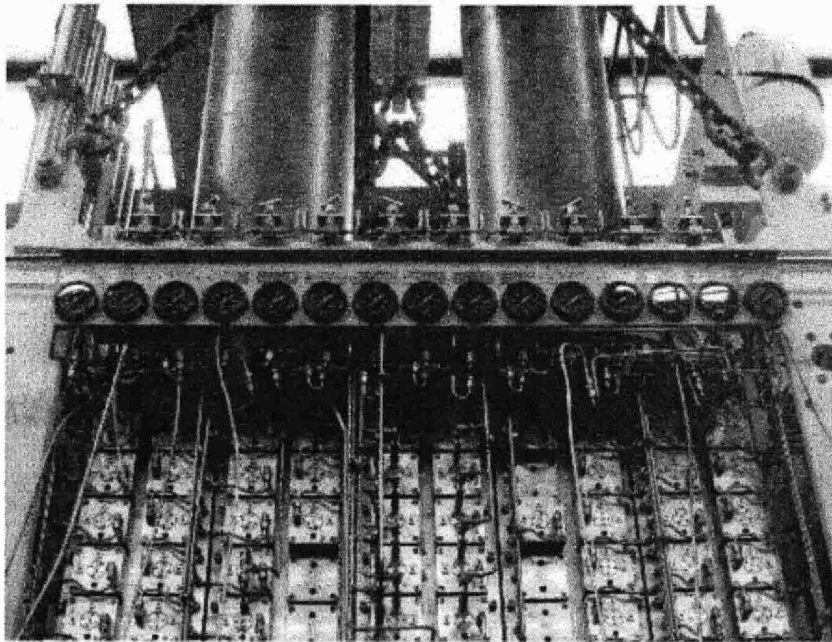
With reference to recommendation #3, the Hydril Controls MUX control pod relies solely on electrical pressure transducers to monitor the critical operating pressures within the pod. If any of these transducers were to fail subsea, there is no way of monitoring the pressures within the pod. Analogue gauges on the pod would allow the ROV to monitor critical pressures and ensure the pod was functioning correctly. This could avoid the need to pull the LMRP to effect repairs to the pod. See Figure 18.01, below.

**Figure 18.01:** This shows a typical MUX pod with ROV observable analogue gauges fitted for all critical functions
