BP Deepwater Horizon Investigation: Preliminary Insights

Tommy Roth
Vice President, Cementing Product Service Line

John Gisclair
INSITE Support Service Coordinator
September 26, 2010

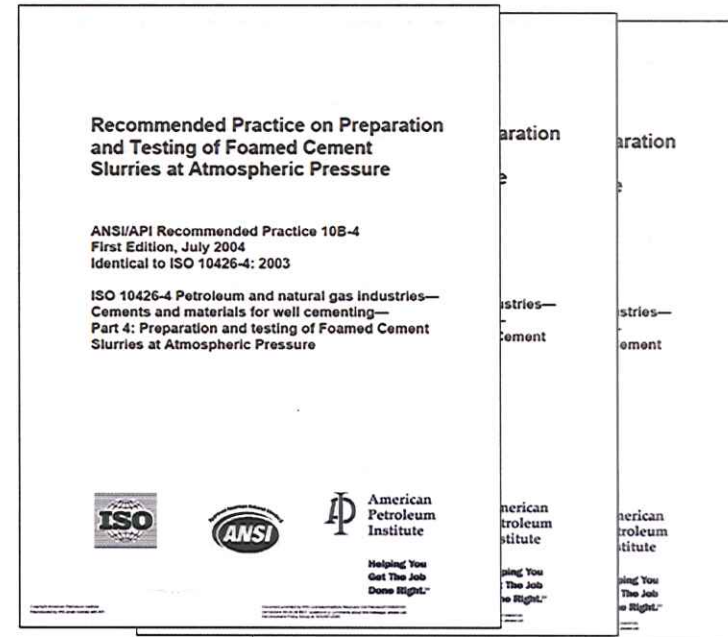
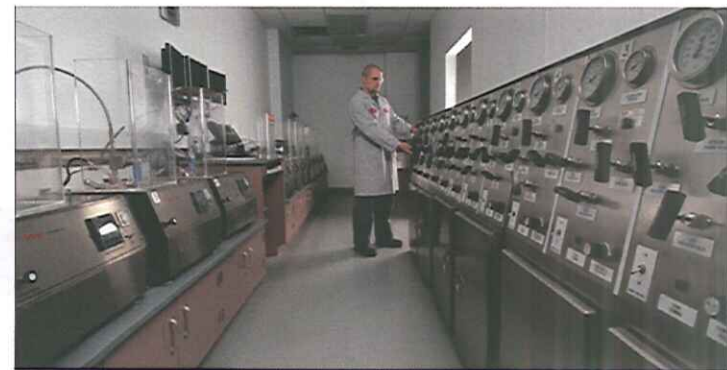
Pre-Job Cement Laboratory Testing

Laboratory Testing	Feb 10	April 06	April 12	Lab Hours
Thickening Time	✓		✓	35
Compressive Strength	✓		✓	147
Foam Compressive Strength	✓		✓	99
Free Water (included in foam stability test)	✓		✓	
Fluid Loss ¹				
Rheology	✓		✓	14
FYSA Rheology	✓		✓	2
Transition Time ²				
Foam Stability	✓		✓	99
Mud Balance Density	✓		✓	1
Slurry Mixability	✓		✓	1
Spacer – Mud Compatibility		✓		5
Spacer wettability – conductivity		✓		2
Spacer wettability – glass rod		✓		2
Total				407

- 16.7 ppg base slurry was mixed per API standards, using rig cement blend and rig water
 - D-Air 3000™ was included in the rig blend that was tested
 - D-Air 3000™ is used to removed entrained air during initial mixing of slurry to ensure accurate surface slurry density
- 16.7 ppg base slurry was conditioned for 3 hours
- 16.7 ppg base slurry was foamed to 14.5 ppg using API's 5-blade foam blender
 - The base slurry foamed in 8 seconds
 - The 5-blade foam blender best represents the energy imparted from the Halliburton field foam generator
- The foam slurry was transferred to a stability test cell and cured for 48 hours
- Foam slurry passed all API 10B-4 9.3.4 requirements
 - The density of the cured foam slurry, using the Archimedes principle, was identical at top and bottom
 - Indicates no free water
 - Indicates no settling
