IN RE: OIL SPILL by the OIL RIG
"DEEPWATER HORIZON" in the
GULF OF MEXICO,
on APRIL 20, 2010

MDL No. 2179

REVISED EXPERT REPORT OF
DR. FREDERICK "GENE" BECK
ON WELL DESIGN, CONTROL, DRILLING, AND MONITORING

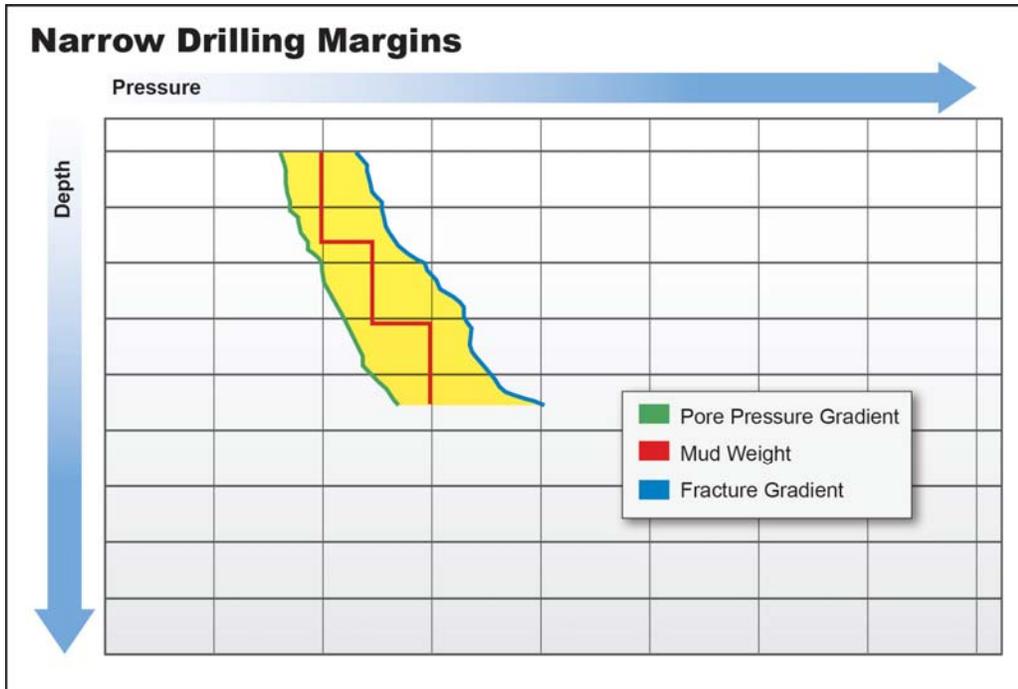
The difference between the pore pressure and the fracture pressure is commonly referred to as the "drilling margin." The Chief Counsel's Report includes a useful graphic, redrawn as Figure 1 below, which demonstrates the fundamental concept of drilling margin:

Figure 1: Narrow Drilling Margins⁵⁷

If an operator allows the mud weight to drift outside of the drilling margin window, the results are either a kick (formation fluids entering the wellbore) or lost circulation (wellbore fluids flowing into the formation). Specifically, a kick is the result of a mud weight that is too low, and lost circulation occurs when the mud weight is too high. Both of these conditions are to be avoided during the drilling process. A kick can lead to a blowout as an uncontrolled flow of hydrocarbons enters the well and rises up the wellbore.

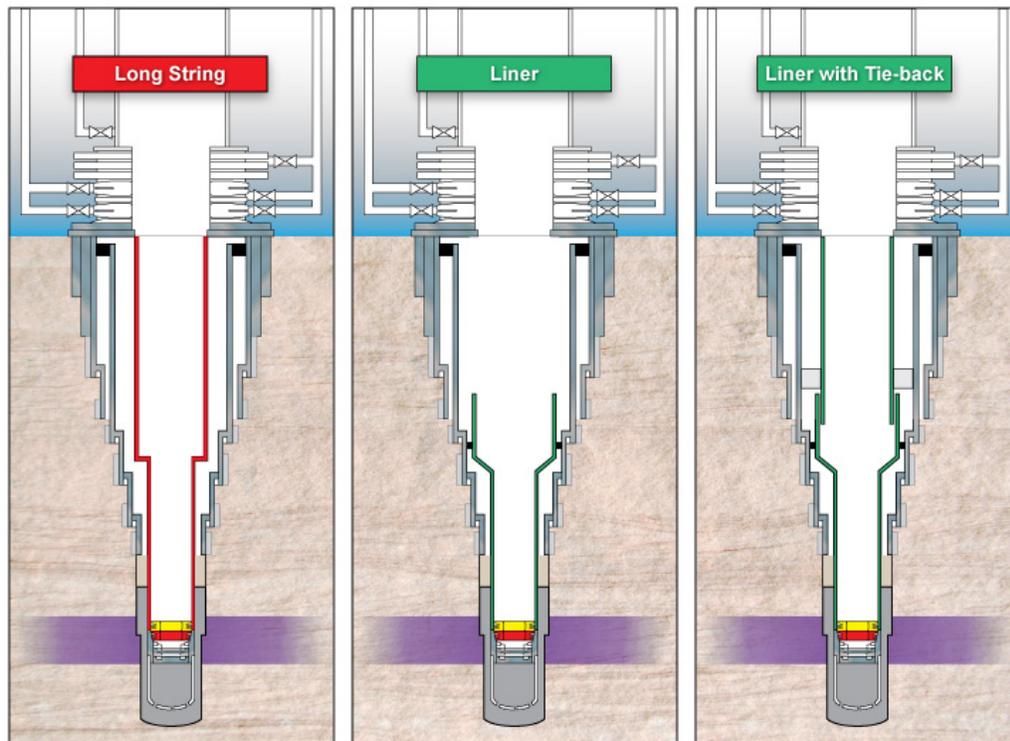
After a well has been drilled, the well operator typically installs additional tubing in the well that will enable it to move hydrocarbons from the target formations to the surface. These lengths of tubing are often referred to as production casing or production liners. BP had options in regard to the type of production casing it could use for the Macondo well. One option, a long string production casing, extends continuously from the seafloor to the bottom of the well. Another option, a liner, is run only a short distance from the bottom of the well to a selected height in the well. The liner is later "tied-back" to the surface with another length of production liner, but this operation is generally not performed until after the well is ready for production. If using a liner/tie-back for the Macondo well, BP would have set the short length of liner adjacent to the production zone and then move forward with temporary abandonment procedures. The tie-back would have been installed later, after a production platform replaced the *Deepwater Horizon*. These different casing options are shown in Figure 4 below:

Figure 4: Casing Options in Deepwater Drilling

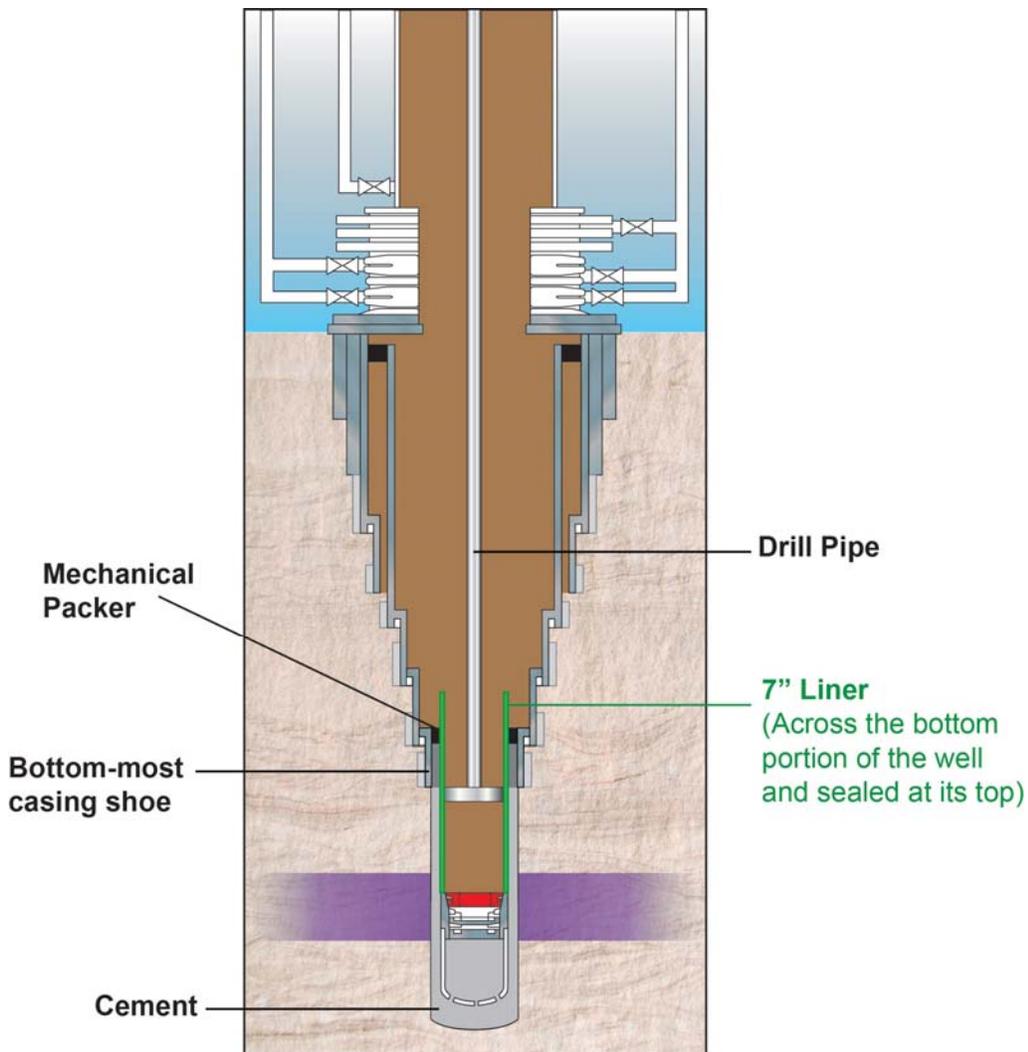
In contrast, use of a liner/tie-back would have presented a much lower risk of cement contamination. As explained above, a liner-tie-back allows the last hole interval drilled to be covered with a relatively short section of casing (the liner). A second, longer section of liner (the tie-back) is installed later to "tie" the liner back to the surface. This is illustrated in Figure 5 below:

Figure 5: Detail of Liner Design

If BP had used a liner for the Macondo well, cement would have been pumped much further down using the drill pipe, directly into the liner at the bottom of the well, presenting a much lower risk of contaminating the cement. The drill pipe diameter is typically 5-1/2 or 5 inches and has much less surface area for drilling mud contamination to occur. Further, the wiper plugs would only need to wipe one size of casing, and the wiper plug would be positioned in the liner near the bottom of the well. The wiper plug would not have had to traverse over 7,421 feet (1.4 miles) of the 9-7/8 inch

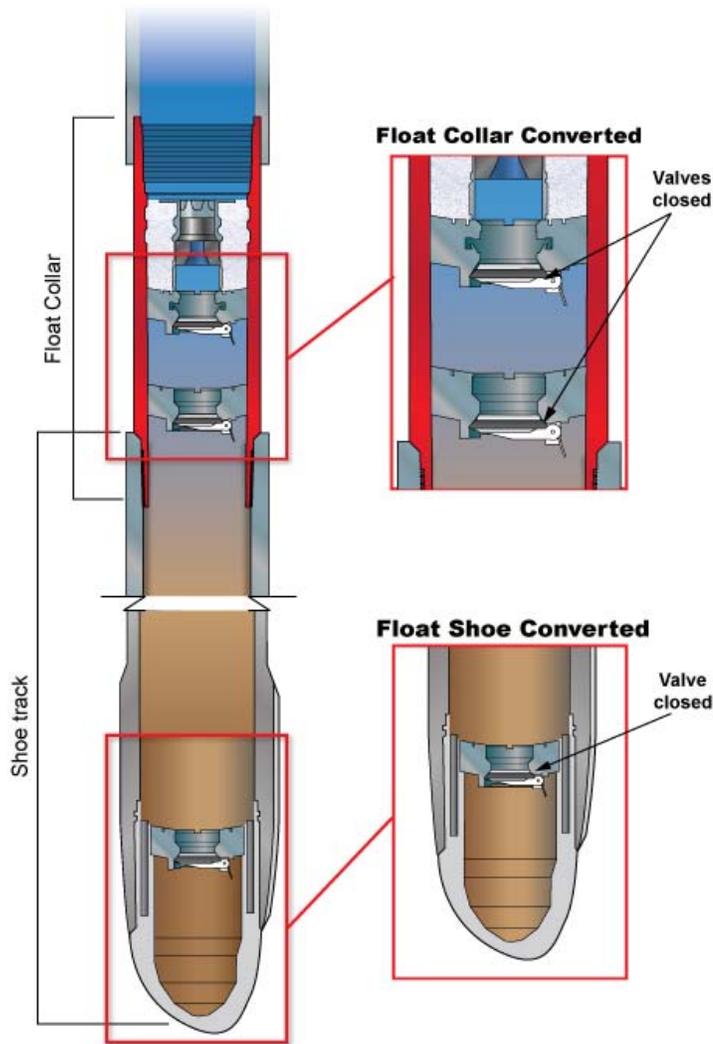
shoe track—one set in a float collar and another set in a float shoe. Float collars and float shoes are often built with two check valves each, creating additional redundancy. Installing a check valve at the very bottom of the casing string by way of a float shoe has the benefit of preventing drilling mud or formation fluids from entering the shoe track casing, potentially compromising the shoe track cement job, as shown in Figure 6 below.

Figure 6: Available Mechanical Barriers to Flow

Nevertheless, despite the fact that the Macondo well was a “nightmare well,”⁷² BP elected not to use a float shoe. In doing so, BP imprudently removed a potential barrier to hydrocarbon flow, despite the fact that BP had regularly taken gas kicks and the fact that so much gas had previously reached the rig floor that BP ordered Transocean to disable the general gas alarms on the drilling floor.⁷³

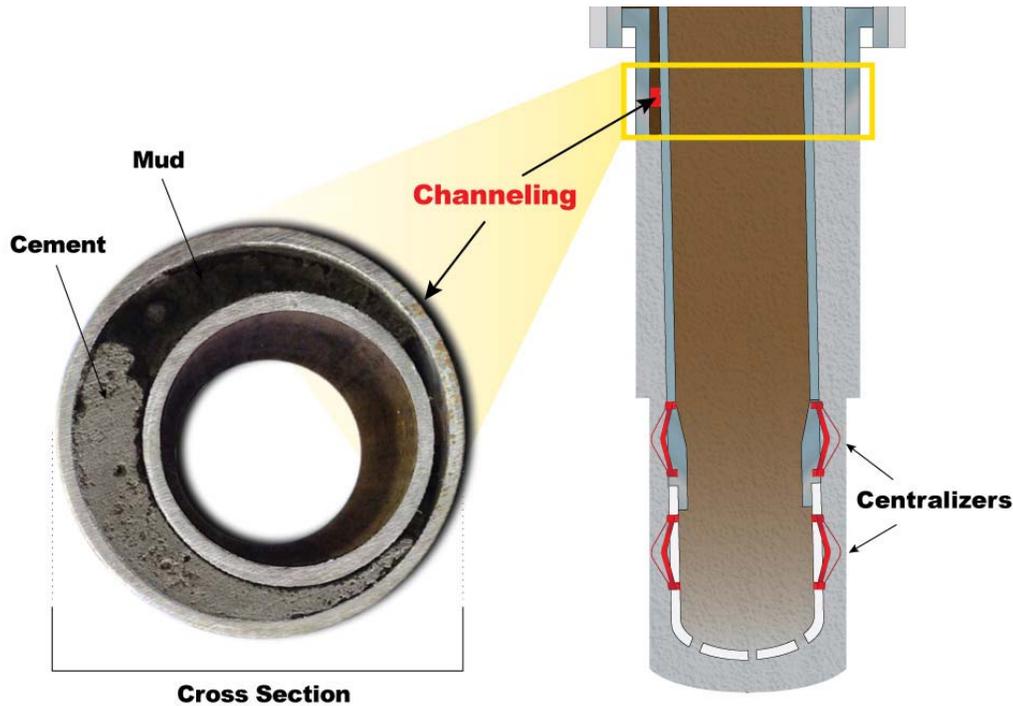
severely compromise a primary cement job. The Figure 7 shows the channeling that can result with inadequate centralization.

Figure 7: Channeling

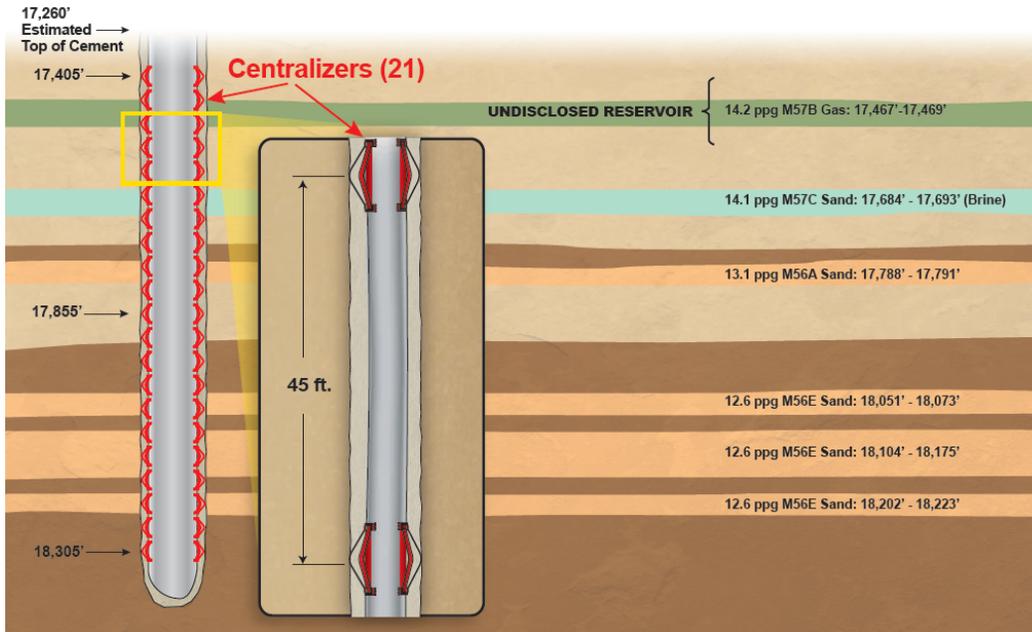
BP's centralizer placement failed to comply with BP's written practice requiring "at least 30m (100 ft) of centralized pipe above the distinct permeable zone."⁹³ As shown below, BP's placement of the six centralizers in the Macondo well appears to have been random and did not centralize the pipe at 17,804' where BP (erroneously) identified the uppermost pay sand M56A (see Figure 9 below). Gagliano's twenty-one centralizer plan, in contrast, placed each centralizer 45 feet apart and properly centralized the drill pipe at, above, and below the M56A zone (see Figure 8 below).

Revised Figure 8: Halliburton's Gagliano Recommendation: Normal Centralizer Placement and Parameters

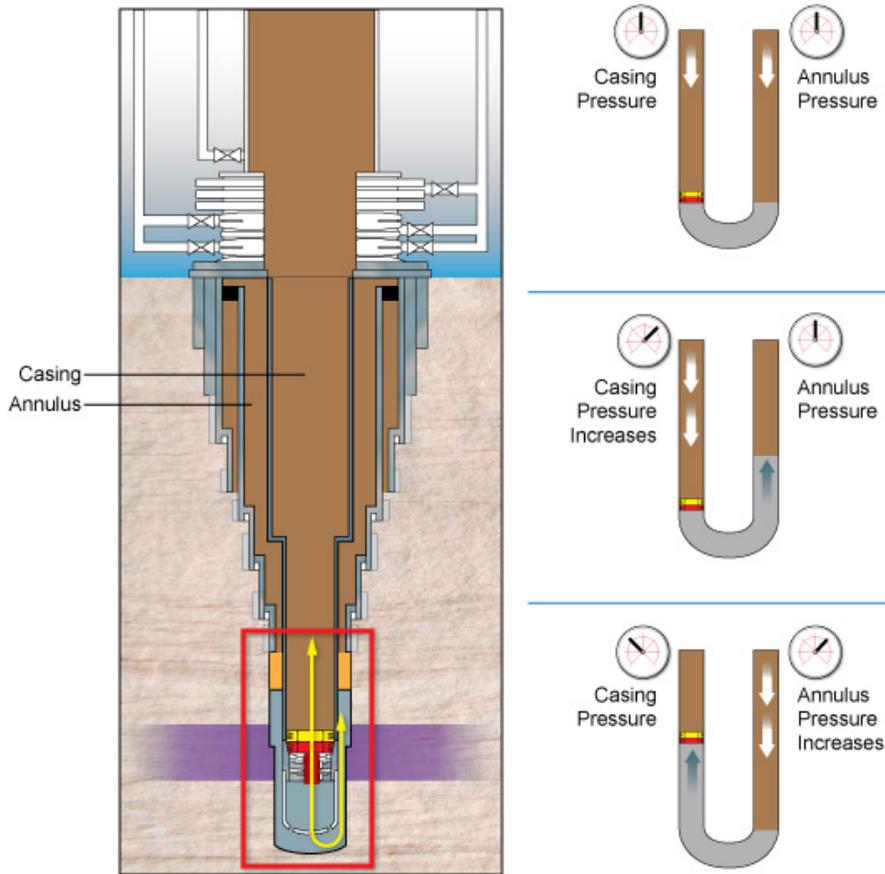
Figure 10 shows u-tubing:

Figure 10: U-Tubing

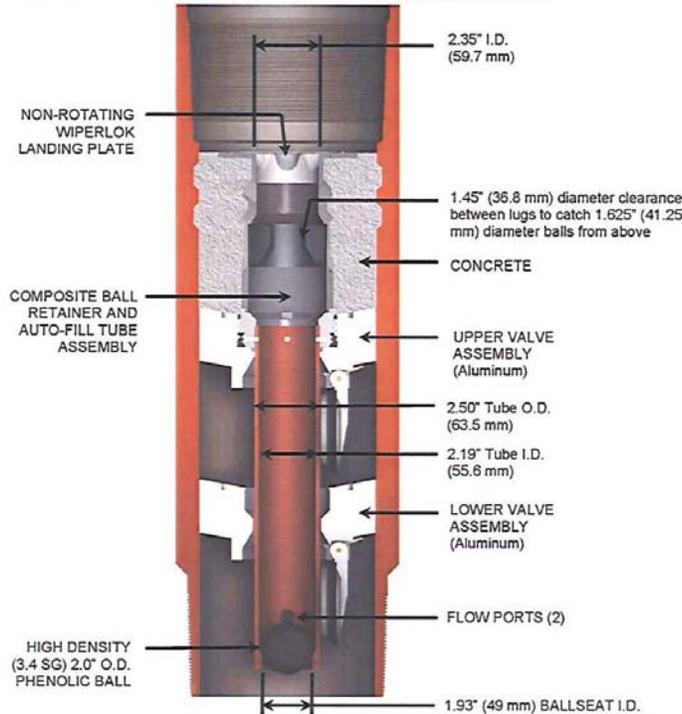
Figure 11: Weatherford M45AP Float Collar Used In Macondo Well⁹⁷

The Weatherford M45AP is an auto-fill type float collar. “Auto-fill” means that the check valve feature of the collar is held open while running in the hole to automatically fill up the casing and to prevent increasing the pressure on the formations to be cemented (called “surging” the formation) which could fracture the formation and prematurely cause a hydrocarbon kick or lost circulation. The Weatherford M45AP float collar used by BP has a phenolic resin auto-fill tube that holds two aluminum flapper-type check valves in an open position. Inside the auto-fill tube is a high density ball that is held in place at the top by three fingers and on the bottom by a

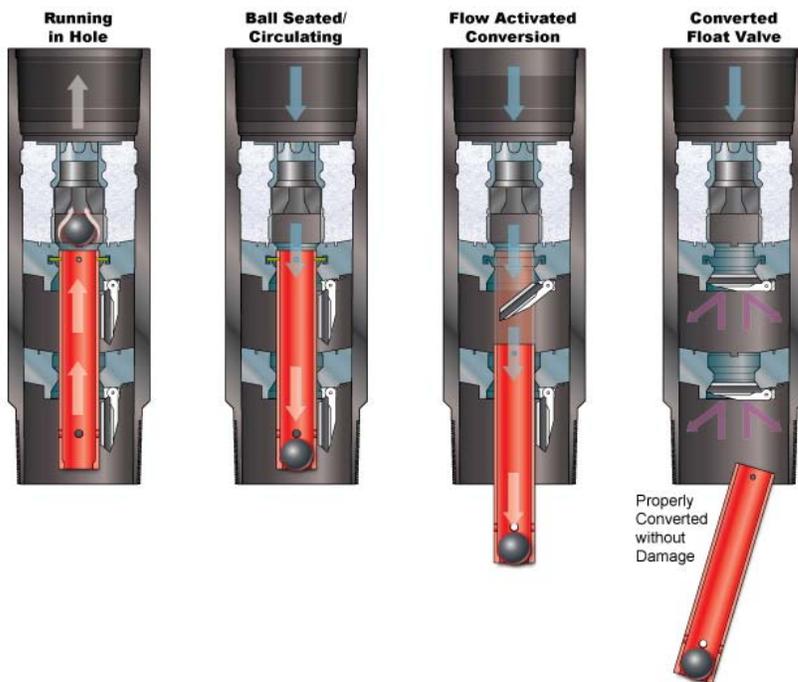
Once the casing is successfully positioned at the bottom of the well, the float collar must be converted so that it will act as a check valve. The conversion method described by Weatherford is to circulate fluid through the two ports at the bottom of the auto-fill tube at a rate of 5-8 barrels per minute with equivalent pressures of 500 PSI to 700 PSI.⁹⁸ Establishing a flow rate within the limits specified by Weatherford creates a differential pressure across the two ports which pushes the phenolic auto-fill tube out of its position and allows the two aluminum flapper valves to close. Once this conversion is accomplished the well is circulated and then cemented. This conversion process is illustrated in the following figure:

Figure 12: Flow-Activated Auto-Fill Float Collar Properly Converted Without Damage
