INCIDENT REPORT

Drift Off and Emergency Riser Disconnect

Transocean Horizon

June 30, 2003

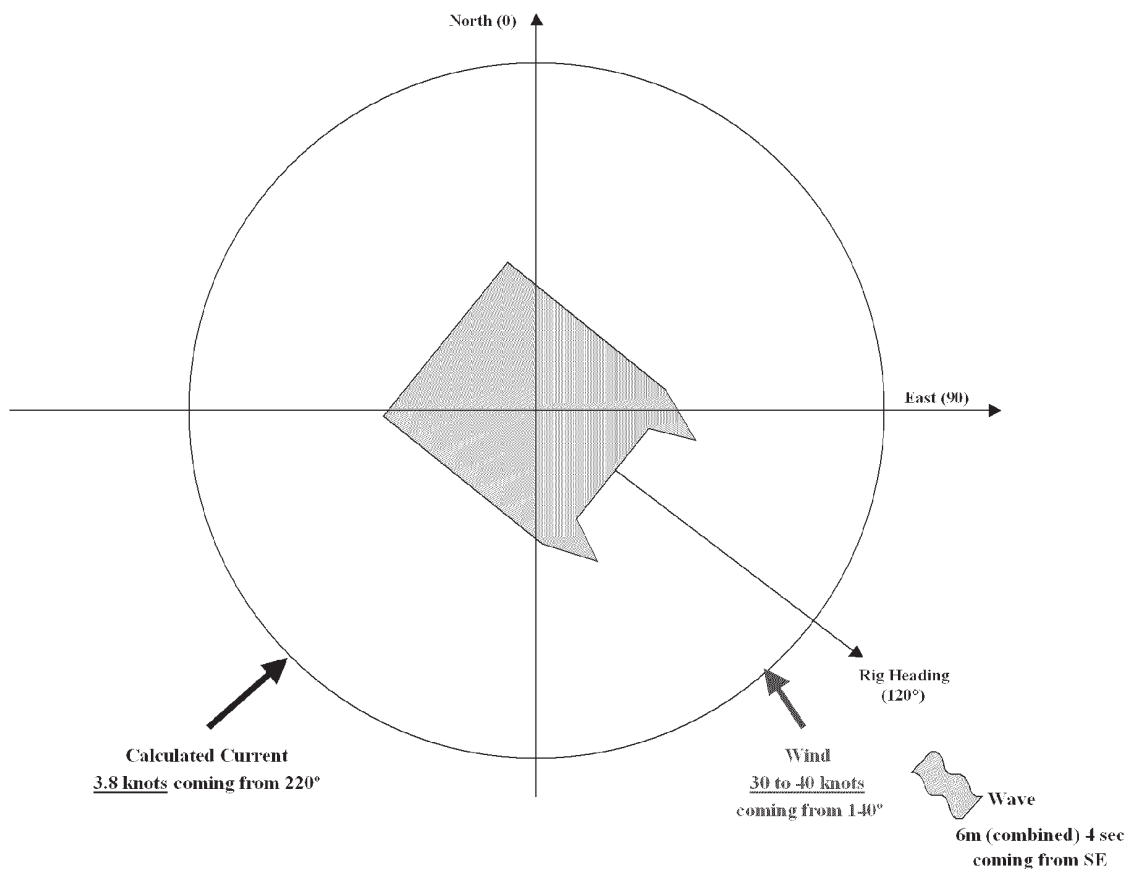
Deepwater Horizon Orientation vs. Environment

Comment on Calculated Current: this “current” is calculated by the DP system. It represents all the disturbance forces acting on the vessel with the exception of wind (wind speed is measured directly). This calculated current will therefore include the effect of disturbance forces like current but also waves and any other un-modeled forces. **So there’s more than just sea current behind this calculated current value.**

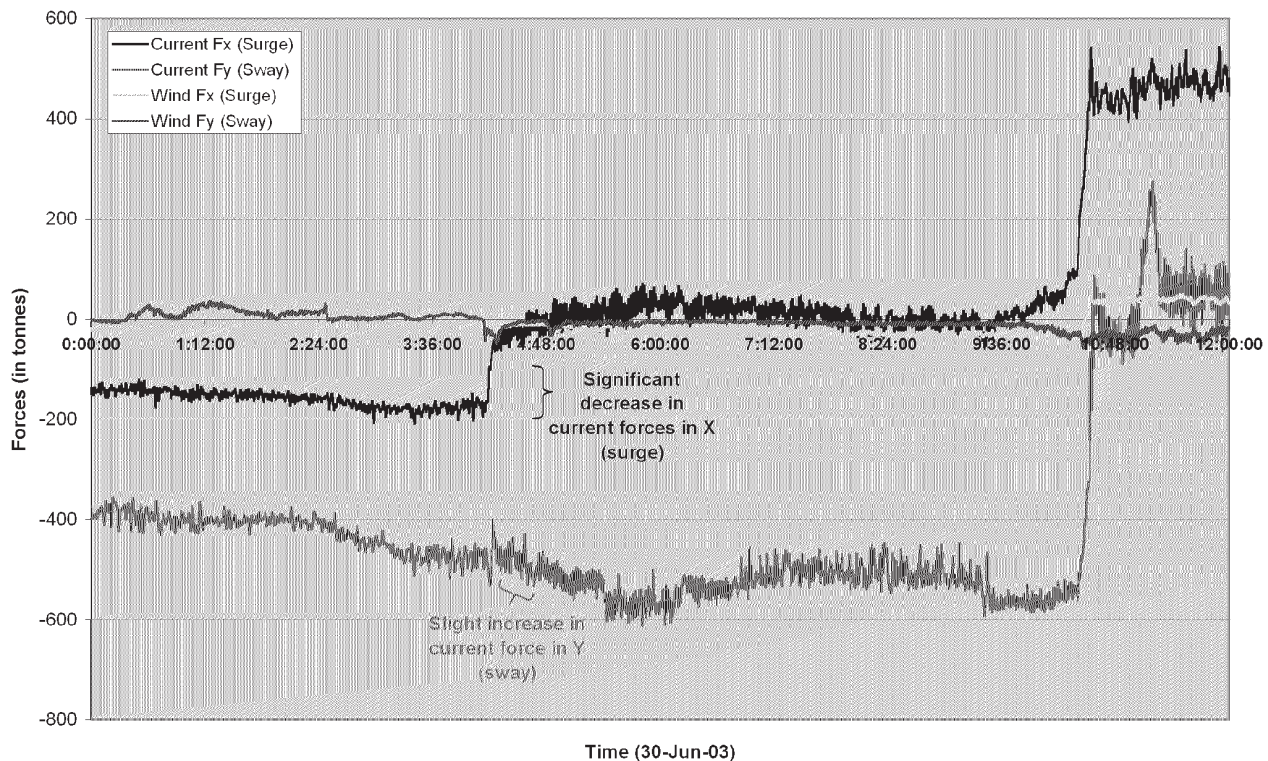
Wind and Current Forces on the Vessel

Looking at the forces acting on the vessel before and after the heading change, the consequence of the heading change was a significant decrease of “calculated current” forces in Surge and a slight increase of the “calculated current” forces in Sway. This is indicated on the graph below.

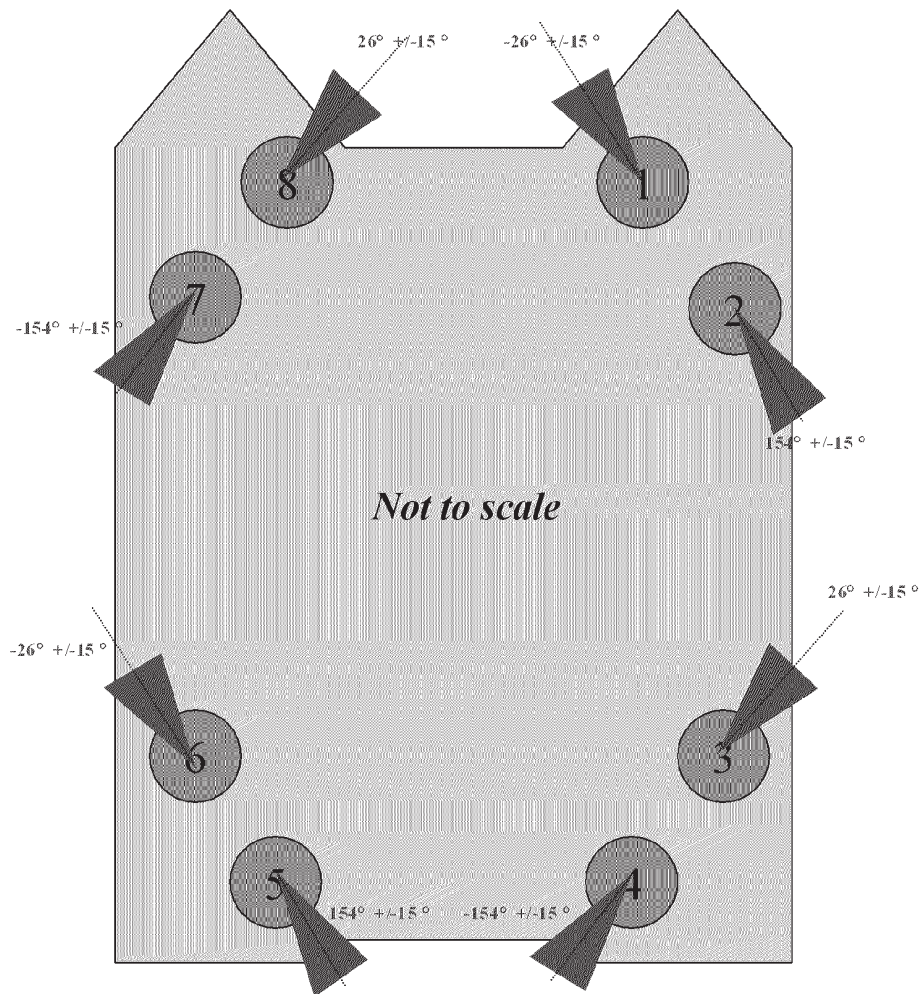
Each thruster on the Deepwater Horizon is fitted with one Azimuth Forbidden Zone designed to protect the closest thruster. These forbidden zones are only active in the software if that other thruster is in use. **Please note that these forbidden zones are the only ones active in the software.** For example, if Thruster 2 is in use, then the Azimuth Forbidden Zone for Thruster 1 will be active, and vice-versa. The Azimuth Forbidden Zones are indicated on the simplified schematic below.

Thrusters interaction between Thrusters 2 & 3 and Thrusters 6 & 7 is considered negligible in view of their 38.7m (127') separation.

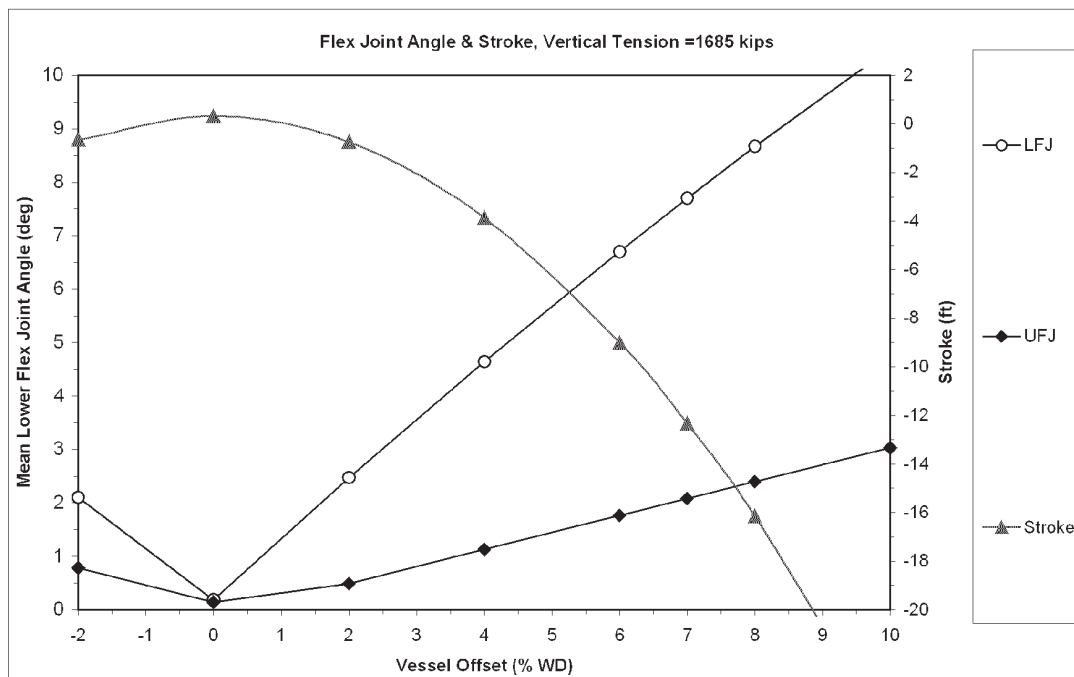
Figure 4.1 Riser Operability – 10-yr Winter Storm, 16 ppg Mud 1685-kips Vertical Tension

Riser operability performance was studied for a 16-ppg mud weight in various storm and current environments. A composite plot of flex joint angle (upper and lower) and stroke as a function of offset are provided in Figure 4.1 and Figure 4.2 for each environment. For drilling operations, Table 4.1 provides allowed excursions versus estimated DP station keeping performance. The results indicate extremely good riser operability for the typical 10-yr return winter storm and loop events.

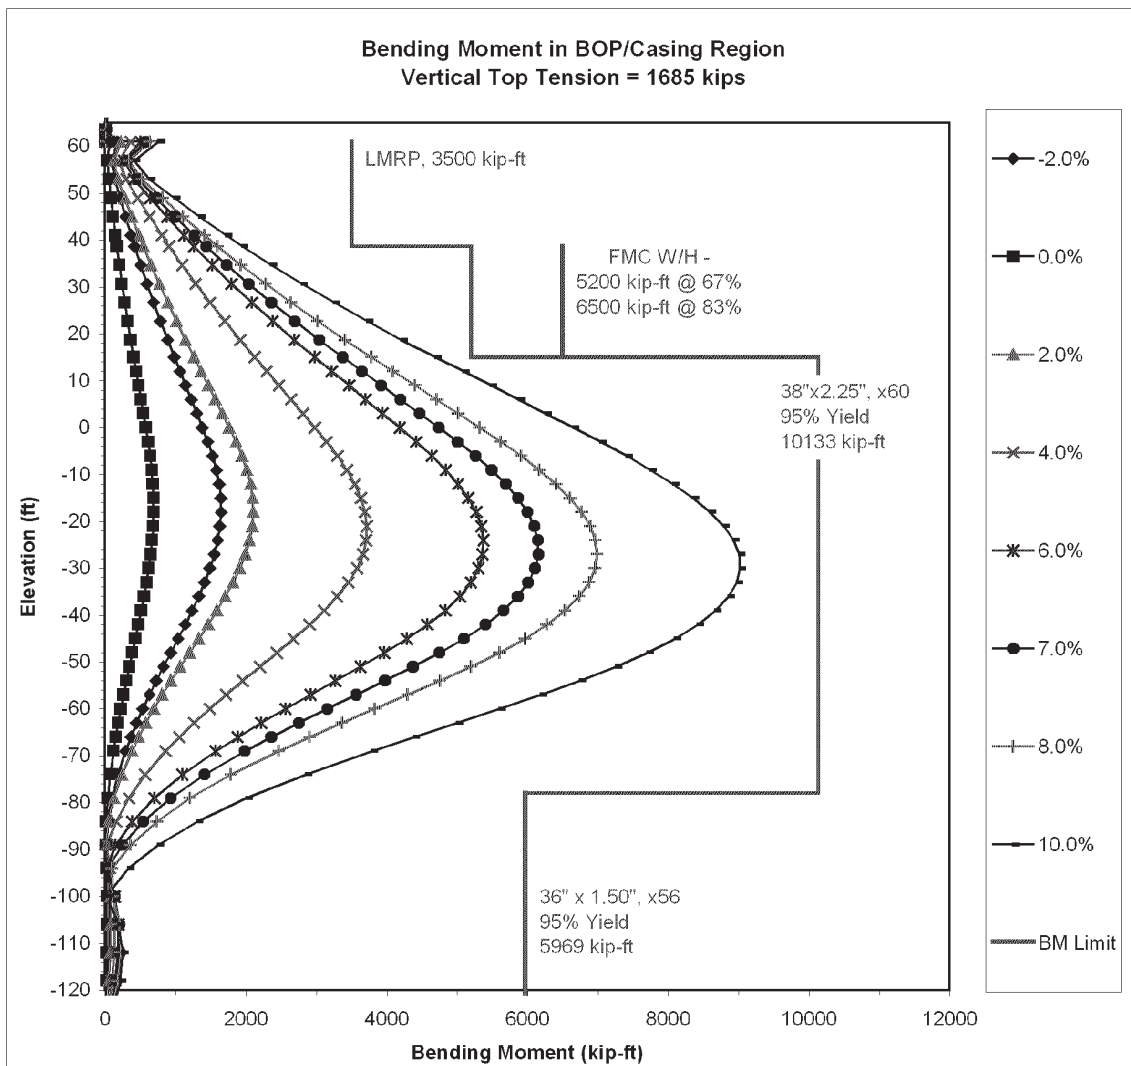
Figure 4.3 Casing Bending Moment vs. Offset – 10-yr Winter Storm

Figure 4.3 and Figure 4.4 provide bending moment profiles in the casing and stack regions for the 10-yr winter storm and loop current environments. Results are presented for various vessel offsets with 16-ppg mud. On each figure, the limiting bending moment is shown as a vertical line for each the LMRP, BOP, and casing regions.

For offsets out to the point of stroke out (~9% offset) the 10-yr winter storm and loop current events generate bending moments that are within the allowed values for both the wellhead and casing components. First yield of the casing should not be exceeded until beyond 10% of water depth.
