Subject: Deepwater Horizon

Reference: Acceptance of Well Control Equipment

WEST Report # 1040

Section 1: Project Summary

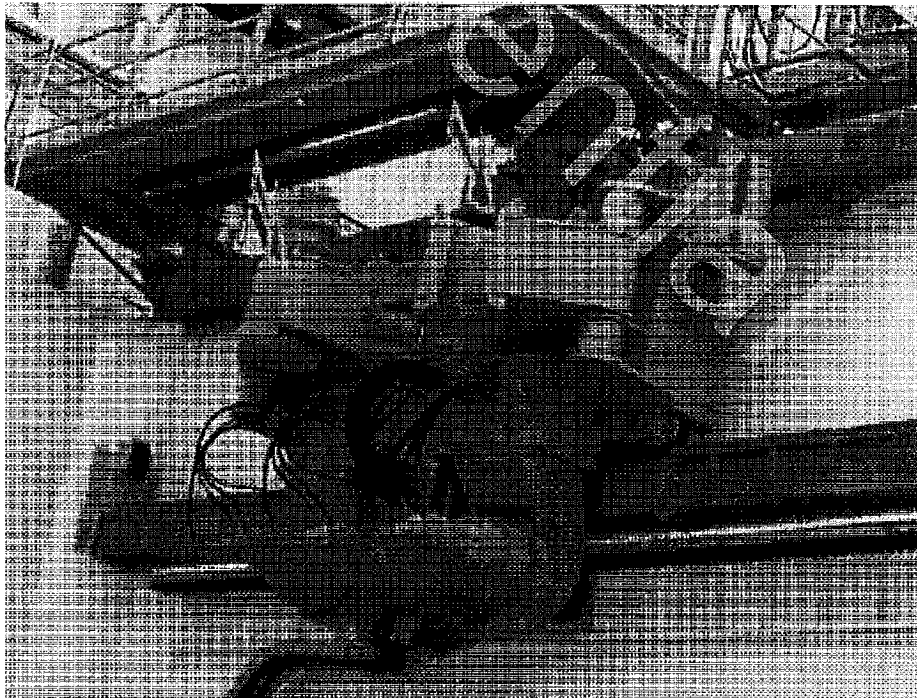
6.8 The BOP handling system should be a good system. It has the BOP and LMRP captured at all times when moving it. This shows the gripper arms used to secure stack the BOP when it is on the test stump.
