# BOP Timeline

Apr. 20

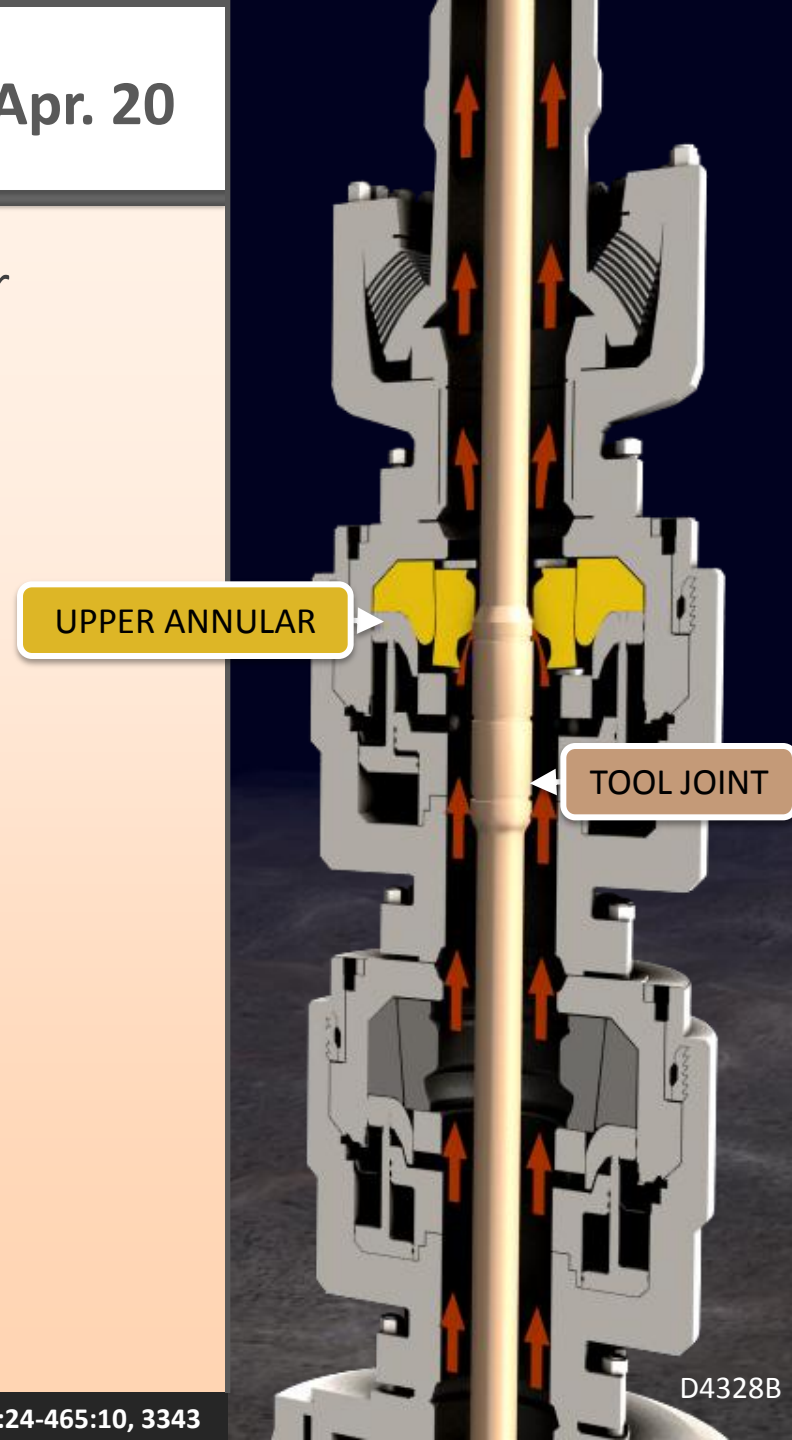
- ~21:40 – Mud overflowed onto the rig floor
- **21:42 – Annular closed**
  - Annular closed on tool joint shoulder which prevented the annular from sealing
