VBRs Closed and Sealed

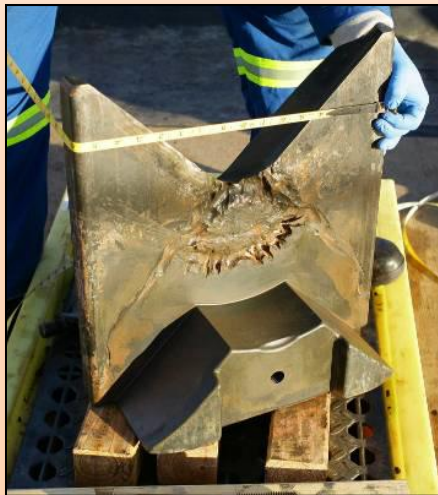
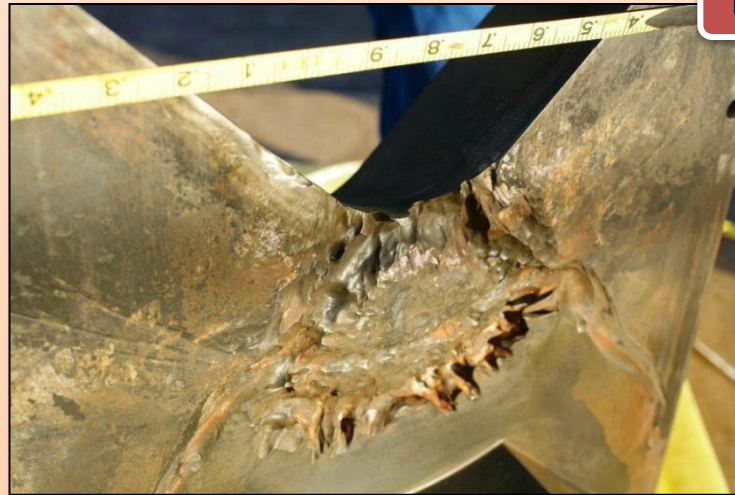
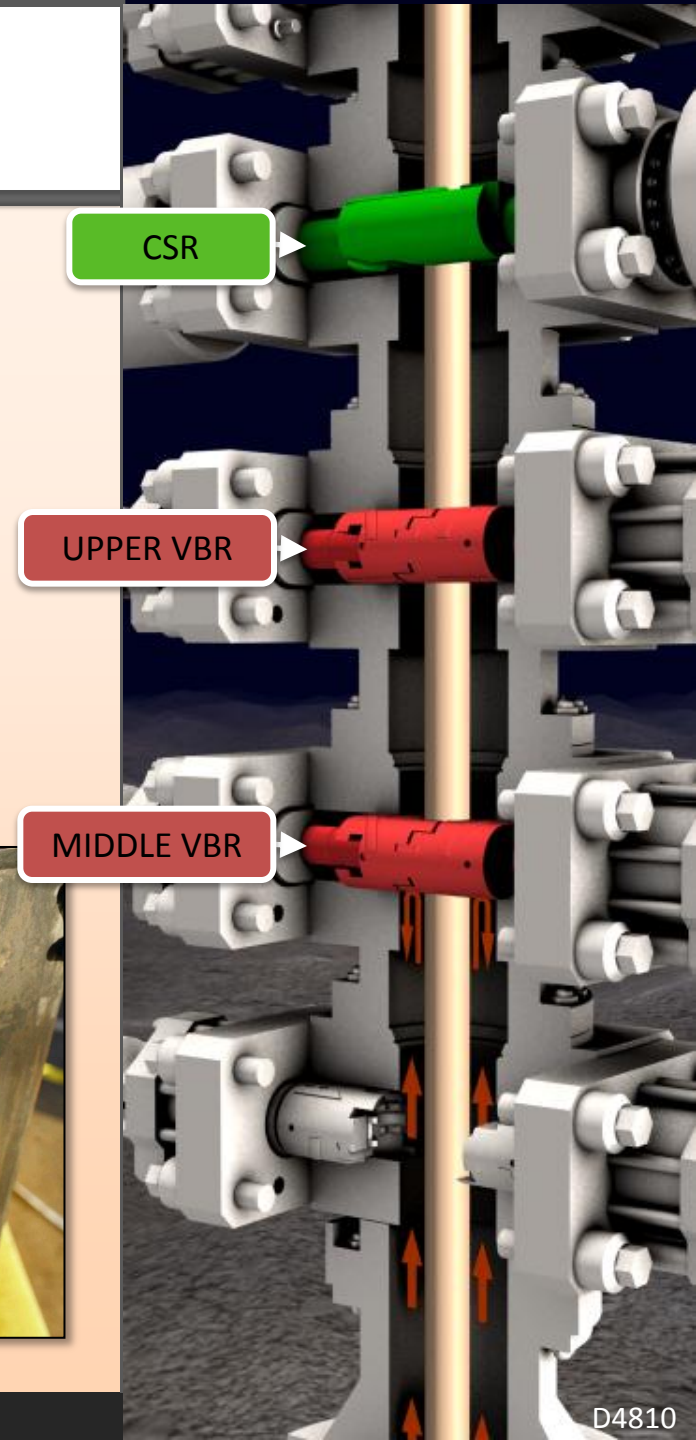
- VBRs must have held seal until April 29 when casing shear ram closed
 - Erosion on underside of CSR supports flow through drill pipe
 - VBRs below the CSR sealed the annulus causing concentrated flow up drill pipe
