BSR Did Not Fully Close Due to Drill Pipe Partially Outside Its Blades

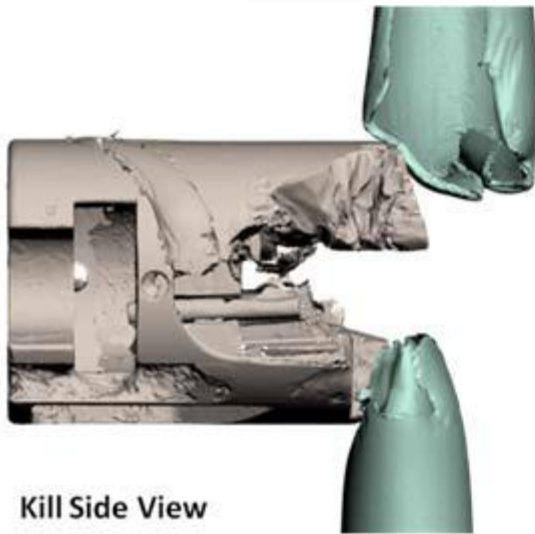
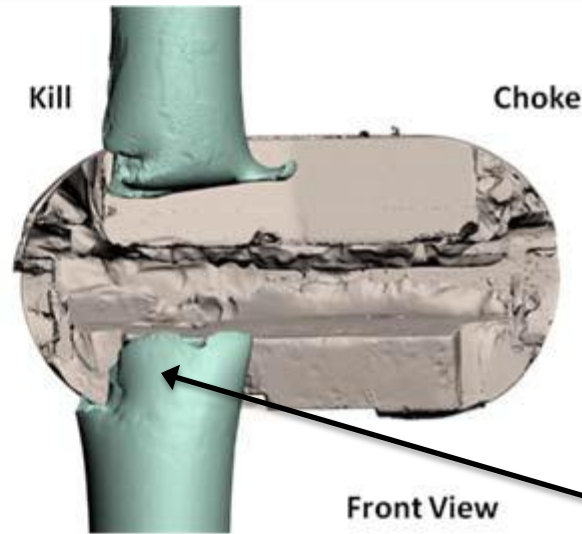
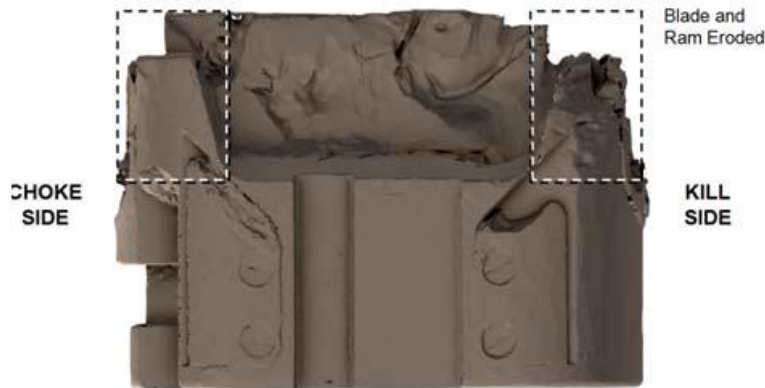
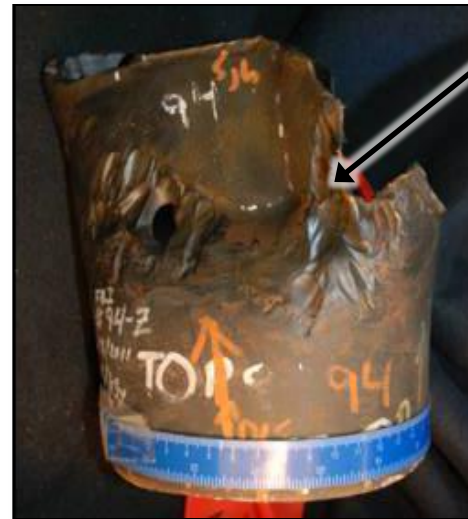
Physical evidence shows the BSR was unable to fully close because the drill pipe was partially outside its blades
