Evidence Supports Force From Above Being Transmitted to Drill Pipe Below BSR

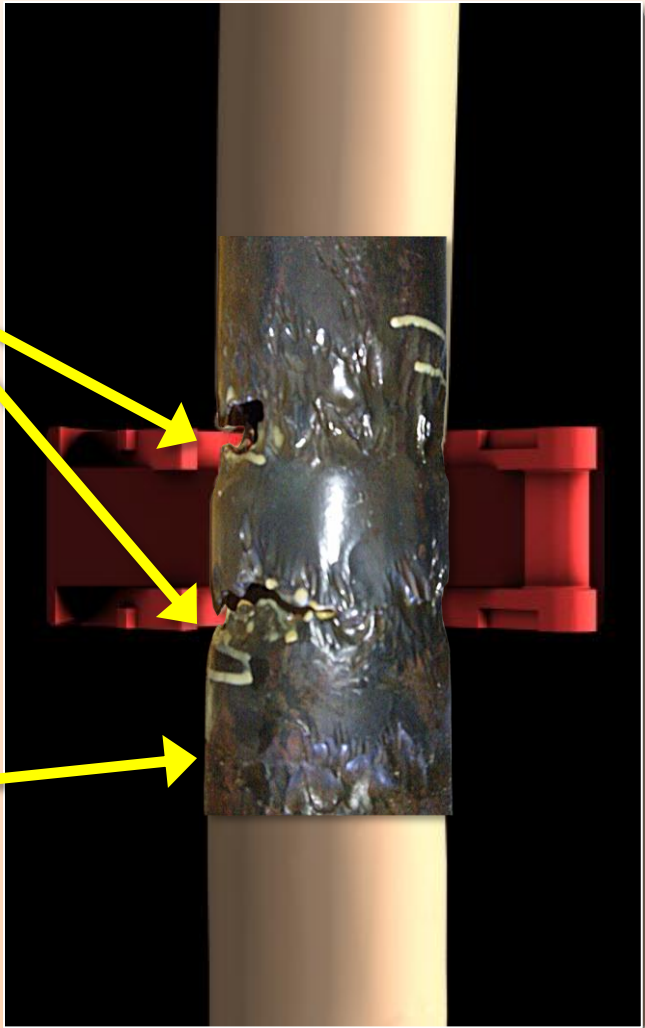
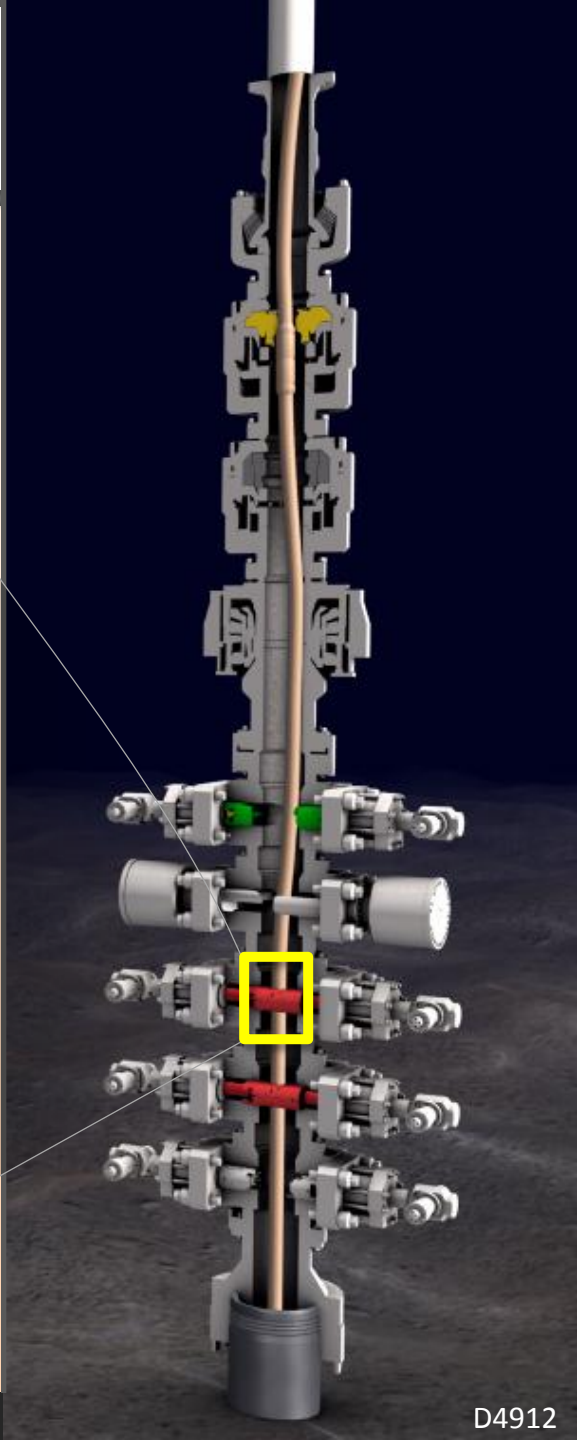
Heavier erosion at likely second VBR seal

Lighter erosion at likely first VBR seal

Segment 148: Showing erosion patterns where contacted upper VBR
