*In re: Oil Spill by the Oil Rig Deepwater Horizon  
in the Gulf of Mexico on April 20, 2010,*

**REBUTTAL EXPERT REPORT  
OF FORREST EARL SHANKS II**

November 7, 2011

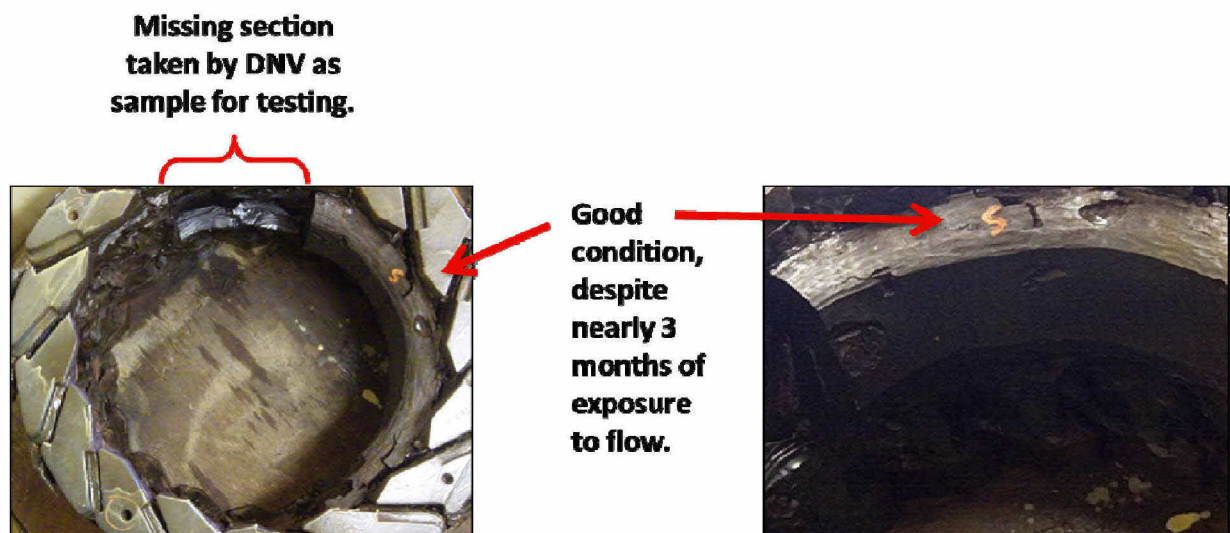
**Figure 1. DWH Lower Annular**

The below picture of the DWH's lower annular illustrates this point. It was taken during the forensic examination of the DWH BOP in Port Michoud, and shows that approximately half of the packing element of the lower annular remains in good condition, despite its exposure to nearly 3 months of flow after the blowout:

The BSRs would have been exposed to different conditions, depending on whether the VBRs sealed the wellbore at the time the BSRs were activated.<sup>22</sup> In either case, however, the BSRs would have only been exposed to erosive flow for a few seconds before they would have sealed. The presence of flow does not necessarily mean that the elastomeric elements will erode immediately, or even at all, because erosion typically requires extreme flow velocity and that is directly applied to a surface.

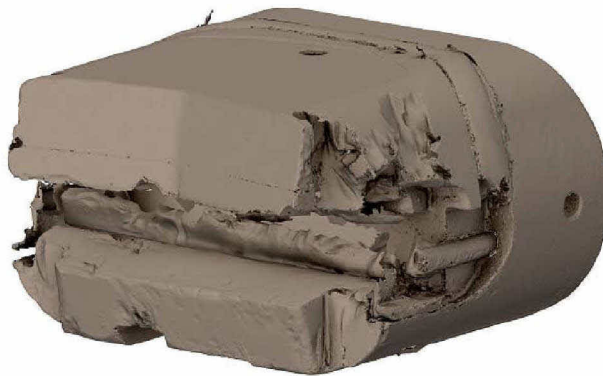
**Figure 2. Erosion Varies Based on Exposure to Erosive Conditions**

Even the BSRs, which were closed all but a few inches, sustained greatly varying levels of erosion in different areas despite months of exposure to flow:

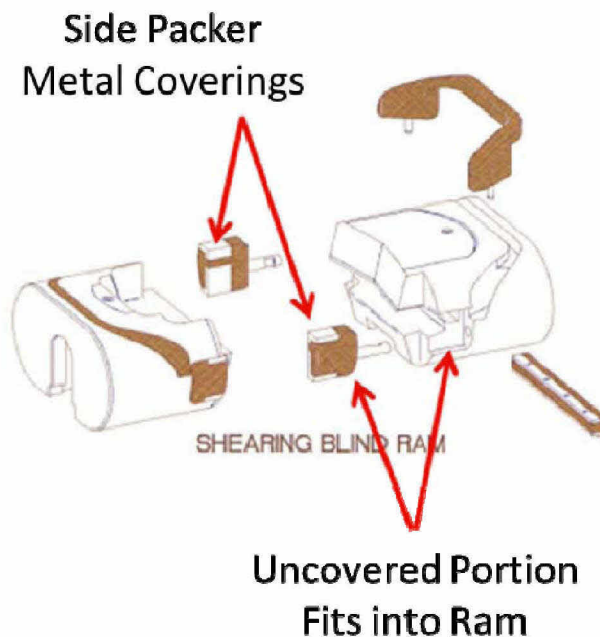
**Figure 3. Cameron SBR Side Packers Have Metal Coverings**

Moreover, metal erodes more slowly than elastomeric material, and the majority of the side packer material facing the flow is designed by Cameron to be protected by metal coverings or by being inserted into the ram blocks themselves:<sup>23</sup>

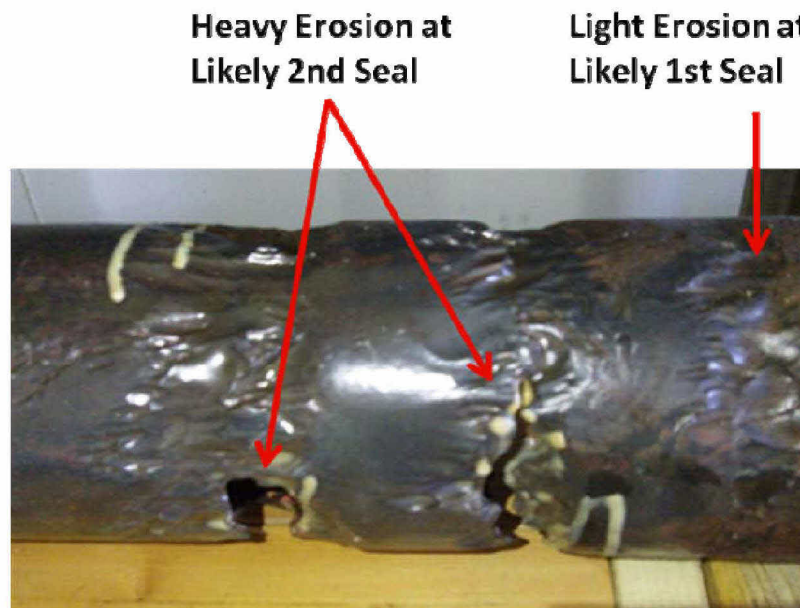
**Figure 4. VBRs Appeared To Have Sealed Despite Minor Erosion.**

Moreover, the amount of erosion depends on the length of exposure to the erosive conditions. BOP packers may remain able to form a seal even after brief exposure to erosive forces. For example, the picture below shows the section of the drill pipe that was found in the upper VBRs. It appears that the VBRs sealed on April 20 in a first location, despite being exposed to erosive forces that resulted in minor erosion to the drill pipe, which would also have caused erosion on the VBR packer. This erosion was likely caused by fluid jetting between the VBR packers and the drill pipe in the moments just before the VBR achieved its seal. It appears that the drill pipe subsequently moved down a few inches, where it remained and experienced significant erosion over time. Even in the presence of sufficient force to erode steel, the upper VBRs were still apparently able to create a seal in at least the first location.
