**Subject: *Discoverer Enterprise***  
**Reference: Acceptance of Well Control Equipment**

WEST Report #3925

WEST was requested by BP to go to the *Discoverer Enterprise* to perform an audit of the well control equipment in regards to its fit for purpose condition.

**Section 3: WEST Recommendation Summary and Disposition**  
**Discoverer Enterprise, Job #3925; 27 April to 16 May 2010**  
**Prepared for BP**

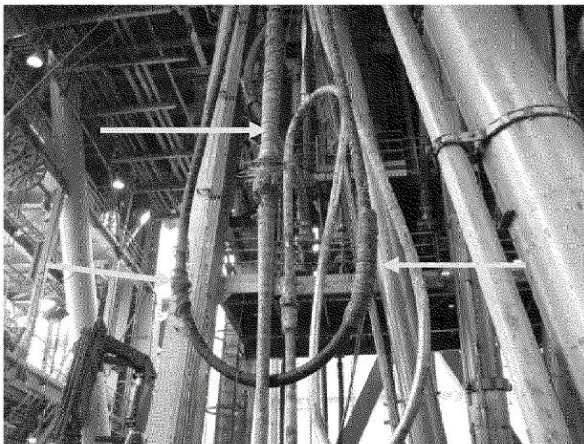
**Figure 1:** Damaged moonpool Coflexip type hoses

The Coflexip type hoses in the moonpool were visually inspected. All hoses in the moonpool were observed to have damage to the outer protective sheath, and will need to be replaced. It was also noted that the moonpool hoses didnot have safety slings installed. Safety slings should be installed from the rig hard piping to the Coflexip type hoses. Reference IADC Safety Alert00-24. See Figures 1 and 2.

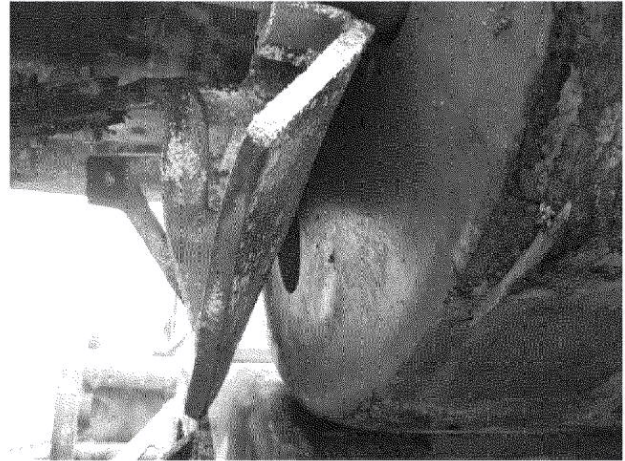
**Figure 3:** Damaged riser buoyancy thrust collar.

The riser on deck was spot checked. The overall condition of the riser was in satisfactory condition. Several buoyancy module thrust collars were found to be bent and will need to be repaired or replaced, the thrust collar nuts and bolts were found to be corroded and should be replaced.

Several buoyancy modules were observed to be damaged; these damaged modules should be repaired. See Figure 3.

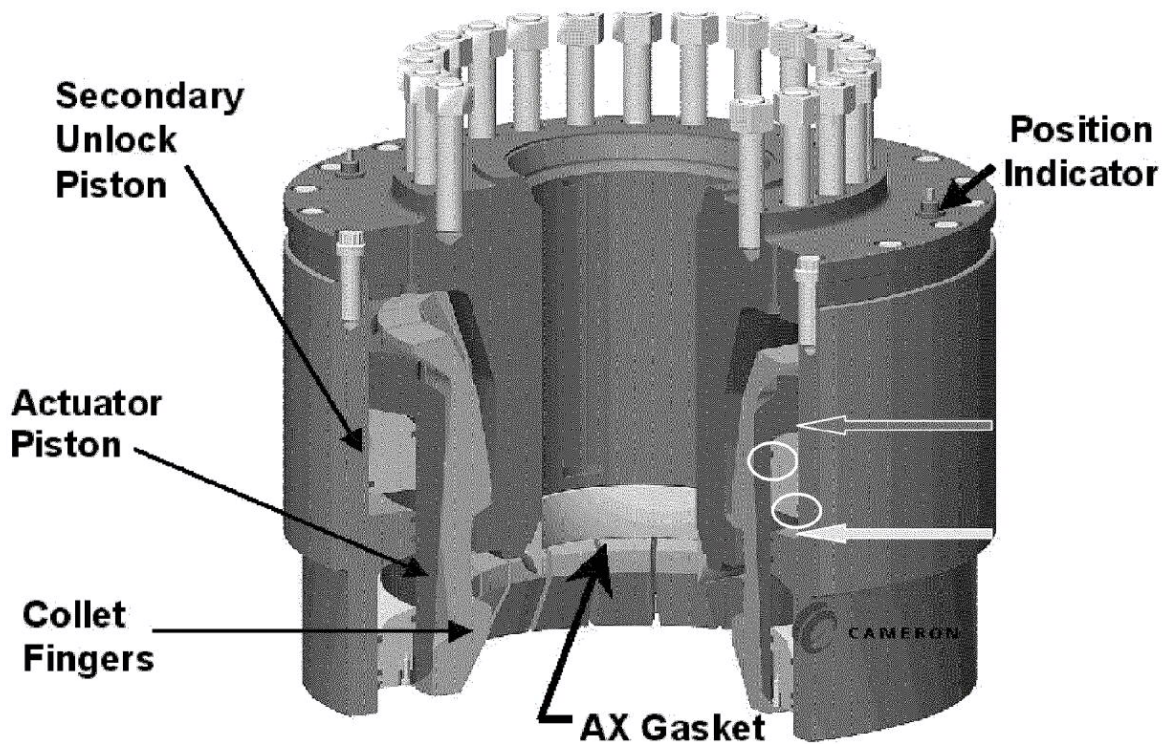
**Figure 4.3:** The yellow arrow shows the HC Collet Connector secondary unlatching cylinder, the two circles show the secondary piston seals, one of these two (or both) seals has failed causing operating fluid to migrate upward into the primary unlatching cylinder area, shown with the green arrow.

Figure 4.3 refers to the Cameron HC Collet Connector delivered to the rig to be fitted into the wellhead connector position.

Prior to fitting the connector had operator pressure tests carried out to determine the integrity of the hydraulic circuits. The primary lock circuit and primary unlock circuit's were both successfully tested to 3,000 psi /10minutes. The secondary unlock circuit could not be tested and was found to be communicating with the primary unlock circuit, fluid was visible leaking back through the primary port at the connector head. The leak was witnessed by WEST and Transocean, pressure testing was suspended awaiting a response from the OEM and Transocean management.

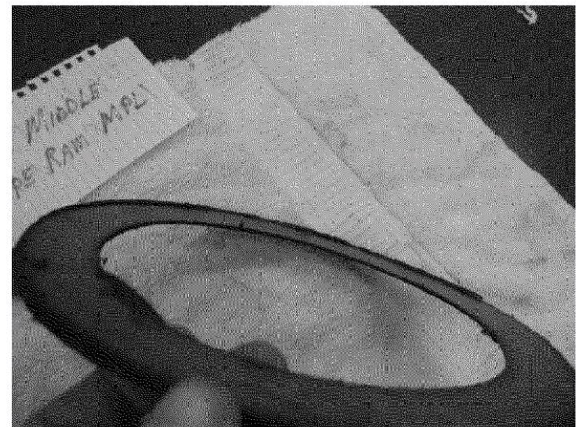
**Figure 5.1:** The aft middle pipe ram MPL locknut bearing that was replaced.

A signature test was performed on the aft middle pipe ram open and close ports. The pressure to open or close should be in the 100-200 psi range. The pressure to open the ram was 380 psi. If a pressure greater than 200 psi is required to open or close the ram, the locks should be disassembled for inspection. The MPL was removed from the housing and both locknut bearings replaced. The aft middle pipe ram MPL has yet to be retested. See Figure 1.

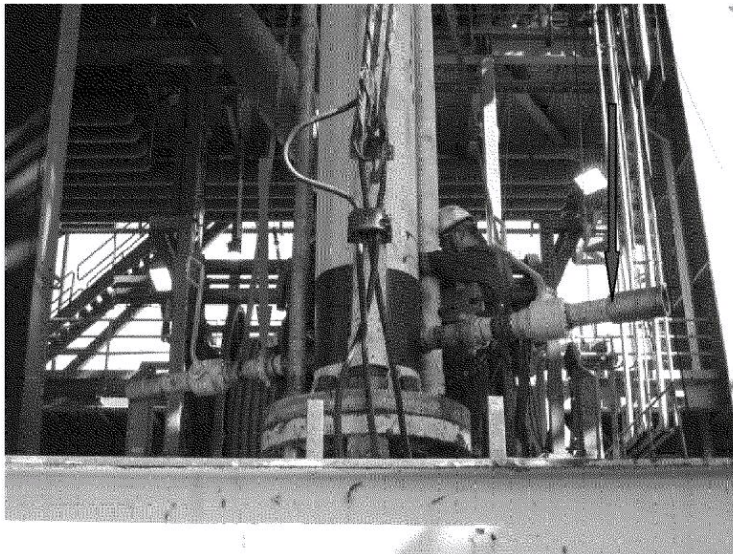
**Figure 12.2:** ROV operated ball valves (red arrows) installed and MUX cables installed on the riser joint.

Two ROV operated ball valves were mounted near the bottom of the first riser joint and secured with straps. MUX cable clamps were installed on the first joint of riser and the MUX cables were secured within the clamps. See Figure 12.2.
