Macondo System is Not Constant Over Time: Drillpipe Detached

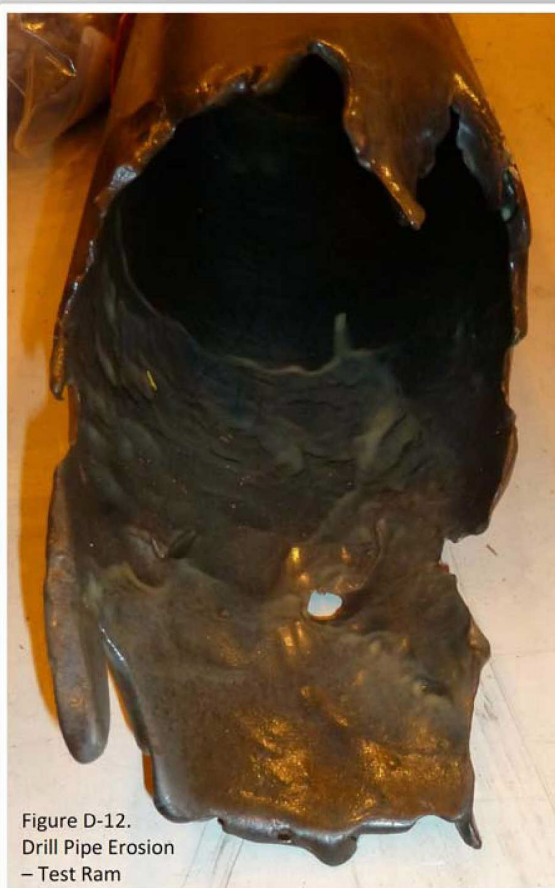
Figure D-12.
Drill Pipe Erosion
– Test Ram

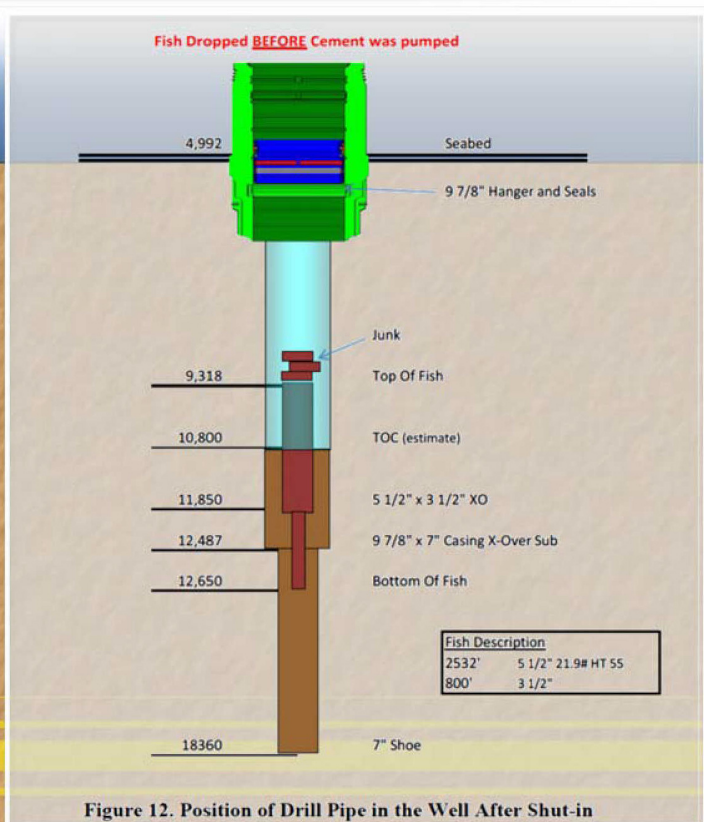
Figure 12. Position of Drill Pipe in the Well After Shut-in
