MACONDO WELL INCIDENT
Transocean Investigation Report
Volume II

June 2011

Appendices

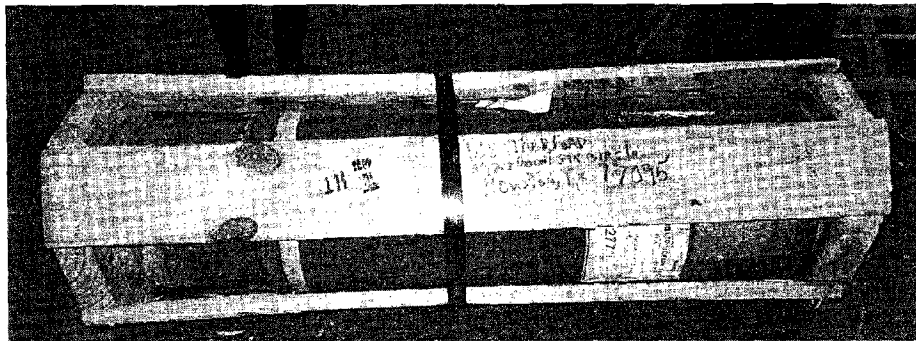
Figure 1: As-received Sample 1

On September 1, 2010, an exemplar cementing float was delivered to Stress Engineering by the Transocean Investigation Team. It is the understanding of SES that this float has never been used in an on-site drilling application. The sample was packaged in a wooden crate secured with a metal band; see Figure 1. The box and pin ends were protected with paper and masking tape. The label on the end of the crate was identical to the label on the float. The impression on the float reiterated the information found on the paper label; see Figure 2. The crate was disassembled so the float could be photo documented under Transocean Offshore Deepwater Drilling, Inc.'s supervision. See Appendix A for complete unpacking pictures.

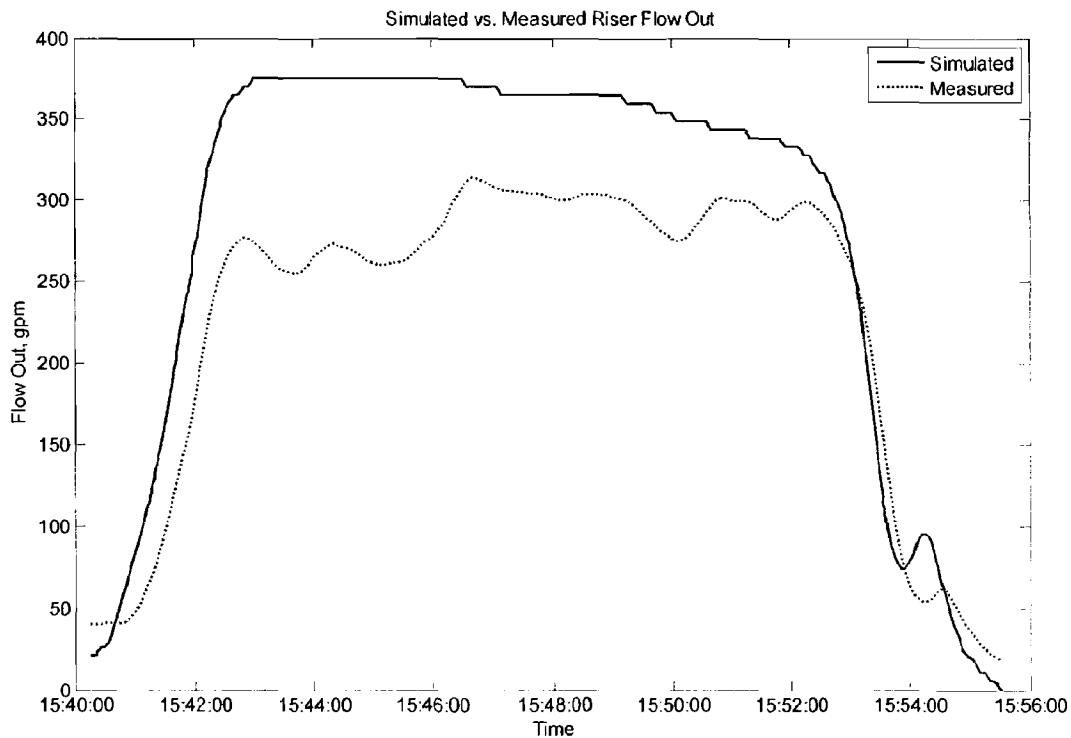
Figure 16: Simulated flow out vs. measured flow sensor data, kill line displacement

The Sperry-Sun flow sensor data indicates a response similar to that observed for the choke line displacement. Figure 16 compares the simulated output to the measured flow sensor returns. Integrating the sensor data over the pumping interval indicates a return volume of 84.8 bbl, compared to the anticipated pump volume of 106.1 bbl. This suggests a volumetric efficiency for rig pump #2 of 76.8% (see Table 14).

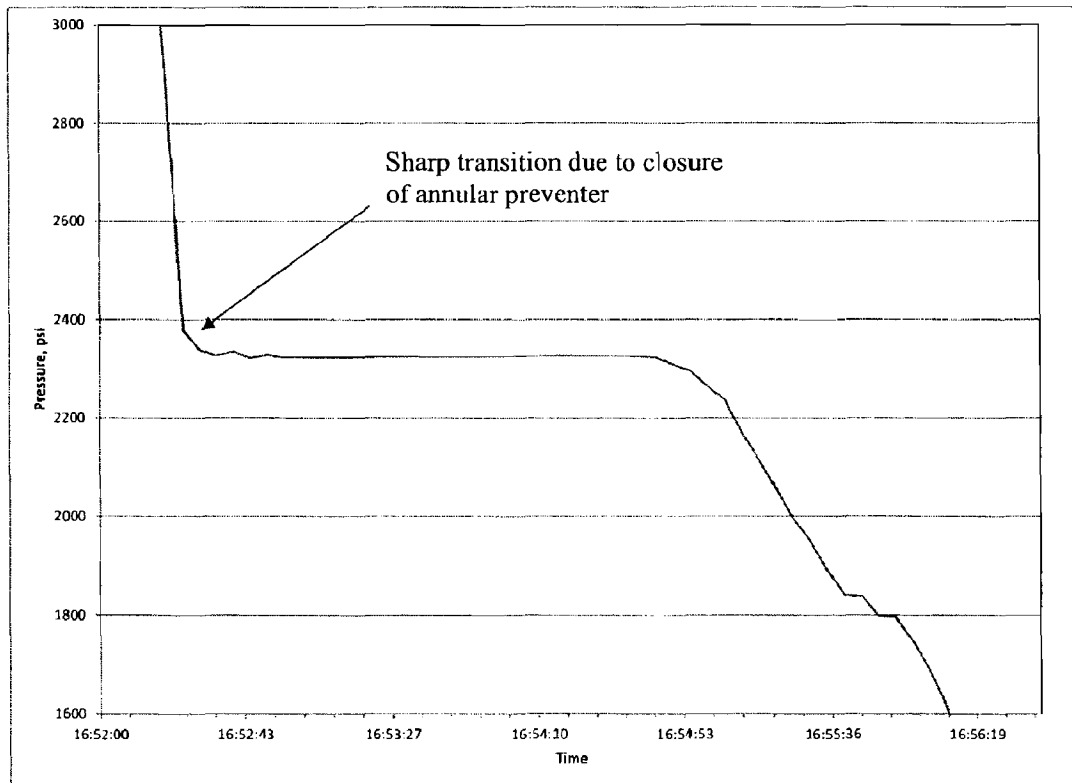
Figure 30: Standpipe pressure signal during annular preventer closure

The measured standpipe pressure of 2,325 psi was higher than the calculated value. Based on the shape of the pressure decay just prior to reaching this point, it is surmised that the annular BOP was closed prior to reaching hydrostatic equilibrium; hence the discrepancy in pressures. See Figure 30.
